EVOLUTION OF THE MORPHOLOGY SURROUNDING DETERIORATING SHORE-PARALLEL PROTECTION STRUCTURES ON SANDY ESTUARINE BEACHES

KATHERINE HELEN KOROTKY

Rutgers, The State University of New Jersey

JANUARY, 2019

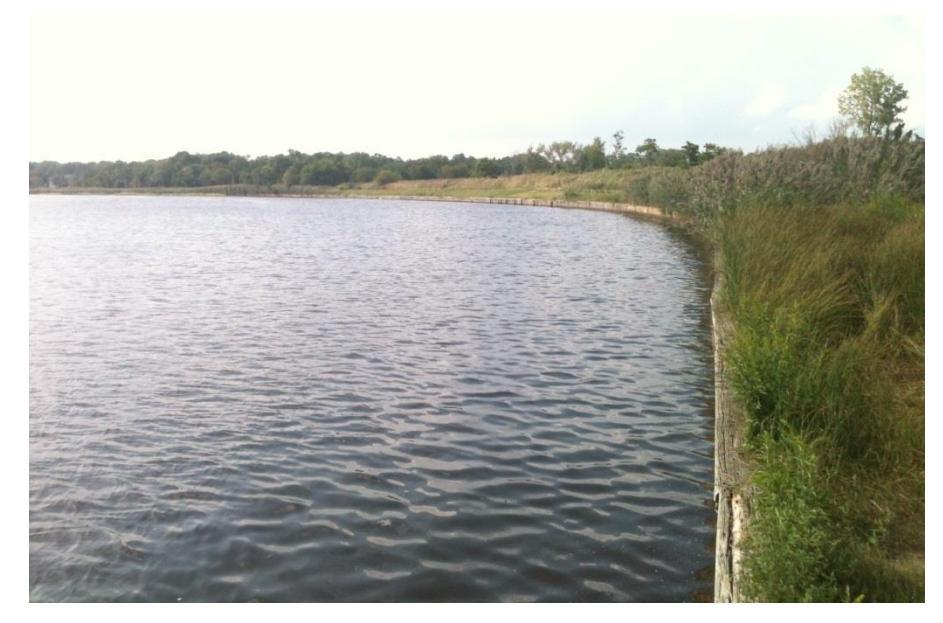
Figure 17. Bulkhead 9 at the Great Kills site contains no gaps erosion landward.

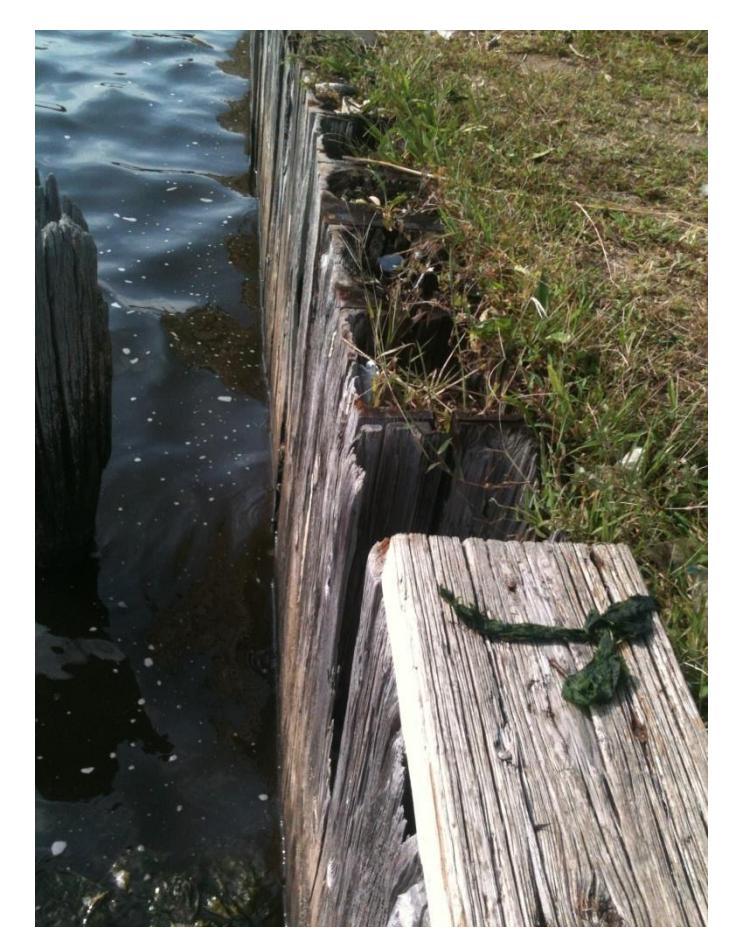
Figure 18. Sections of the cap board are missing and portions of the interior of the sheet piles are eroded on Bulkhead 9 at the Great Kills site.

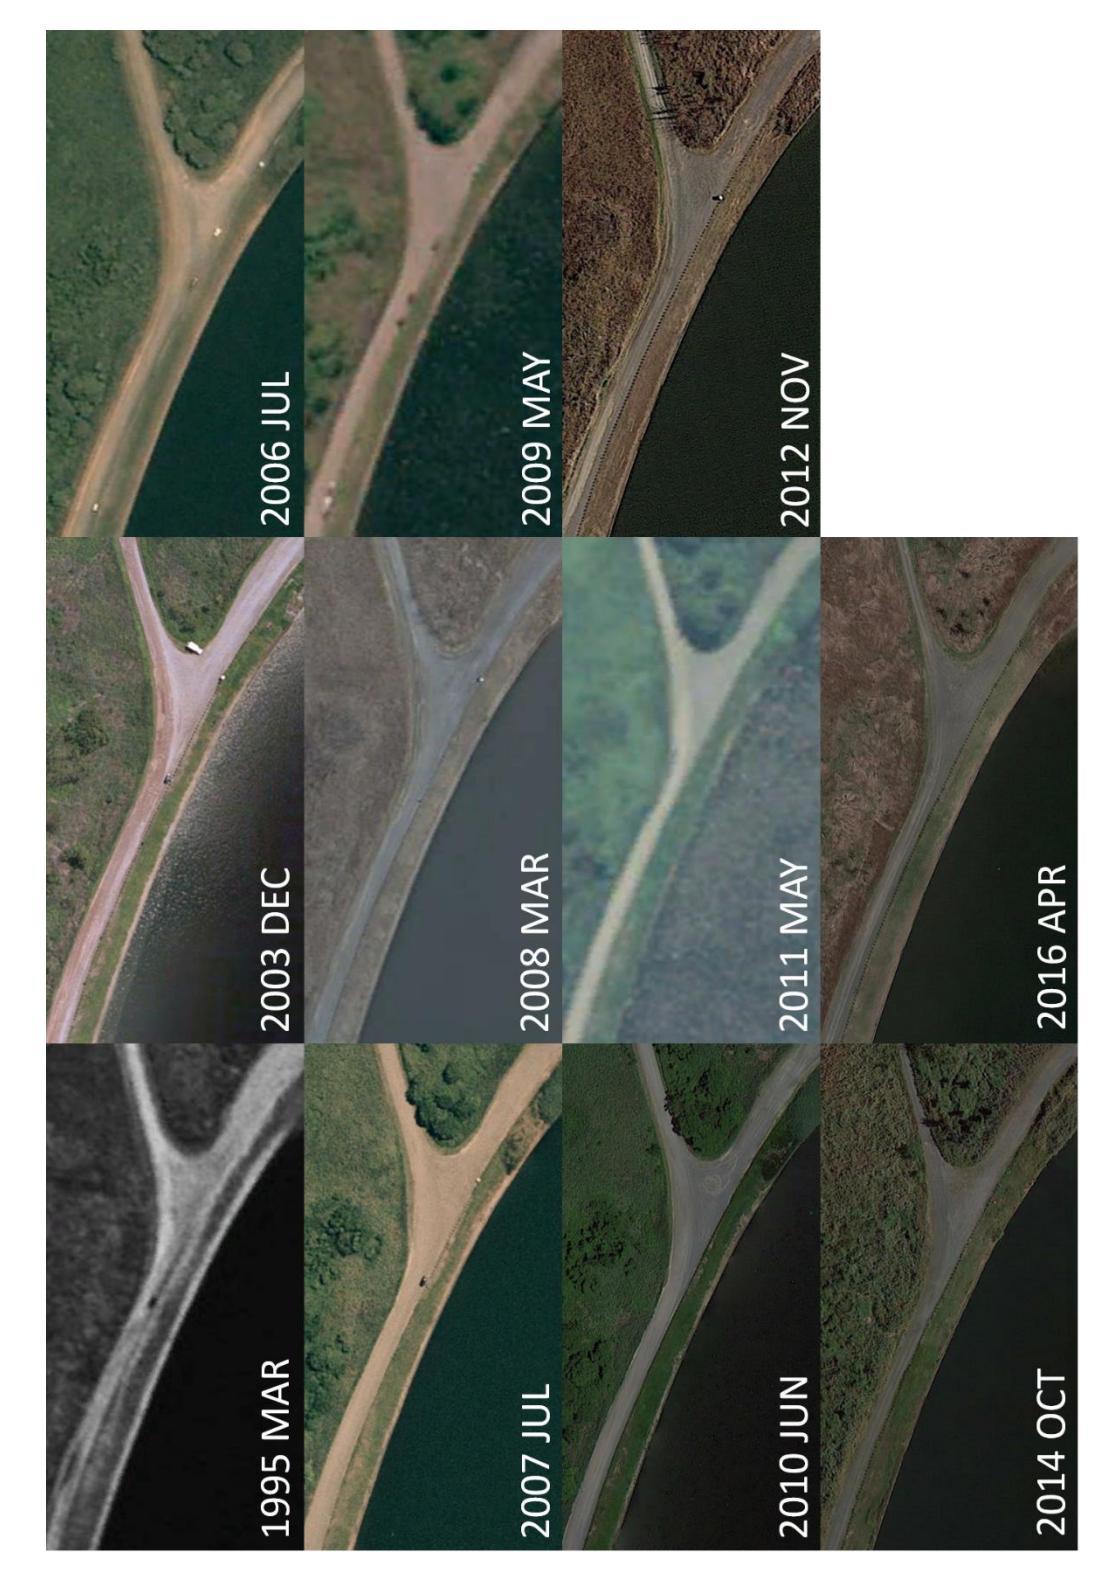
Figure 21. Bulkhead 9 at the Great Kills site has remained intact over the last 26 years. Historical imagery obtained from Google Earth.

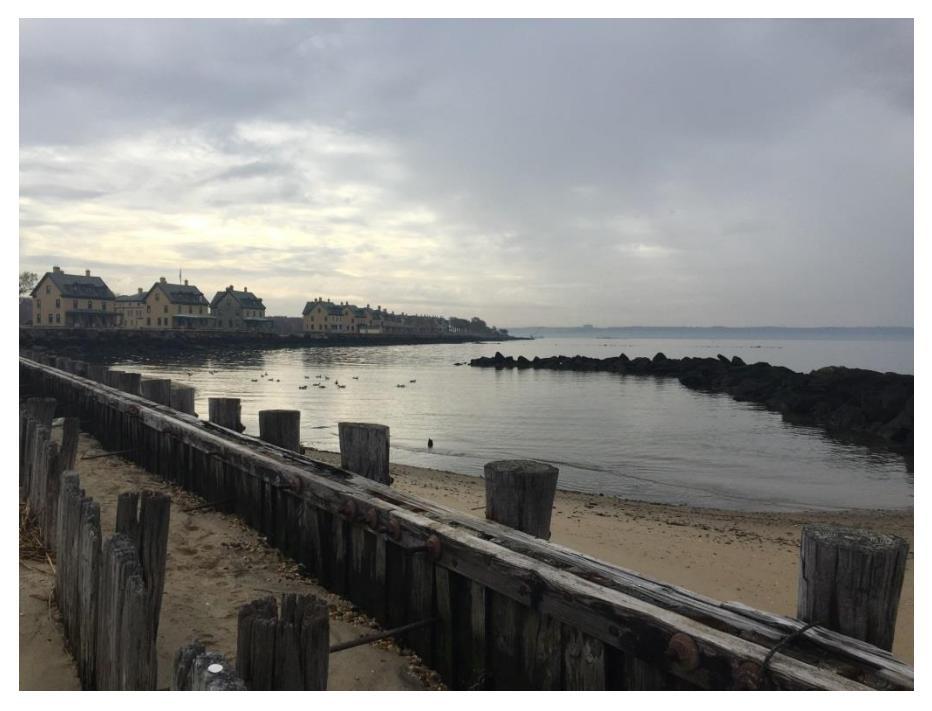
Figure 23. Bulkhead 2 at the Chapel South site is largely intact. Revetment 1 is subaerial during low portions of the tidal cycle. Photo was taken looking to the southeast. Fort Hancock infrastructure is in the distance.

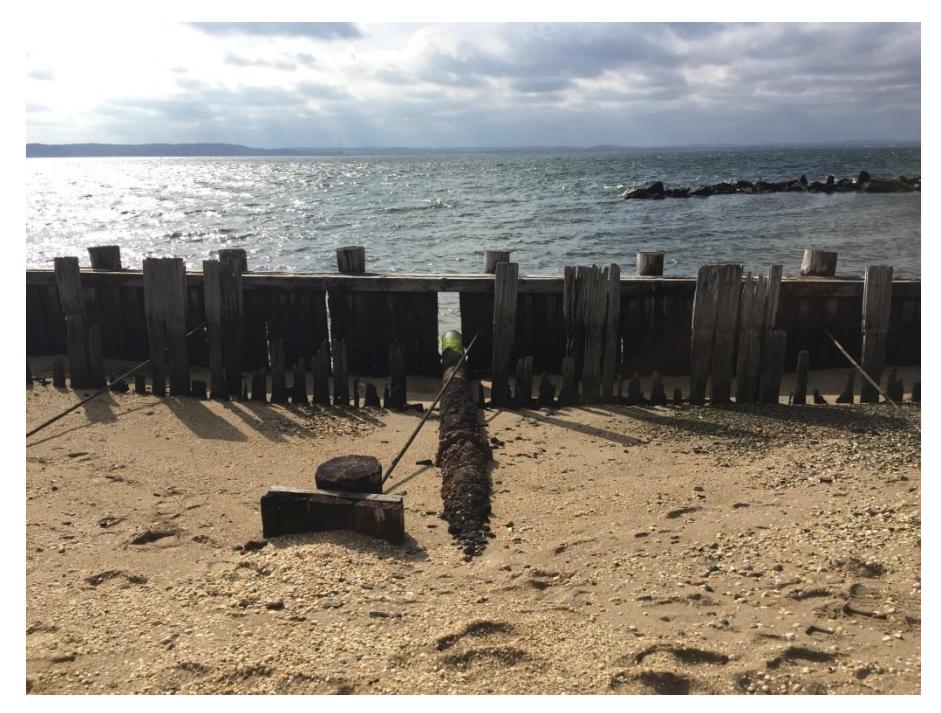
Figure 24. The largest gap (approximately 15 cm wide) in Bulkhead 2 at the Chapel South site allows an outflow pipe to pass through.

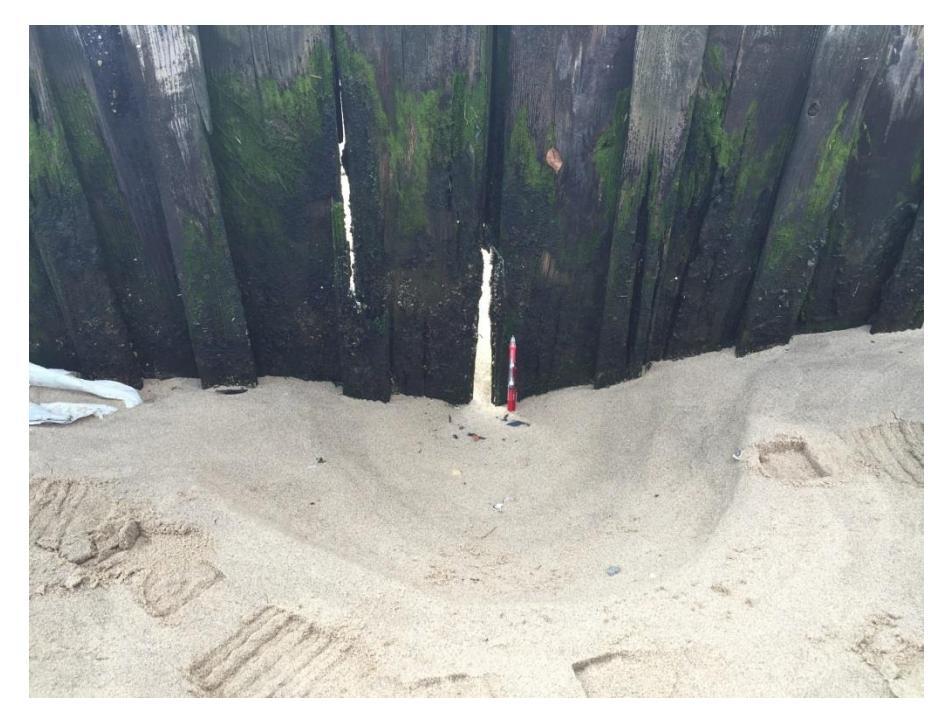
Figure 25. Most gaps in Bulkhead 2 at the Chapel South site are smaller than approximately 2 cm. Drainage cusps are found landward of the gaps.

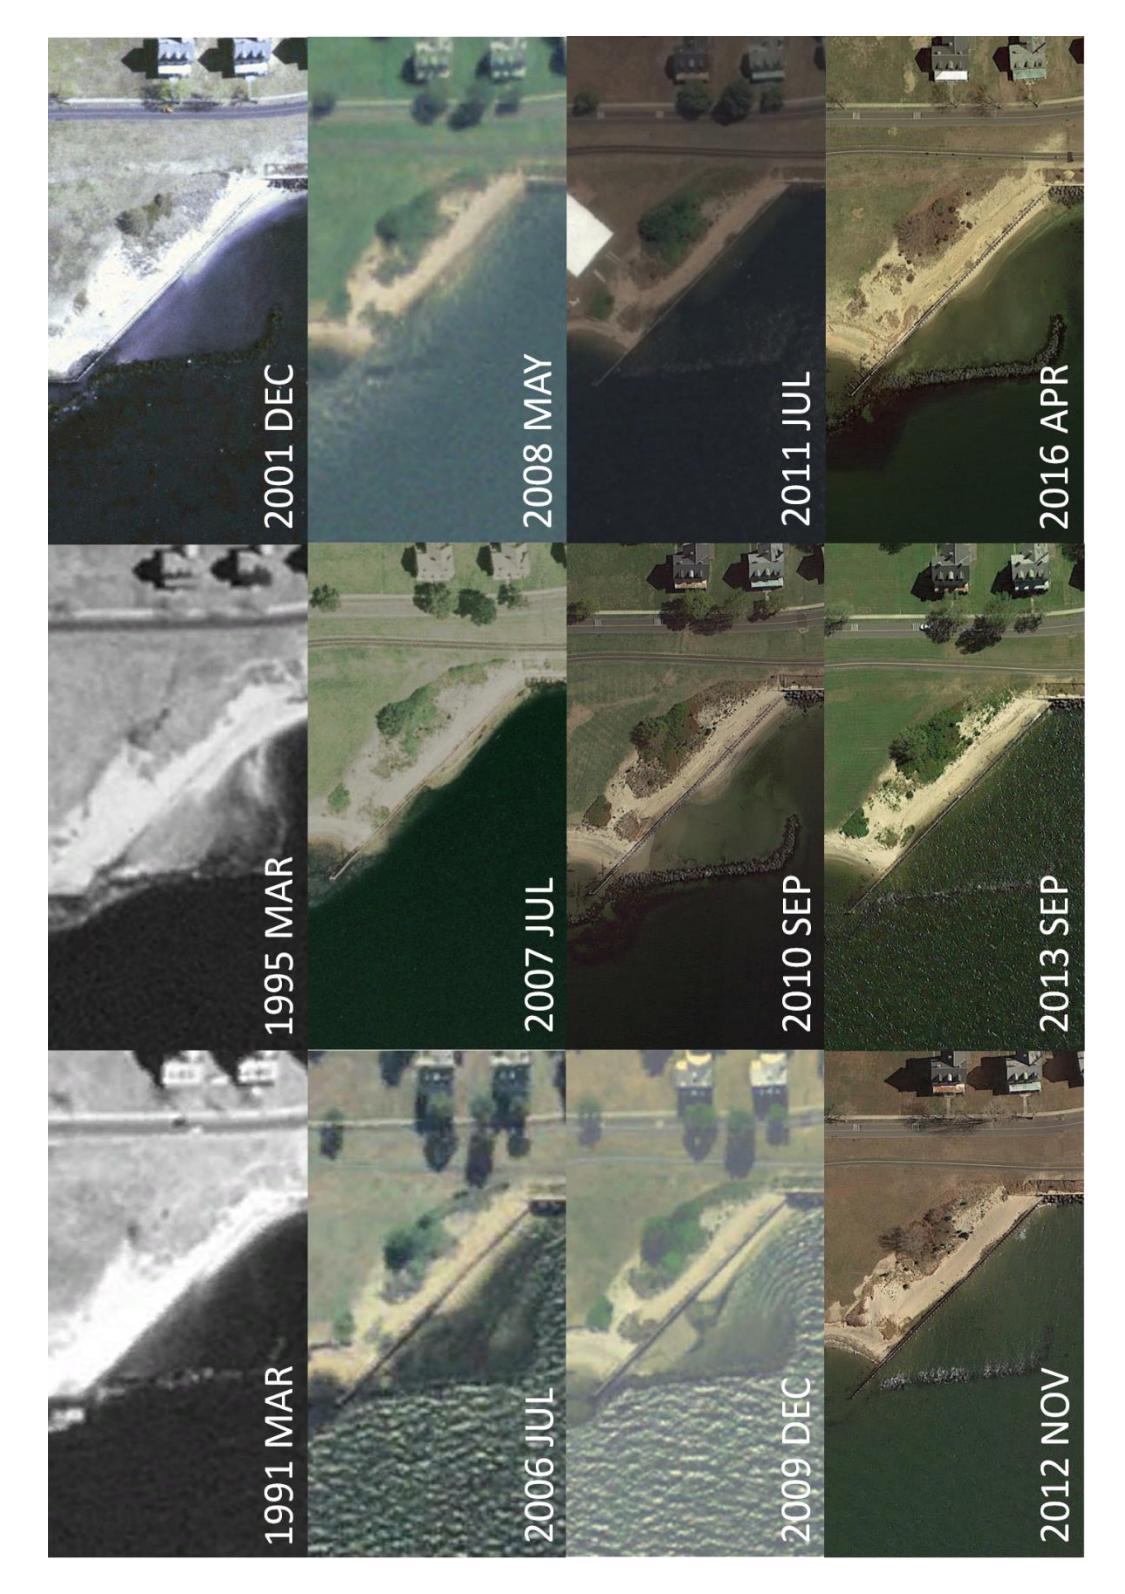
Figure 29. The width of the beach landward of Bulkheads 1 and 2 at the Chapel South site has increased over the past 26 years. Historical imagery obtained from Google Earth.

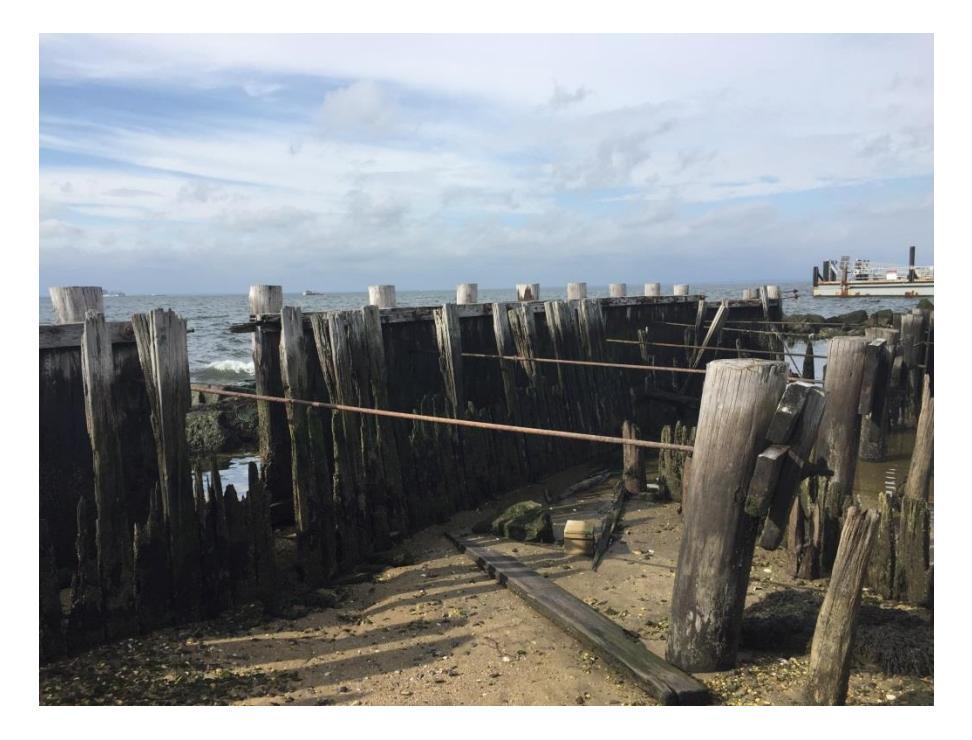
Figure 30. Bulkhead 1 (landward) is deteriorated; only remnants of piles and deadmen remain. Bulkhead 2 (seaward) is largely intact in some areas, while deteriorated in others. Photo was taken at the Chapel North site, looking northwest towards Sandy Hook Bay.

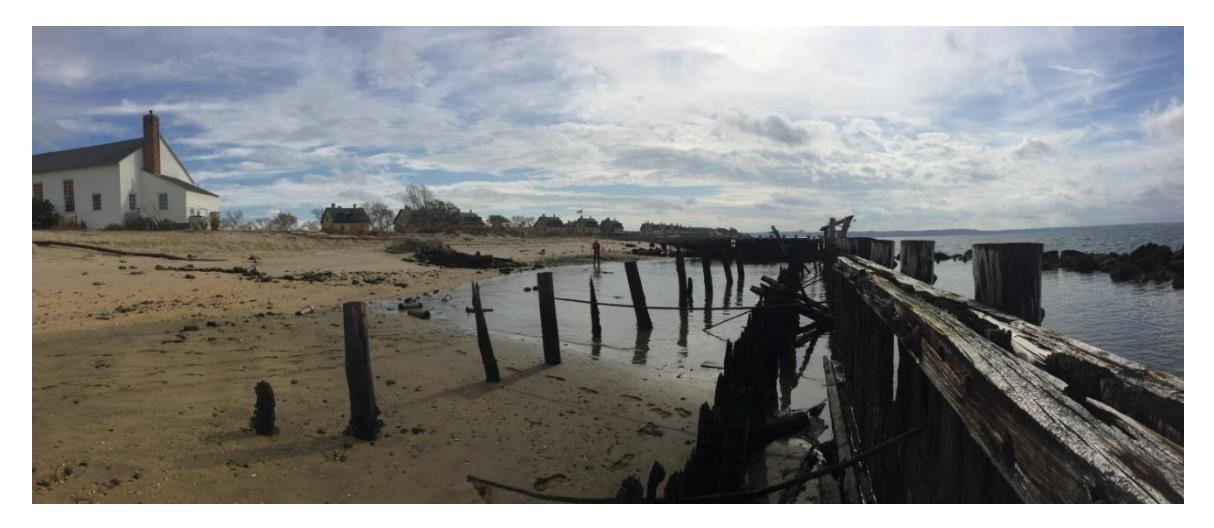
Figure 31. Three structures are present at the Chapel North site. Revetment 1 (far right) acts as a breakwater during low tidal stages. Photo was taken looking towards the south.

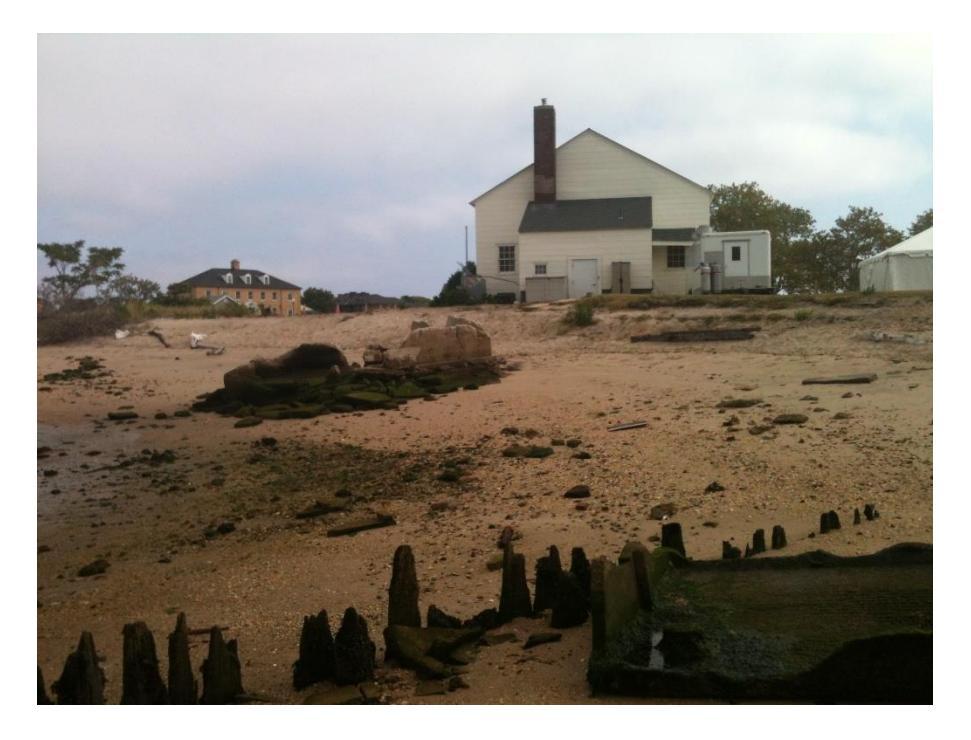
Figure 32. The beach at the Chapel North site is backed by an active erosional scarp, which is encroaching on the Chapel (right of center on the upland area).

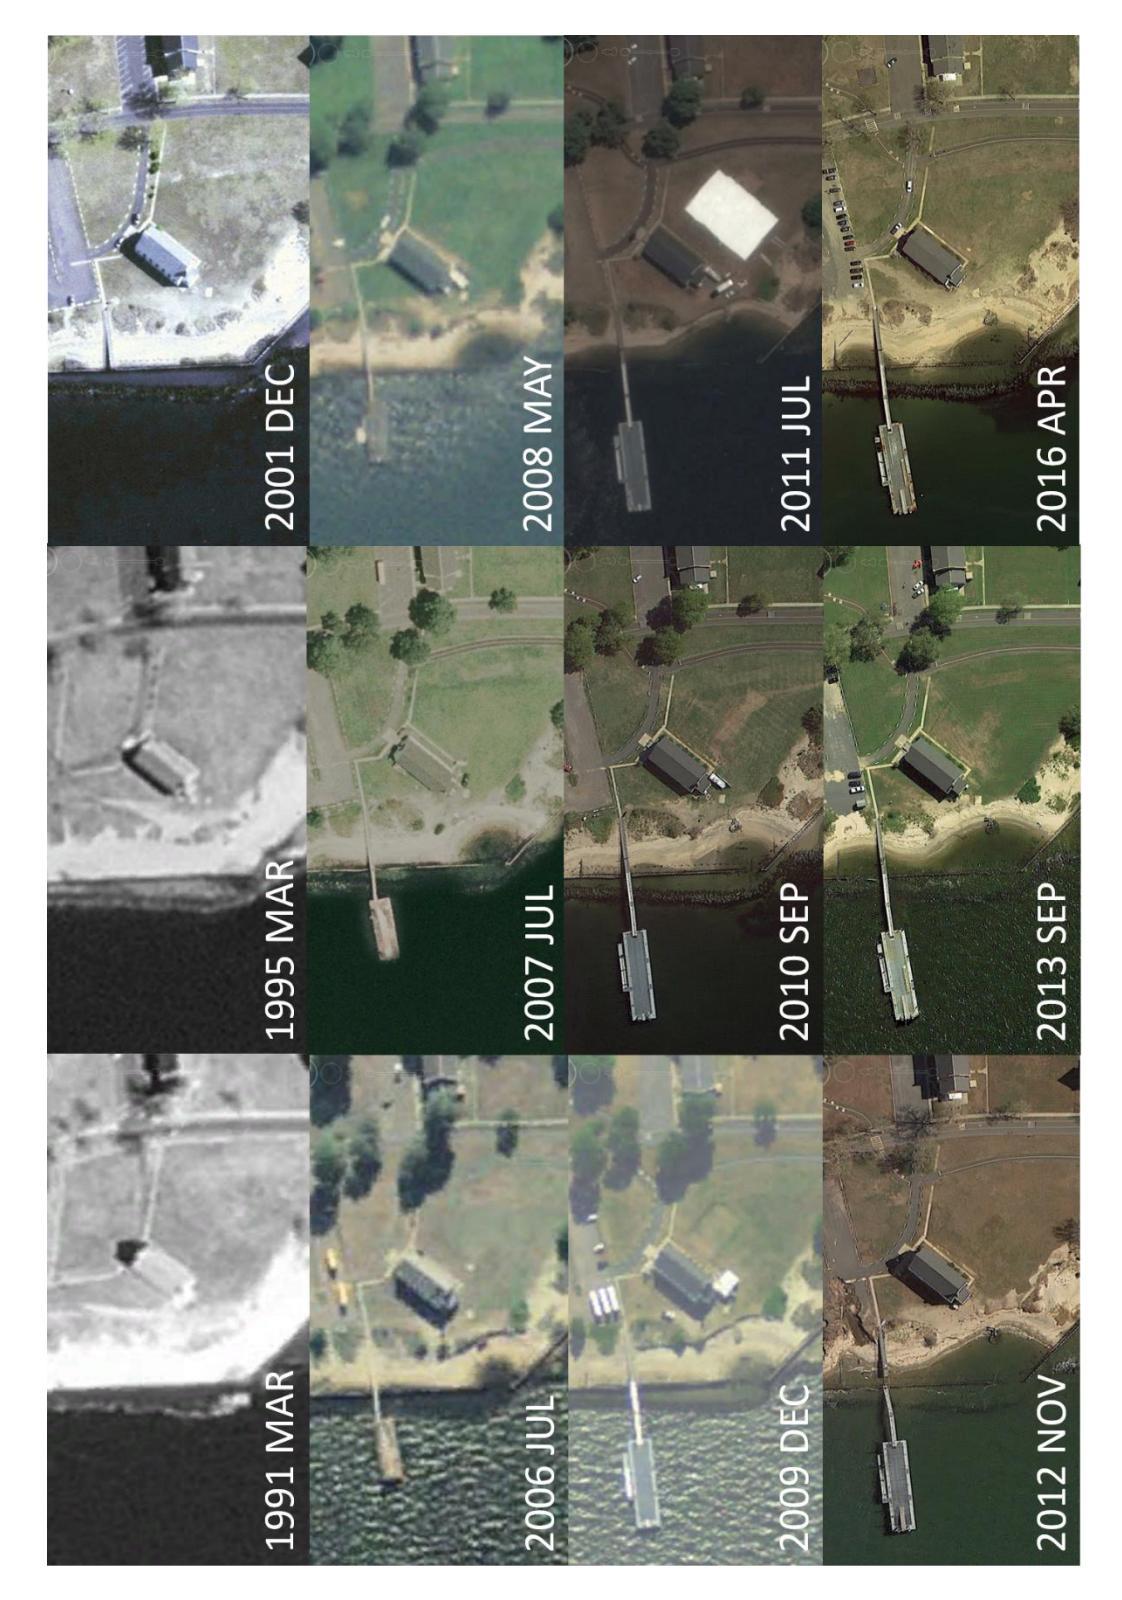
Figure 33. The shoreline at the Chapel North site has transitioned over the course of 25 years from being linear with an intact bulkhead to sinusoidal with open water landward of the bulkhead as gaps in the structure were created. Historical imagery obtained from Google Earth.

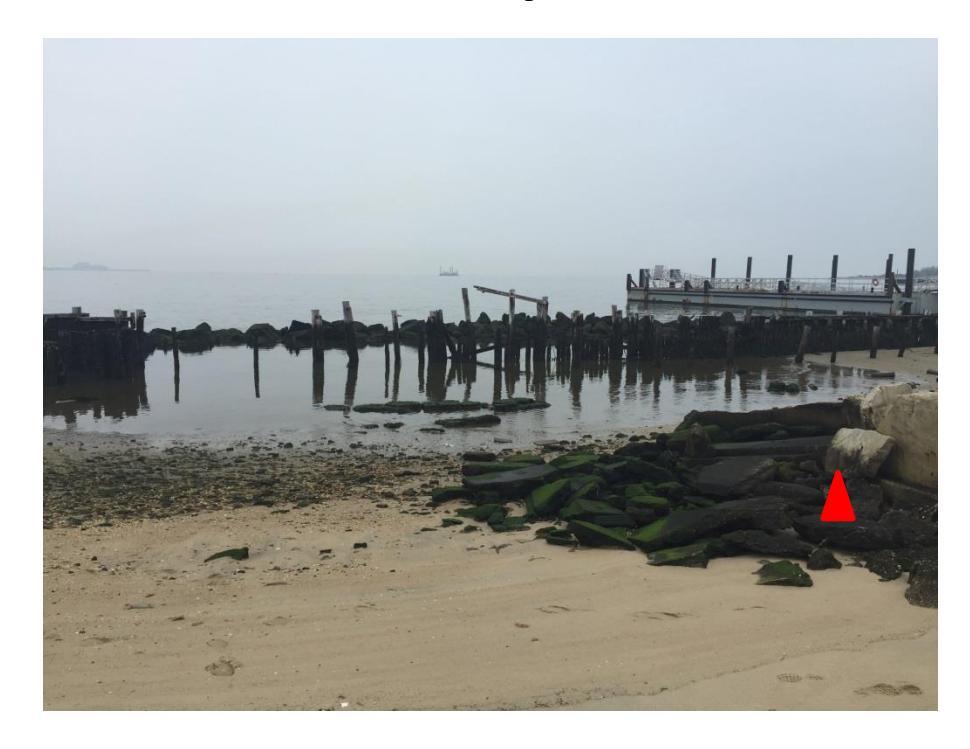
Figure 34. A large reentrant is located landward of a 22 m-wide gap in the bulkheads at the Chapel North site at low tide. Red triangle corresponds to the feature identified in Figure 35.

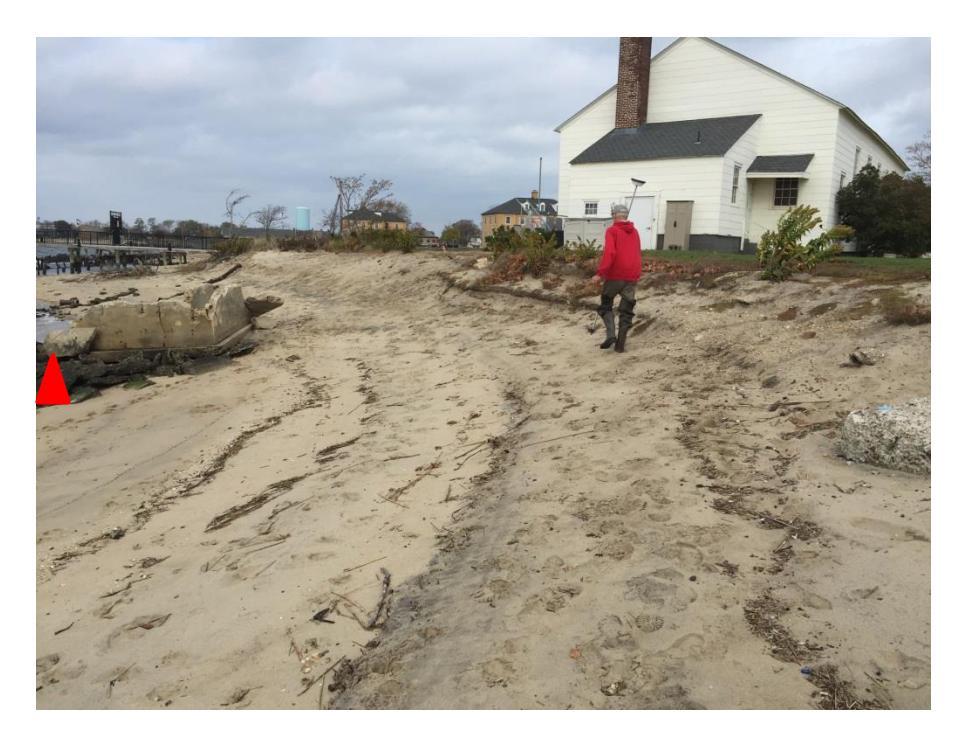
Figure 35. An active erosional scarp at Chapel North site. Red triangle corresponds to the feature identified in Figure 34.

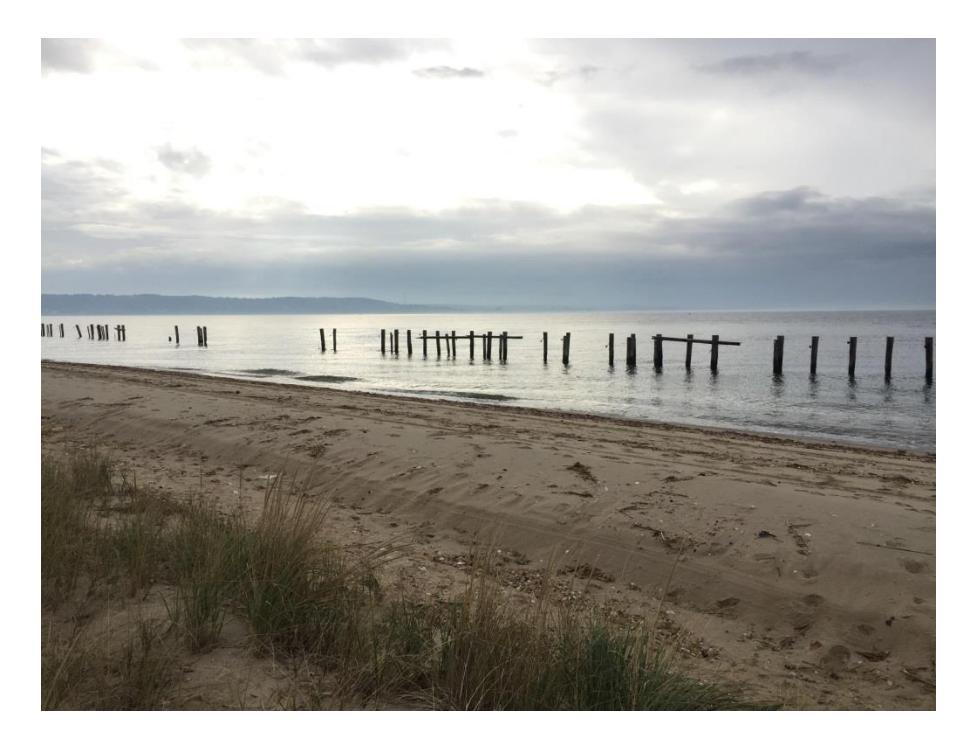
Figure 38. Pilings and fragments of the upper wale are all that remain of Bulkhead 5 above water during higher tidal stages at the Battery Kingman North site.

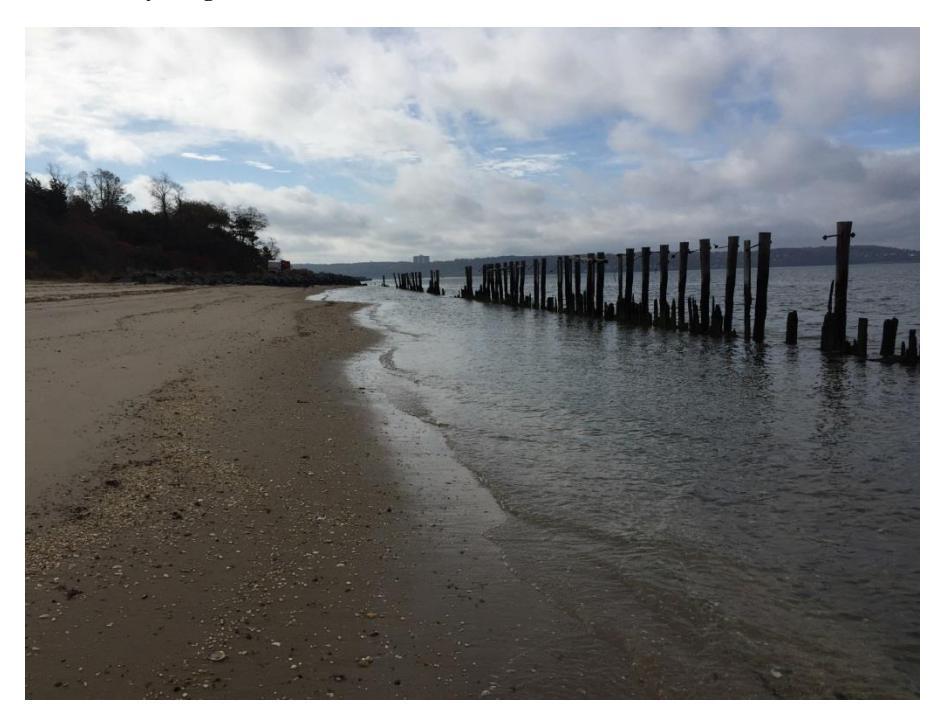
Figure 39. Low tide reveals some sheet piles and lower wales on Bulkhead 5 at the Battery Kingman North site.

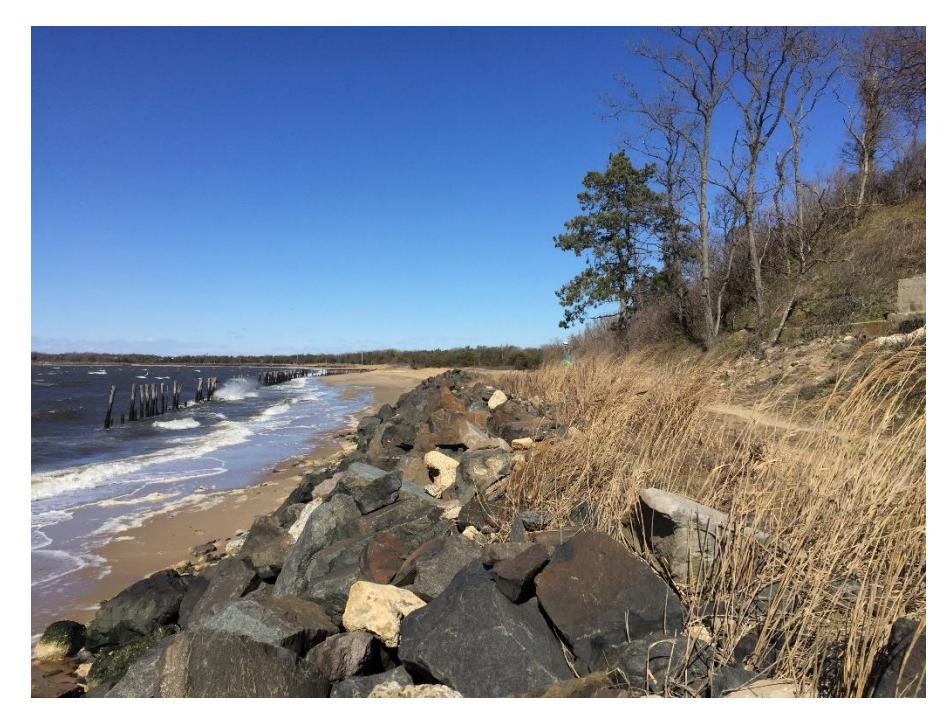
Figure 46. There is no evidence of raveling or erosion landward of Revetment 8 at the Battery Kingman South site.

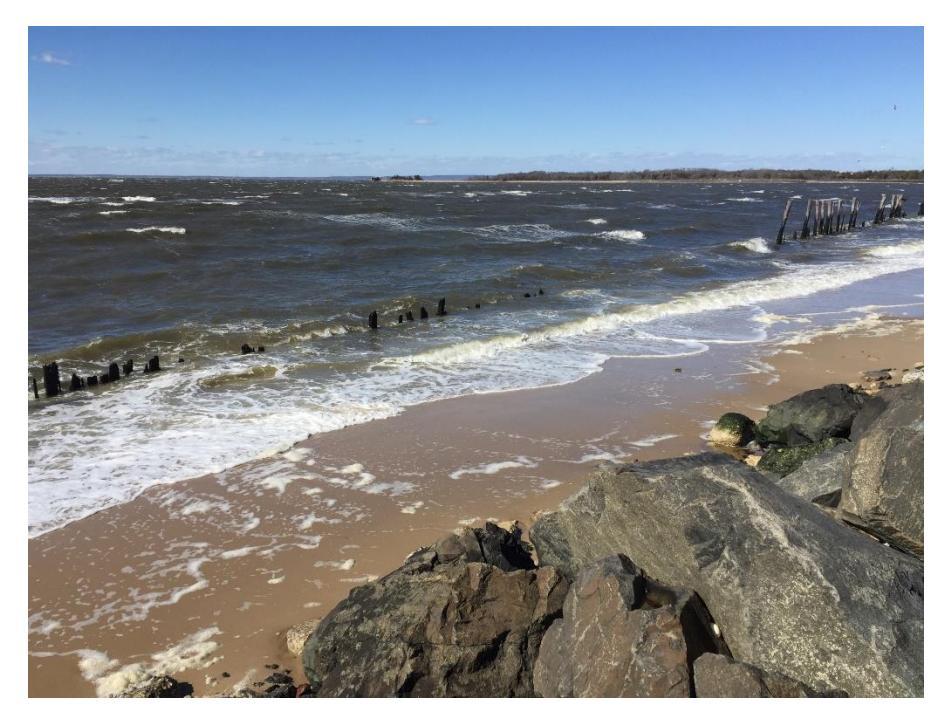
Figure 48. Bulkhead 4 is severely deteriorated and has little effect on the beach fronting Revetment 8 at the Battery Kingman South site.

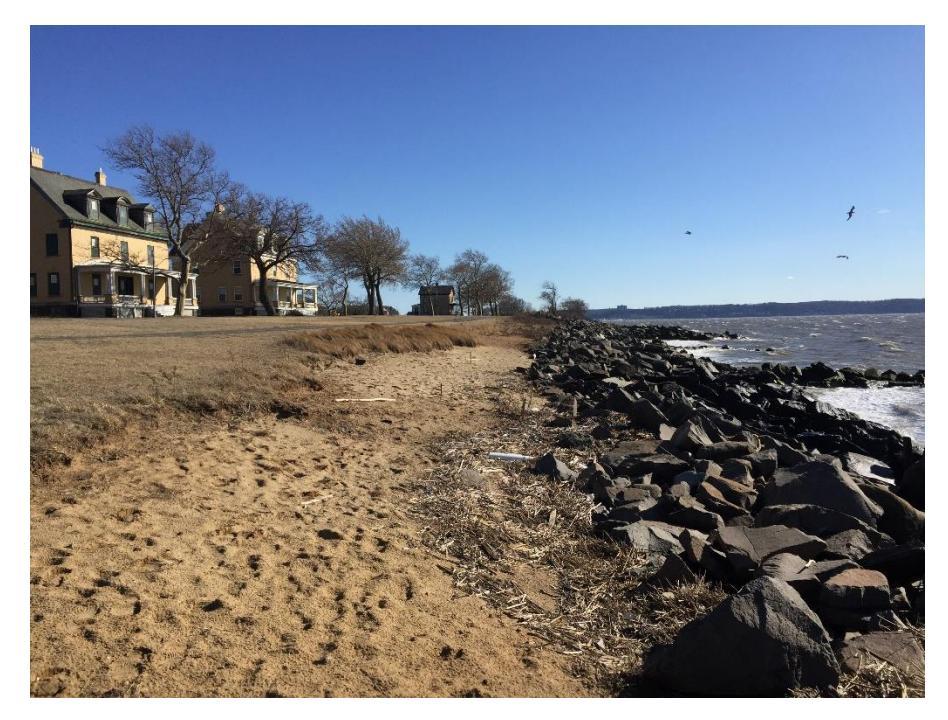
Figure 55. Wrack deposits and evidence of erosion are found landward of the revetment at Officer's Row North site, Sandy Hook Unit, Gateway National Recreation Area. Photo was taken looking south.

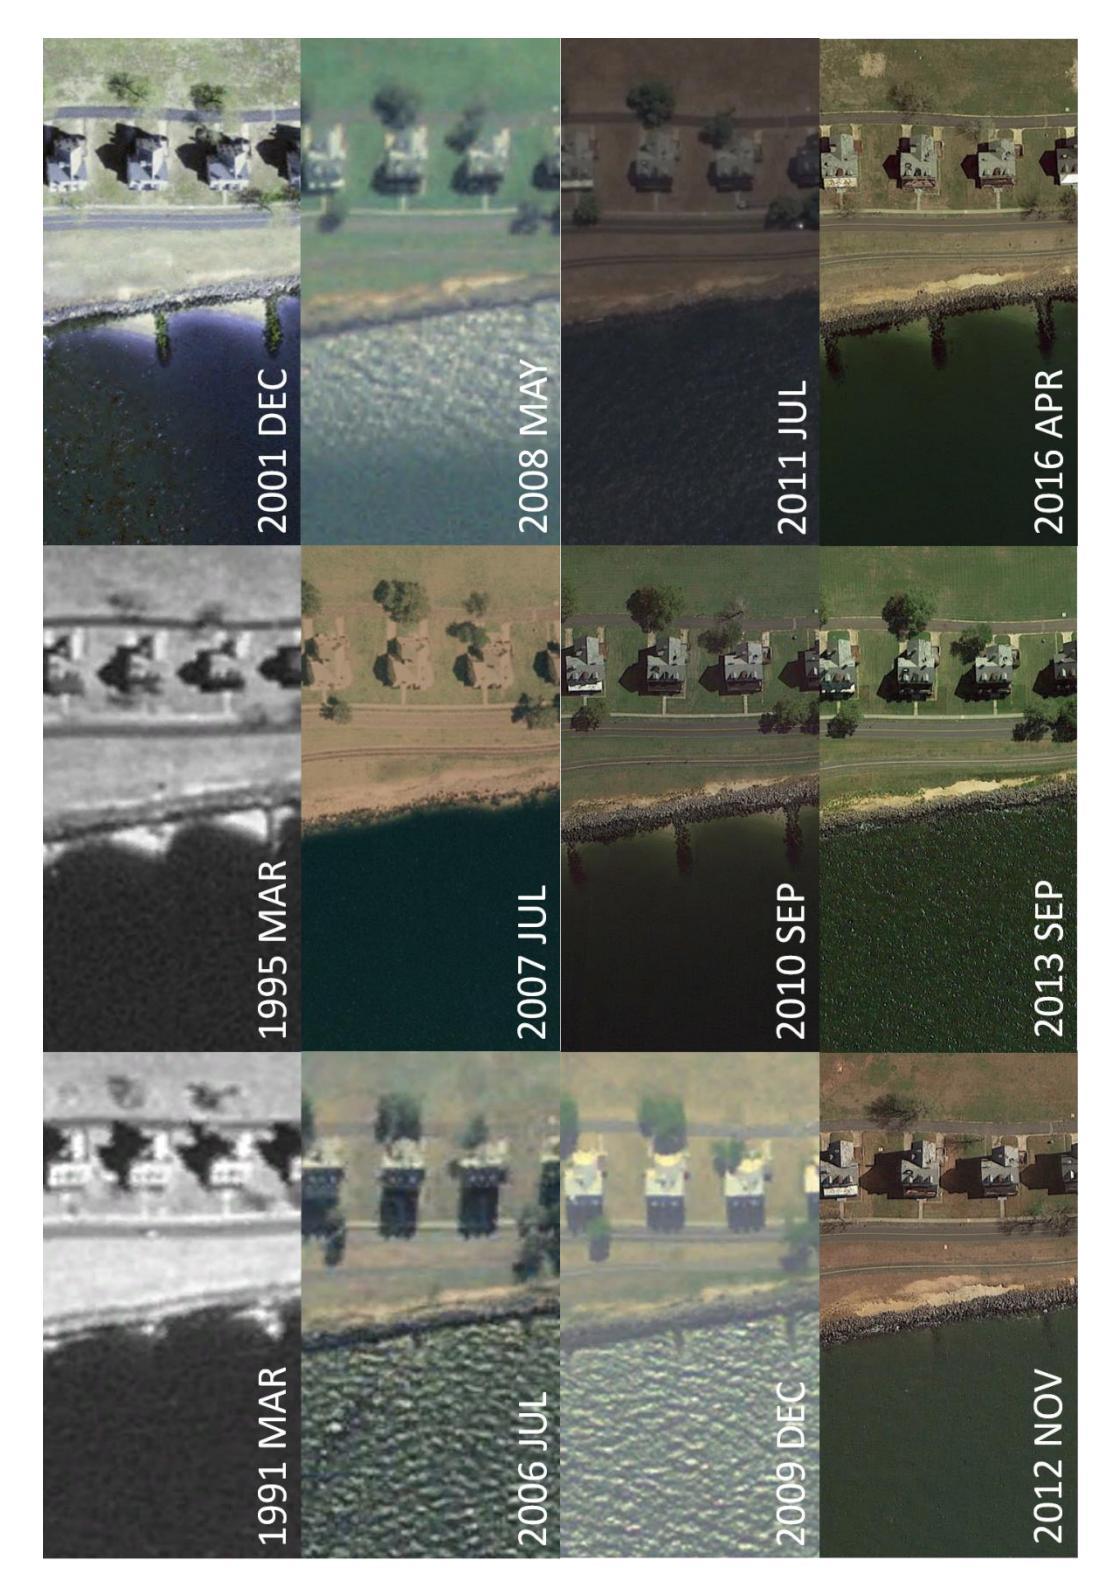
Figure 58. An area of bare sand landward of the revetment at the Officer's Row North site has increased in width over the last 25 years. Historical imagery obtained from Google Earth.
