# FLOOD PLAIN INFORMATION MAIN STEM AND SOUTH BRANCH BIG TIMBER CREEK

CAMDEN AND GLOUCESTER COUNTIES  
NEW JERSEY

PREPARED FOR  
CAMDEN AND GLOUCESTER COUNTY PLANNING BOARDS  
AND  
NEW JERSEY DEPARTMENT OF CONSERVATION  
AND ECONOMIC DEVELOPMENT  
BY  
CORPS OF ENGINEERS, U. S. ARMY  
PHILADELPHIA DISTRICT  
MARCH, 1969

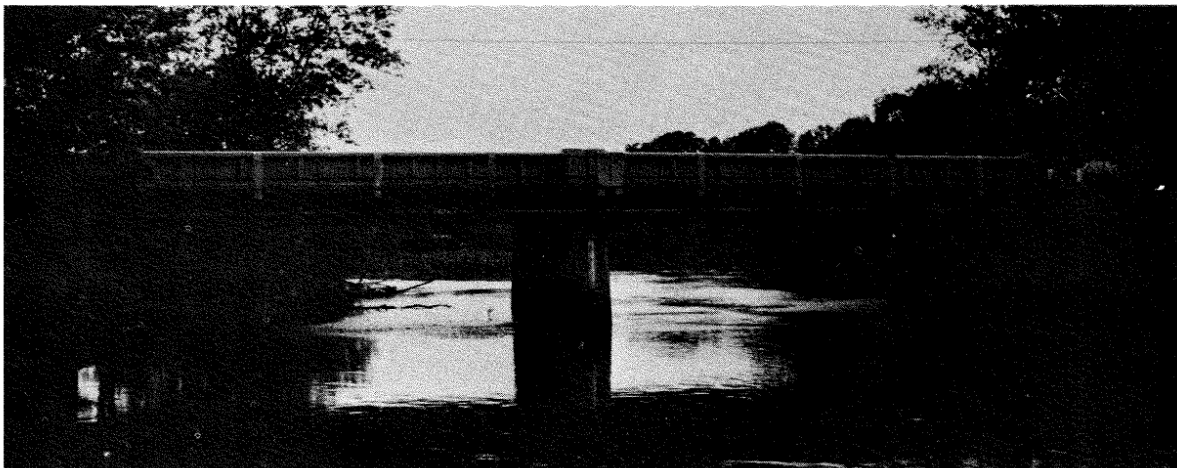
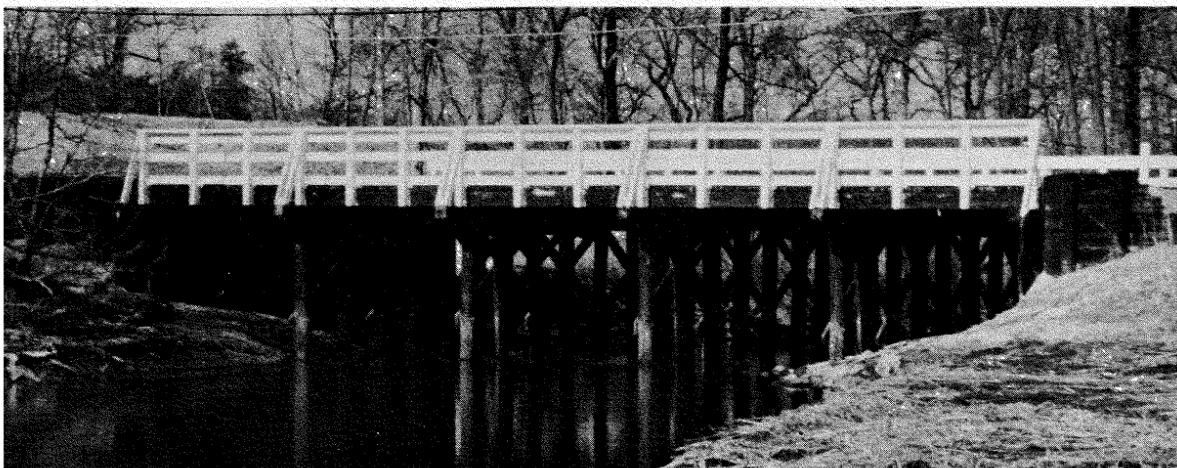
Figure 1.--MAIN STEM AND SOUTH BRANCH BRIDGES

Upper view is upstream side of Evesham Road bridge. Middle view is upstream side of Almonesson-Blenheim Road bridge. Lower view is upstream side of Good Intent to Lower Landing Road bridge.

As can be seen in Figure 1, these two bridges are timber structures supported on closely spaced piles, and it is highly likely that under flood conditions debris would accumulate and increase the obstruction to flow.

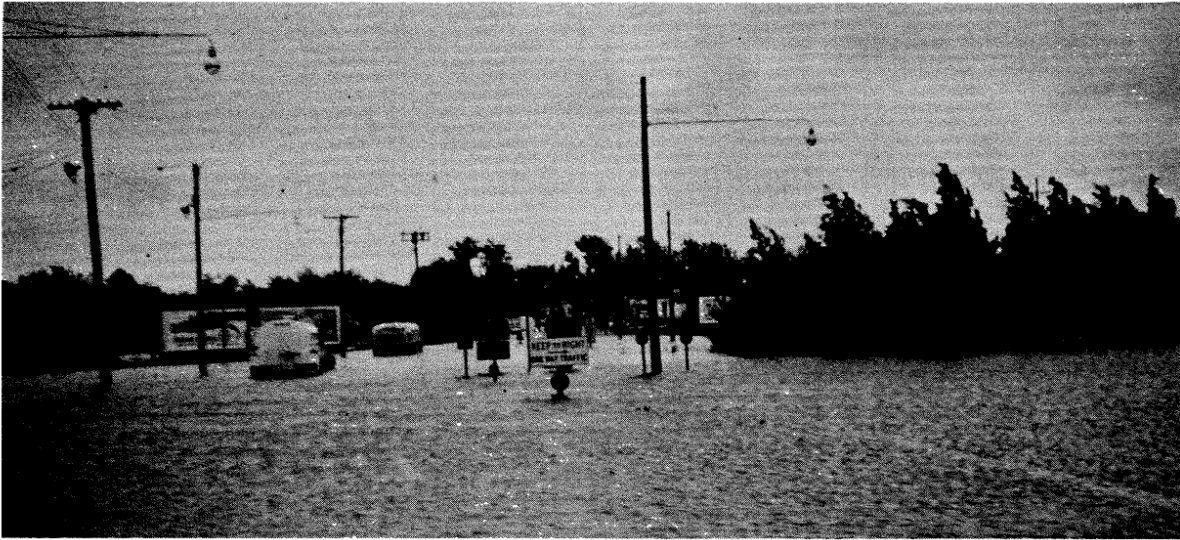
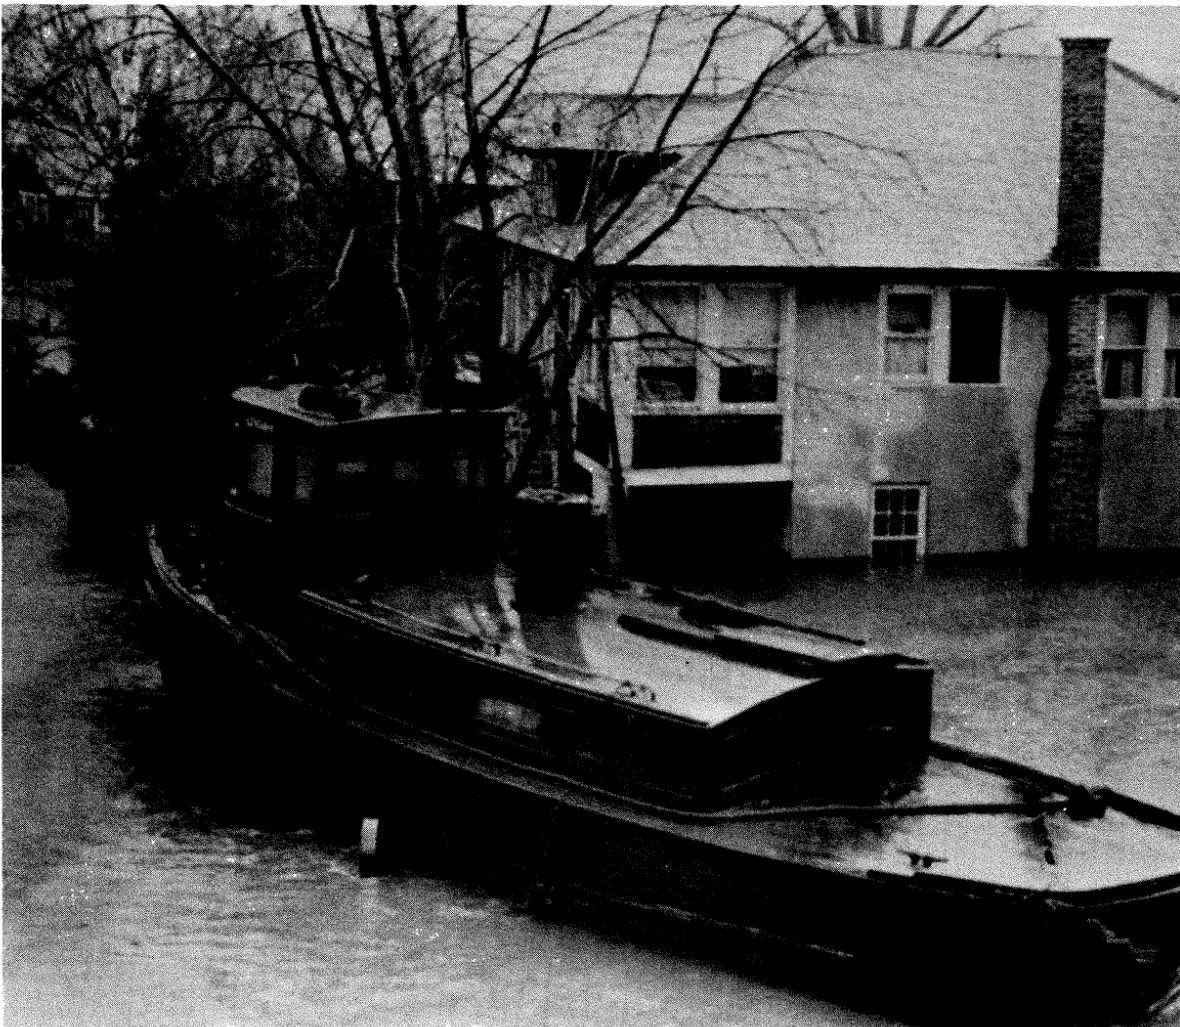
Figure 2.--FLOOD SCENES ON BIG TIMBER CREEK

The upper view is Brooklawn Circle on August 20, 1955. The lower view is a home along Timber Avenue in Westville during the November, 1950 flood.

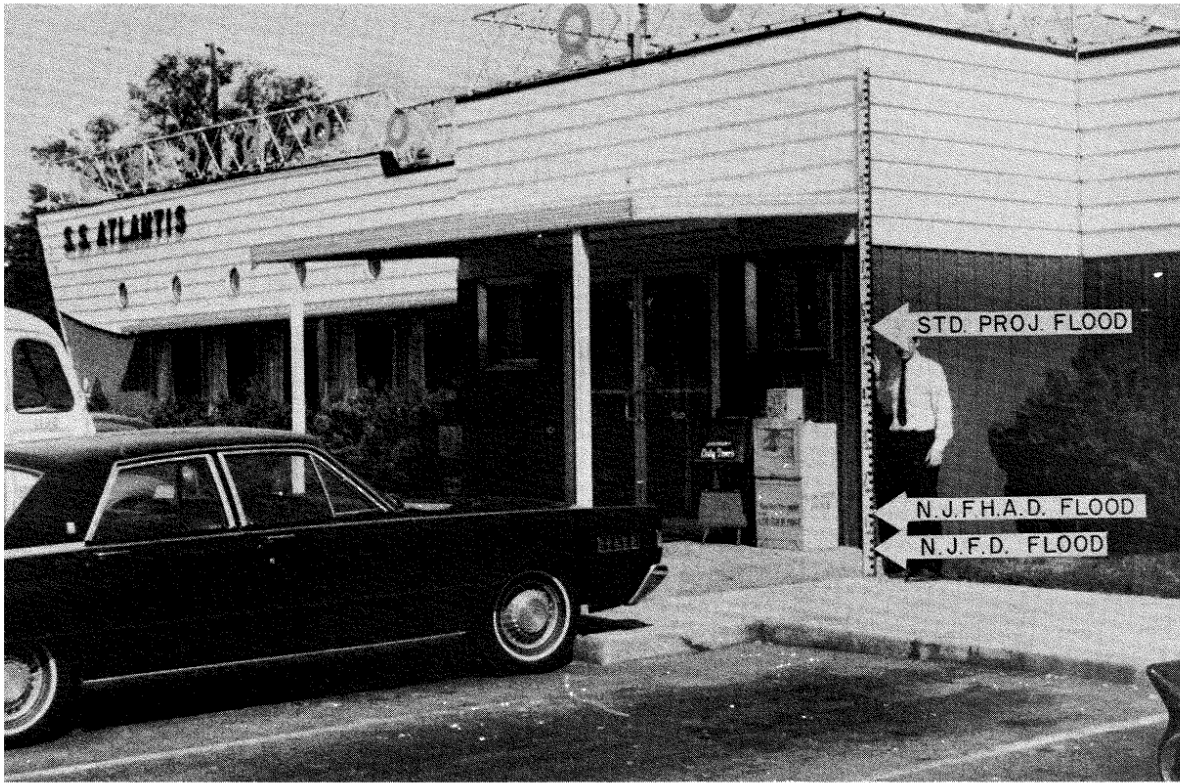
Figure 4.--FLOOD HEIGHTS ON MAIN STEM BIG TIMBER CREEK

The upper view is a diner on the east circle at Crescent Boulevard in Brooklawn. The lower view is the municipal garage on River Drive in Westville.

Figures 3 and 4 show the heights that would be reached by the New Jersey Floodway Design, New Jersey Flood Hazard Area Design and Standard Project Floods on buildings presently existing within the flood plain along the Main Stem and South Branch.
