SPATIALLY RESOLVED INFRARED IMAGING FOR BUILDING PERFORMANCE
EVALUATION

A thesis submitted to the

Master of Science

Graduate Program in Civil and Environmental Engineering

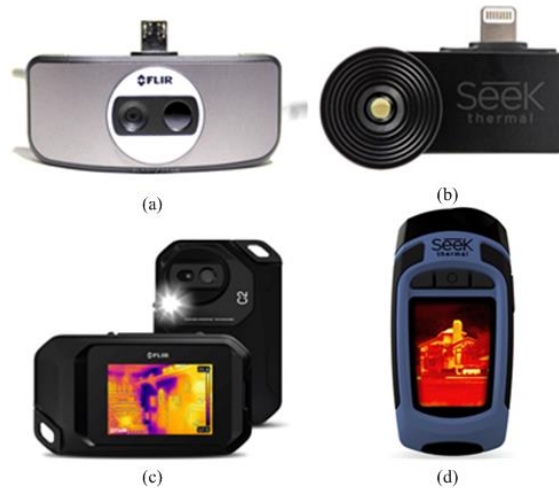
Figure 3: Pocket-sized infrared cameras

(a)FLIR One for Android; (b) Seek Thermal for iPhone; (c) FLIR C2 ;(d) Seek Reveal

Infrared cameras can also be varied in size. The general trend is with the rapid development in thermal technology, thermal devices become increasingly affordable and portable. With the latest technology, the thermal cores become smaller and much less expensive. The FLIR One and Seek Thermal realized the fusion of smartphone and thermal camera. FLIR C2 and Seek Reveal (Figure 3) are the full-featured, pocket-sized, completely standalone cameras that designed for a wide range of building, electrical and mechanical applications. In the past, thermography cameras are almost exclusive assets operated by professionals. This has changed since the introduction of miniature size smart phone-based infrared cameras. These cameras open the door to wide adoption of infrared thermography based building performance inspection by home owners and building operators, which will form the basis for a citizen science framework on building and home inspection.

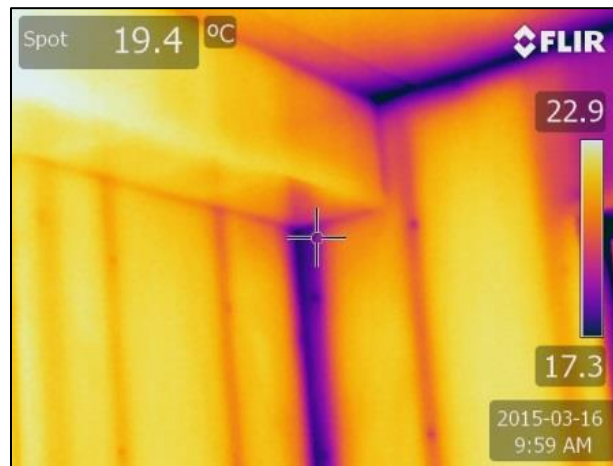
Figure 6: Thermography of interior wall surface with thermal bridge in winter

Thermal bridges, also called a cold bridge or heat bridge, are limited areas in the construction where heat flow is higher than the heat flow in the undisturbed area. They are

usually caused by structural components that penetrate the insulation's thermal barrier. This creates a short-circuit path for the heat flow, which cause unexpected heat transfer and energy waste. Possible consequences from thermal bridges are condensation of water vapor in buildings, especially the older buildings and significant energy loss. Several studies showed that thermal bridges may cause up to 30% of the extra-thermal losses through the envelope in winter, in this way increasing the energy consumption during heating season (Theodosiou and Papadopoulos 2008). Other effect of thermal bridges includes provide habitat for molds and fungi and produce bad indoor air quality conditions (Ascipne et al. 2013; GhaffarianHoseini et al. 2013). To quantify the extent of thermal bridge, temperature factor is used for the assessment of thermal bridge and air leakages. Kalamees (2007 and 2008) determined the typical places of air leakage and thermal bridge through the infrared camera and calculated the temperature factor at the internal surface ($f_{R_{si}}$, –). The temperature factor $f_{R_{si}}$ at the internal surface shows the relation of the total thermal resistance of the building envelope (R_T , $(m^2 \cdot K)/W$) to the thermal resistance of the building envelope without the internal surface resistance (R_{si} , $(m^2 \cdot K)/W$) and can be calculated with measured internal surface temperature ($T_{s,in}$, $^{\circ}C$), indoor temperature (T_{in} , $^{\circ}C$) and outdoor temperature (T_{out} , $^{\circ}C$) according to following equation (Hugo 2012, Kalamees 2007).

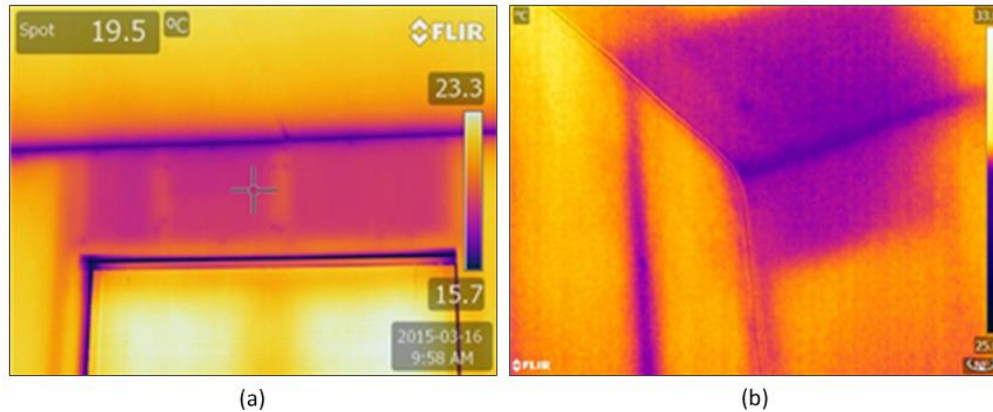
Figure 8: Thermography of interior wall surface with missing insulation

Thermal insulation reduces heat losses by conduction through the building envelope (i.e. wall, roof) during winter and heat gains during summer. Good thermal insulation can reduce the heating or cooling energy costs and improves indoor thermal comfort conditions by increasing the interior surface wall temperature in winter and by reducing it in summer. Missing or damaged insulation can be located when the thermography indicates a temperature difference of about 10 C between the internal and external surface temperature (Residential Energy Services Network, Inc. 2012; FLIR System AB. 2011). On a thermography, missing or poor insulation area will appears to be a light/dark colored patch with distinct edges the outline the problematic areas (Balaras and Argiriou 2002). Examples of missing insulation are shown in Figure 8.

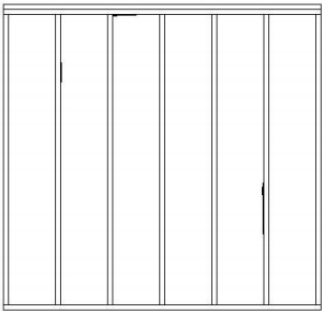
<p>Occasional very small gaps are acceptable for “Grade I”</p>

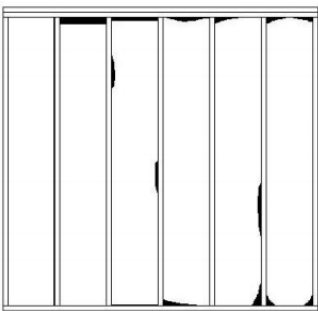
<p>No more than 2% of surface area of insulation missing is acceptable for “Grade II”</p>

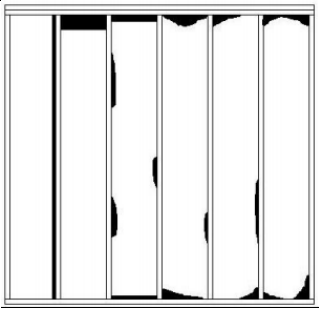
<p>The illustration represents the boundary conditions between Grade III and the situation whereby one must measure the uninsulated areas</p>

The Grade III for missing insulation is designed as no more than 5% of the surface area of insulation missing is acceptable. For an installation that is worse than Grade III, the procedure

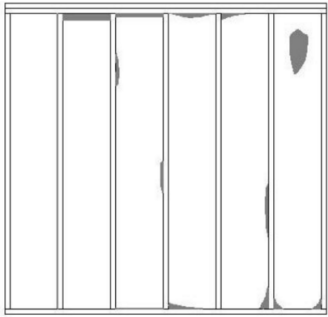
<p>Compression or incomplete fill amounting to 2% or less, if the empty spaces are less than 30% of the intended fill thickness, are acceptable for “Grade I”.</p>

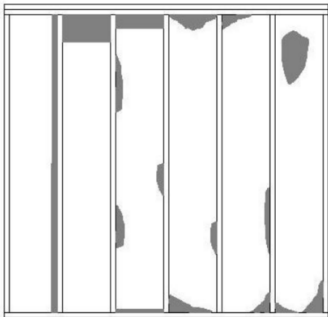
<p>No more than 10% of surface area of insulation compressed or incomplete fill, by up to 30% (70% or more of intended thickness) is acceptable for “Grade II”.</p>

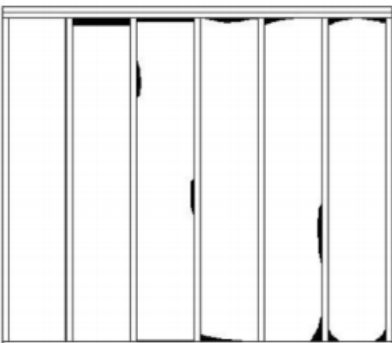
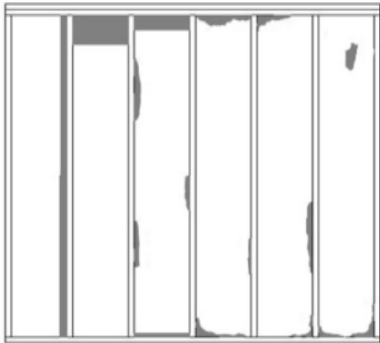
Figure 9: Grade II insulation grading example from RESNET Interim Guidelines for thermographic inspection of Building Insulation Grading Standards

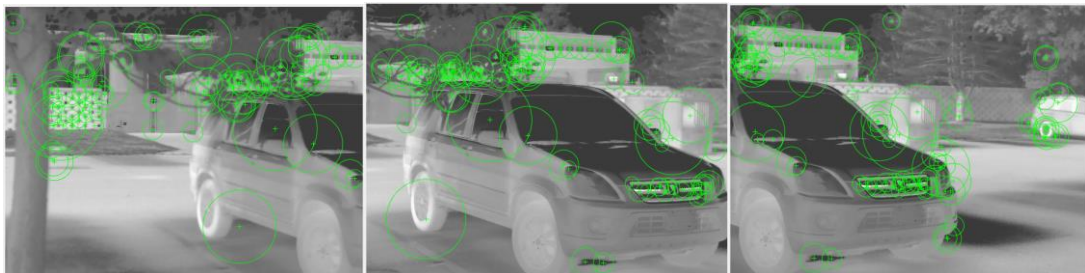
Figure 17: Feature points detected in three infrared images

To address this issue, our approach tries different temperature scales and finds the best result in terms of number of feature points, matched points, and inliers. Once the transformation between images with highest inliers was calculated, these images can be combined to form a panoramic image which can be transferred to any color scale and color palette with a fixed transformation (Figure 17).

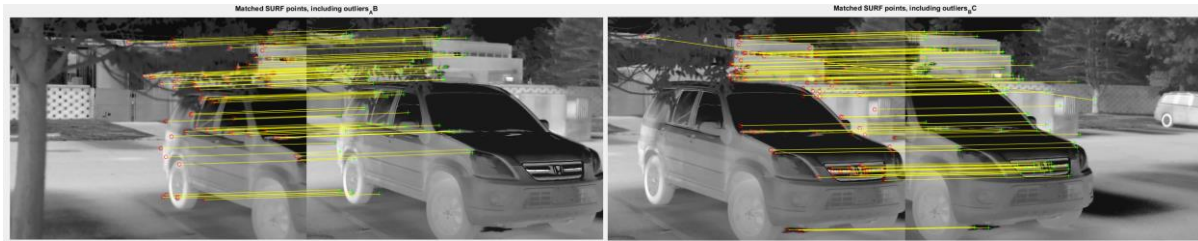
Figure 18: Matched SURF points, including outliers

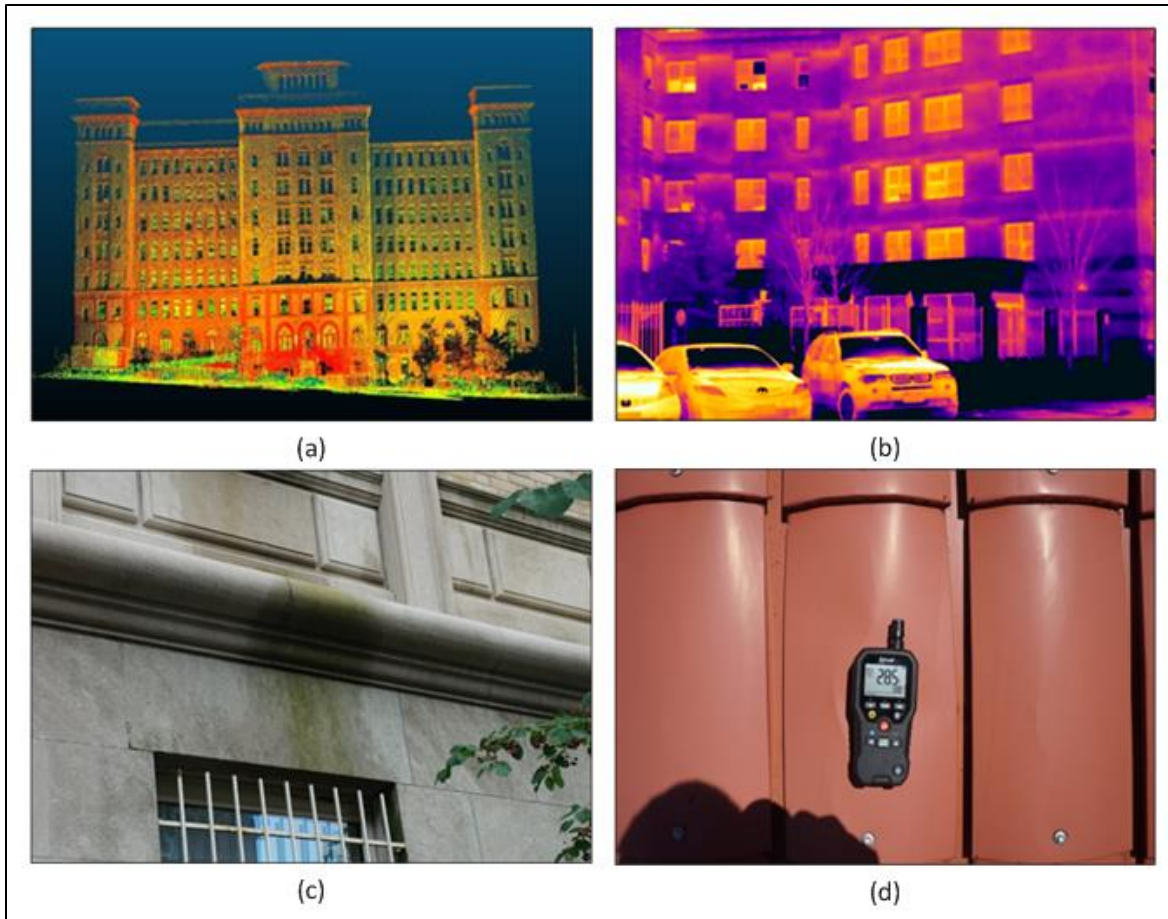
Figure 27: Exterior area data collection

LiDAR data, infrared data, digital images that cover the whole exterior part of the building were collected. This includes exterior walls and roofs. Figure 27 (a) is the point cloud after scan registration. Figure (b) is the exterior wall of the building; the thermal image shows the heat loss at floor slabs. Figure (c) is the digital image taken for the exterior wall area with possible Air Conditioner water leakage issue. Figure (d) is the example of temperature and humidity data collection on site during inspection.

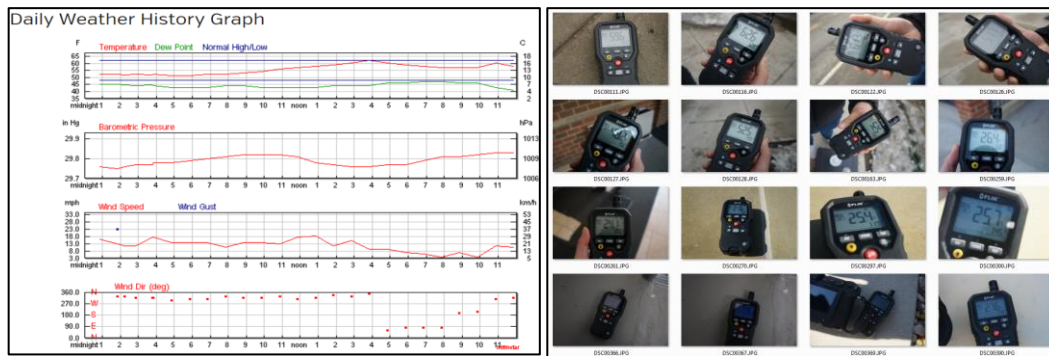
Figure 30: Real-time outdoor temperature and humidity captured from weather station and moisture meter

Environmental condition data were captured from moisture meter, wind speed meter and weather station nearby. Available data from weather station includes: temperature, relative humidity, wind speed and wind speed direction for every 4 minutes (Figure 30).

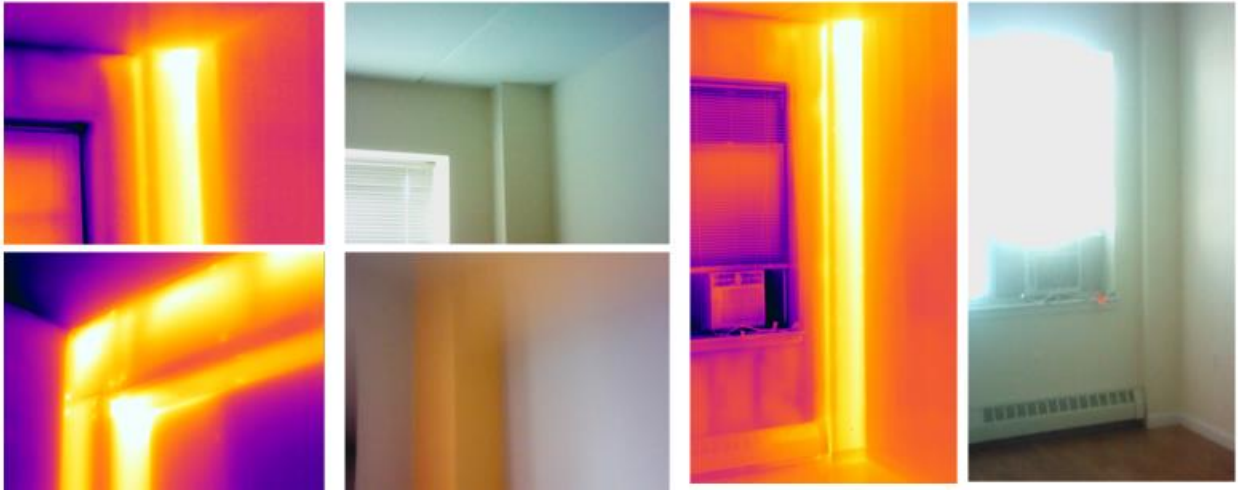
Figure 36: Issues with hot water risers

Hot water riser poor insulated: During field data collection for building 2, we noticed some of the hot water riser pipes are not well insulated (Figure 36). The highest temperature difference between the wall cover the riser and surrounding wall in a same room can reach to 13.2 °F. In this particular building, three out of fifteen apartments had a temperature difference of 10 °F in this case, and seven of fifteen apartments had the temperature difference higher than 5 °F, and 66% of apartments had the temperature difference higher than 4 °F. Insulating the pipes that carry hot water can help reduce the convective heat loss from pipes and increasing the delivered water temperature for end use apartments. On the other side, if the heat gain from poor insulated hot water pipes cannot be controlled, it may lead to overheating issue in the room.
