**EXPERIMENTAL AND ANALYTICAL STUDY OF FIBER-
REINFORCED SELF-CONSOLIDATING CONCRETE AS A
REPAIR MATERIAL**

A dissertation submitted to the

Rutgers, The State University of New Jersey

Doctor of Philosophy

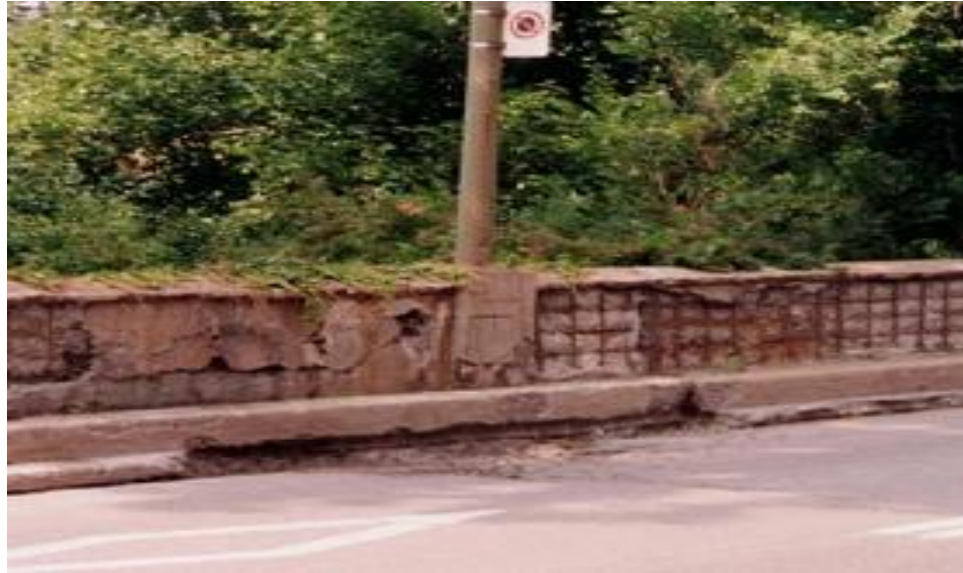
Figure 2.1 Steel Reinforcement Corrosion in a Reinforced Concrete Wall [Khayat, 2006]

Typically, the corrosion of steel reduces its cross-sectional area and causes degradation of the surrounding concrete, which can lead to structural collapse. The rust produced during steel corrosion expands, taking up an increased volume than the pre-corrosion steel. The result of this growth in volume is tensile stress in the concrete, which can eventually cause cracking, delamination, and spalling [Portland Cement Association, 2002]. An example of steel reinforcement corrosion in a surface wall is shown in Fig 2.1.

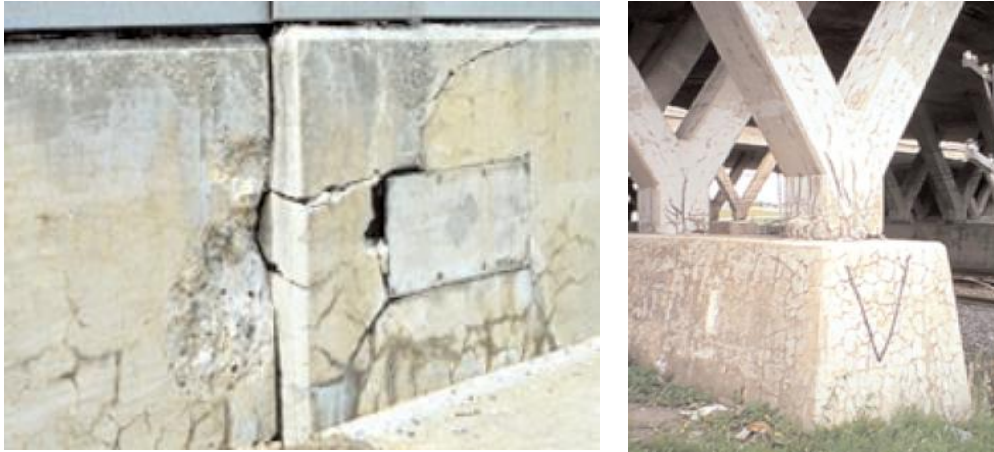
Figure 2.3 Cracking of Concrete from ASR [Kosmatka and Panarese, 2002]

Figure 2.3 shows the deterioration of concrete due to ASR reaction.

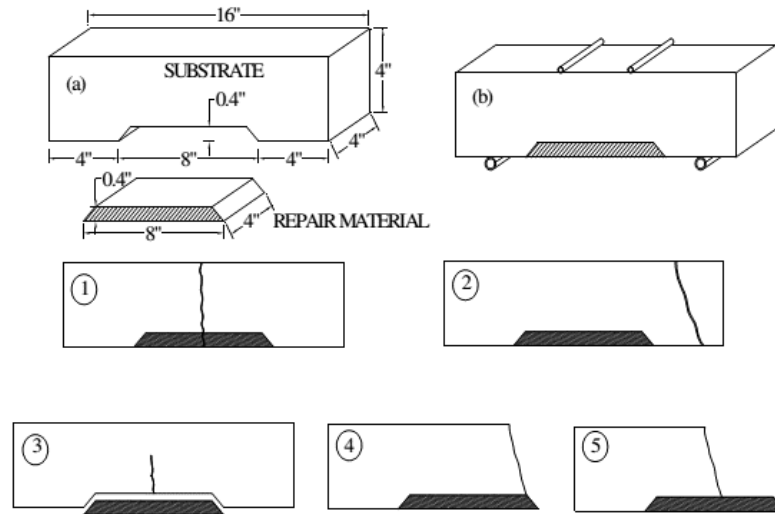
Figure 2.5 Compatibility Test and evaluation: 1,2-compatibility; 3,4,5-incompatibility (a) Specimen arrangement; (b) Third point loading beam test [Czarneck et al 1999].

Flexural strength of concrete is often analyzed through a third-point loading test in which a rectangular concrete prism is subjected to three points of force—causing tensile stresses at its bottom side and compressive stresses at its top. Depending on the point of failure determined through the three-point flexural test, a concrete sample's compatibility with a repair material is determined. If a failure crack appears through the repair material and the substrate, or through only the substrate, the two materials are compatible. If, however, a failure crack appears through the bonded area between the substrate and repair, the two materials are incompatible as shown in Figure 2.5. This test a good indicator of how a repair material will perform under tensile stresses when in a real setting.

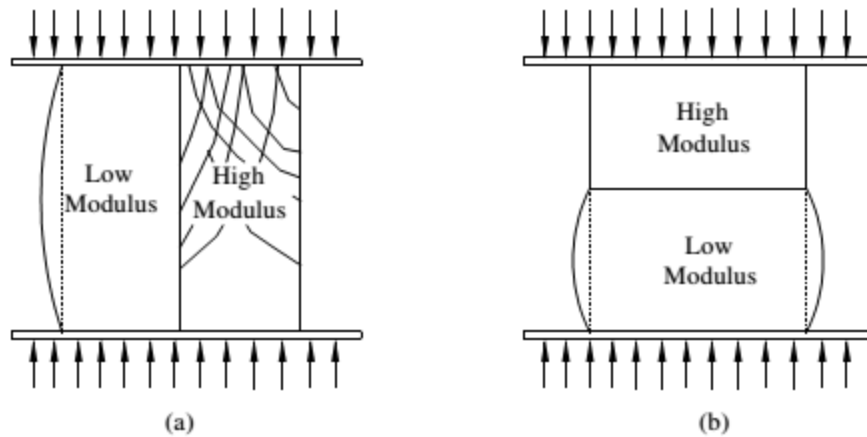
Figure 2.6 Effects of Mismatching Elastic Moduli (a) Load parallel to interface

Because concrete with a high modulus value deforms less than that with a low modulus value, concrete with a lower modulus transfers its stresses to the higher modulus concrete potentially causing cracking (Figure 2.6). Therefore, it is imperative that repair materials have a similar modulus value to that of the substrate [Pattnaik, 2006].

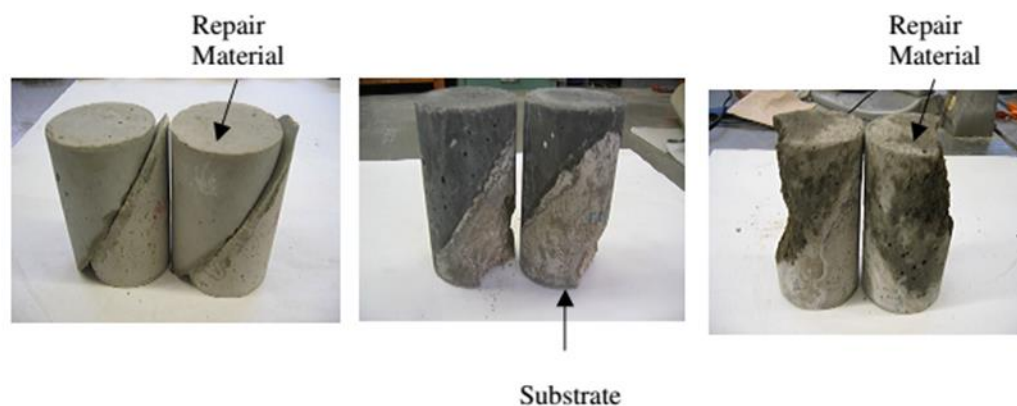
(a) Interface Failure (b) Substrate Failure (c) Repair Material Failure

This method tests the bond strength between the substrate concrete and repair material by simultaneously exposing a cylindrical sample to compressive and shear stresses. The cylinder being tested is half-composed of the substrate and half-composed of the repair material, divided in the middle at a 60-degree cut angle, which produces an elliptical-shaped contact surface between the materials. The bond strength between the substrate and repair is dependent on several factors: friction, the adhesive strength of the bonding substance, compaction of the substance, cleanliness of the substrate's surface, etc. This procedure is explained in ASTM C882. According to Pattnaik [2006], three possible failure modes can happen as shown in Fig 2.8. If the failure occurred in the bond, then the failure mode will be interface failure. The second failure mode is substrate failure, and that's when the failure takes place in the substrate. While the last failure mode is repair material failure and that failure happens when the repair material fails before the substrate.

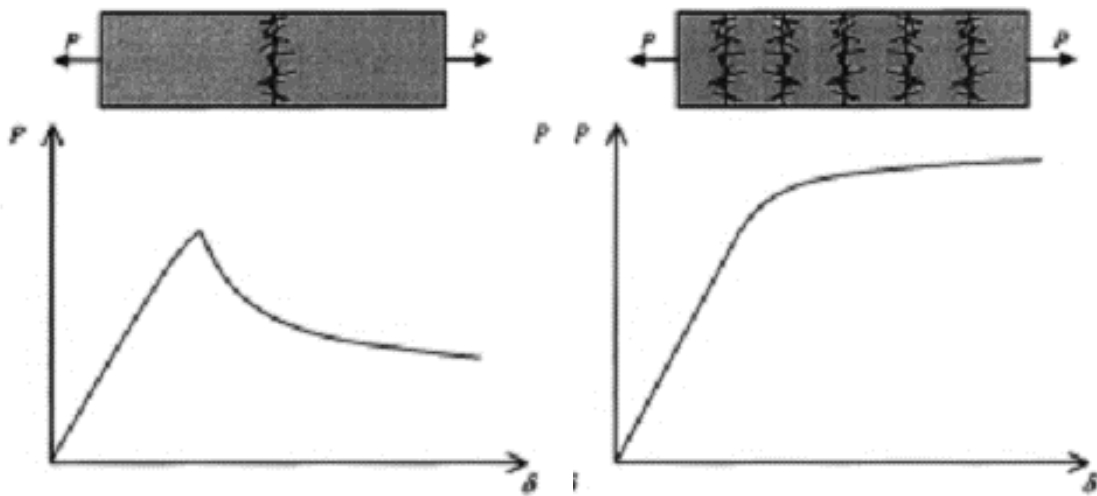
a) Single cracking under uniaxial loading b) Multiple cracking under uniaxial loading

surfaces. Different failure modes can result, depending on the effectiveness of the fibers in providing crack bridging, see Figure 2.9. If the fibers break or are pulled out during crack initiation, or if the fibers cannot carry more load after the formation of the first through crack, then the first cracking strength is the ultimate strength. Further deformation is governed by the opening of a single crack and fibers pulling out and/or breaking along the edges of the crack as shown in Figure 2.9(a). This behavior is also known as tension softening behavior. If-on the other hand-the fibers can sustain more load after the formation of the first crack, more cracks will be formed and what is known as multiple cracking as show in Figure 2.9(b). This behavior is also known as strain (or pseudo-strain) hardening behavior [Vandewalle, 2002].

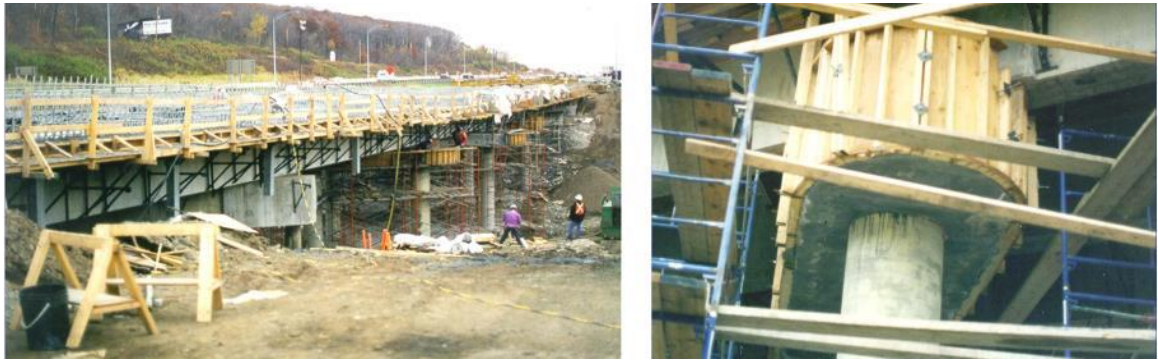
Figure 2.10. Application of SCC for Repair of Bridge Pier Caps and Columns in Quebec [Khayat et al, 2010].

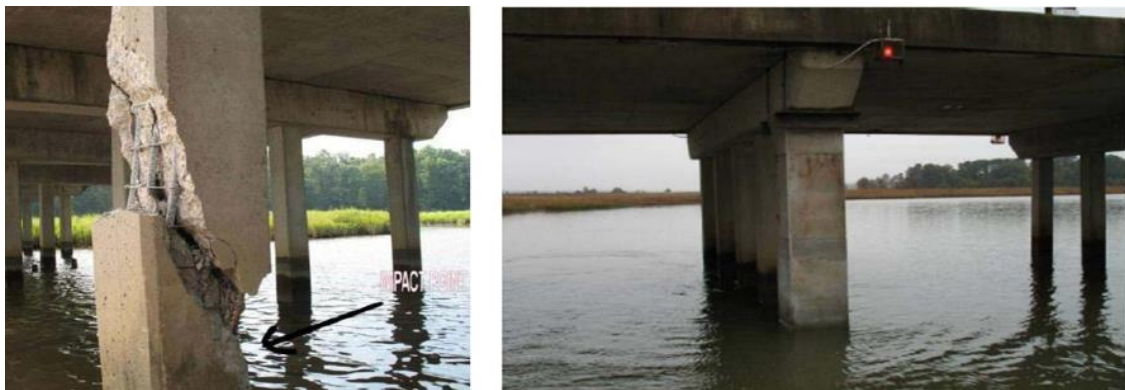
Figure 2.12. Repair of Bridge Pile Damaged by a Barge in Virginia, repaired pile on the right picture [Ozyildirim, 2013].

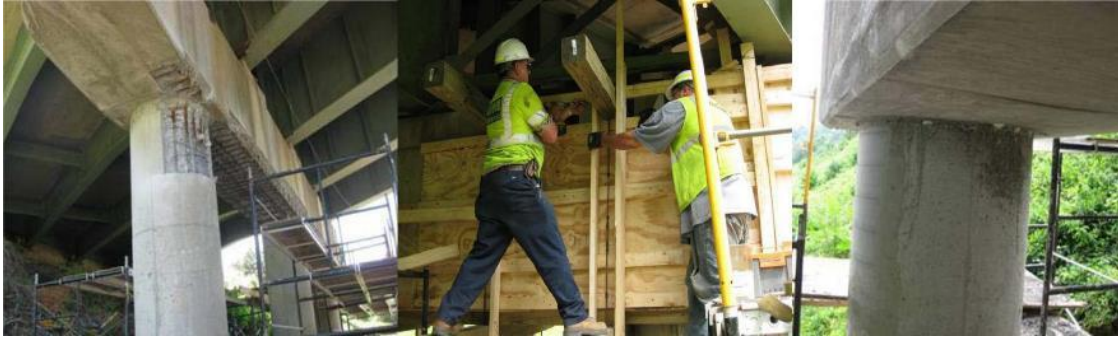
Figure 2.13. Repair of Damaged Column and Pier Cap in Virginia on the Left, Completed Repair on the Right) [Ozyildirim, 2013].

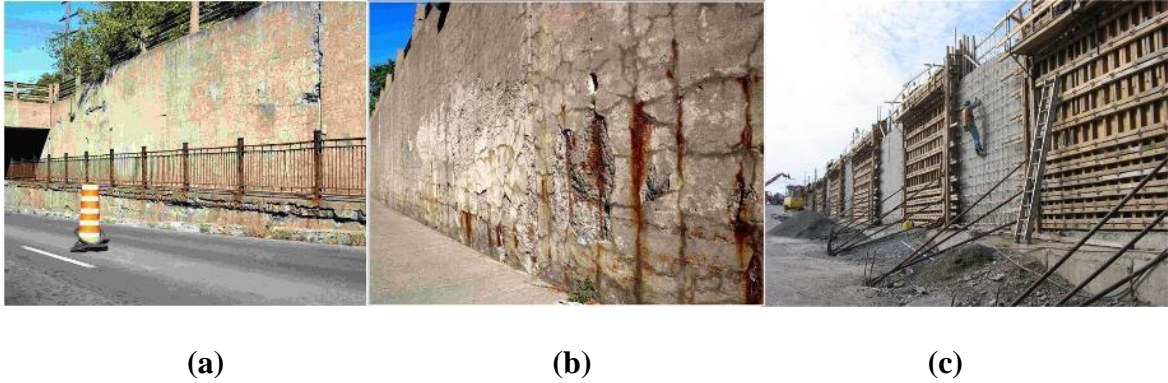
Figure 2.14. Application of FR-SCC in Jarry/Querbes Underpass in Montreal [Khayat et al, 2005].

It is well known that repairs done using concrete are especially susceptible to cracking as a result of shrinkage. To combat this frequent occurrence, fiber reinforcement has been increasingly used to improve tensile and flexural strength while reducing cracking. Not only does FR-SCC have an easy application, just as with standard SCC, it also has increased performance in its hardened form in comparison to conventional concrete; as a direct result of the fiber reinforcement. FR-SCC requires lower amounts of steel reinforcement and ties, lower maintenance, and a smaller labor force. The benefits of using FR-SCC as a repair material were exemplified in 2003, during the repair of the 860 ft Jarry/Querbes Underpass as shown in Figure 2.14. Due to repeated exposure to frost, the underpass experienced harsh deterioration. The repairs needed included sidewalk, pavement and side wall reconstruction. Of the 32 panels cast for the retaining walls, 29 were cast with FR-SCC. In its finality, the underpass was both visually pleasing and effectively repaired, with no cracking due to shrinkage. Because synthetic fibers were used to reinforce the repair concrete, the fresh repair was able to fill voids while maintaining a high level of strength effectively.

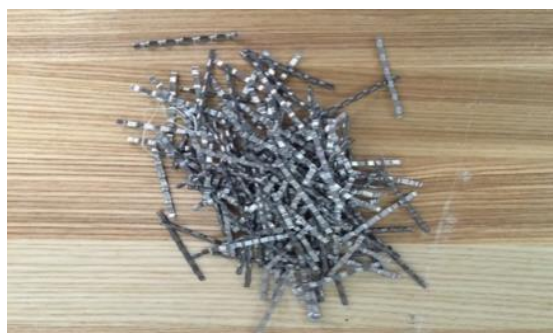
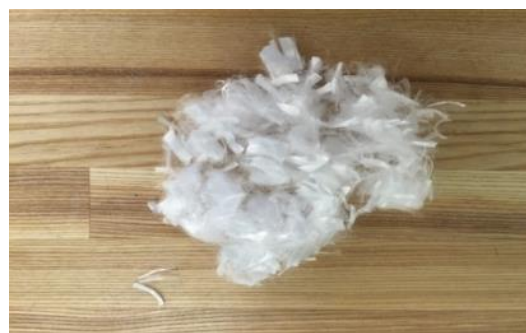
Figure 3.3 Types of Fibers Used

The steel fiber (STF) used is macro crimped with a length of 1.5 in. known commercially as PSI Crimped Steel Fiber, while the polypropylene fiber (PPF) is micro 1/4 in. long known commercially as PSI Fiberstrand 100. Both fibers were made and donated for the project by Euclid Chemical Company. Tables 3.6 and 3.7 indicate the technical information of PSI Crimped Steel Fiber and Fiberstrand 100 respectively. Fig 3.3 shows the both type of fiber.

a) PSI Crimped Steel Fiber

b) PSI Fiberstrand 100 Polypropylene Fiber

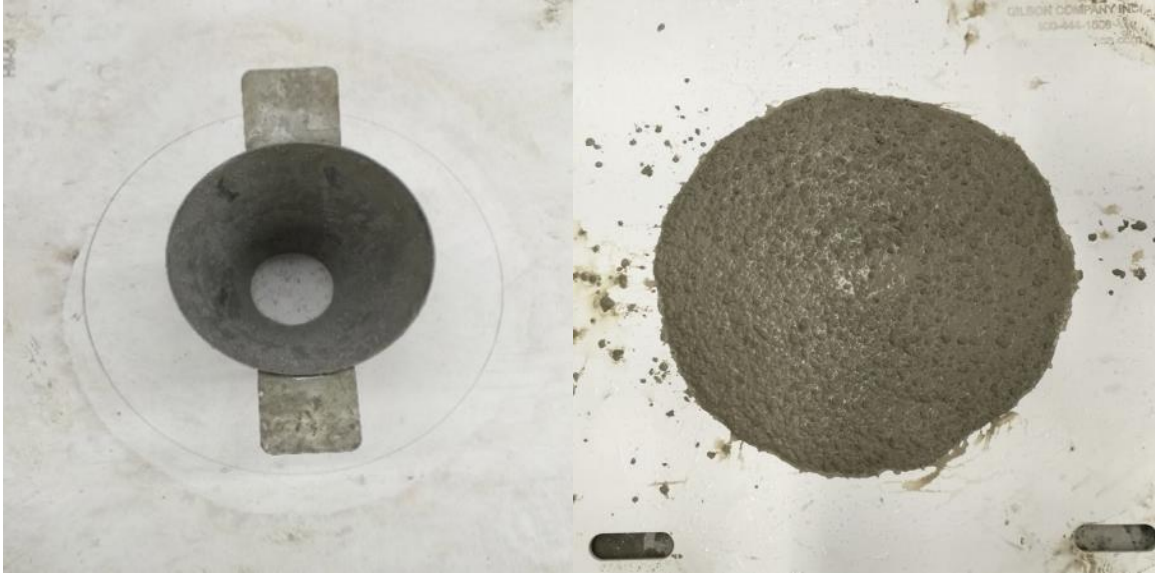
Figure 3.4 Slump Flow Test

The Slump flow test was conducted in accordance with ASTM C1611. A sample of freshly mixed concrete is placed in a mold either in the upright or inverted position as shown in Figure 3.4. The concrete was placed in one lift without tamping or vibration. The mold was raised, and the concrete is allowed to spread. After spreading ceases, two diameters of the concrete mass were measured in approximately orthogonal directions. Slump flow is the average of the two diameters.

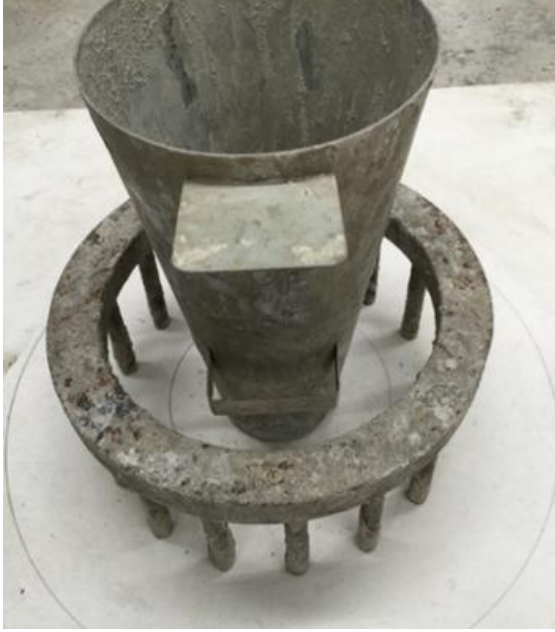
**Figure 3.5 J-Ring Test Setup with
Inverted Cone**

The J-Ring test was carried out in accordance with ASTM C1621. A sample of freshly mixed concrete was placed in a mold, either in the upright or inverted position that is concentric with the J-Ring (Figure 3.5). The concrete then was placed in one lift without tamping or vibration. The mold was raised, and the concrete was allowed to spread through the J-Ring (Figure 3.6). After spreading ceases, two diameters of the concrete mass were measured in approximately orthogonal directions. J-Ring flow is the average of the two diameters. The test is repeated without the J-Ring to obtain the slump flow. The difference between the slump flow and J-Ring flow is an indicator of the passing ability of the concrete.

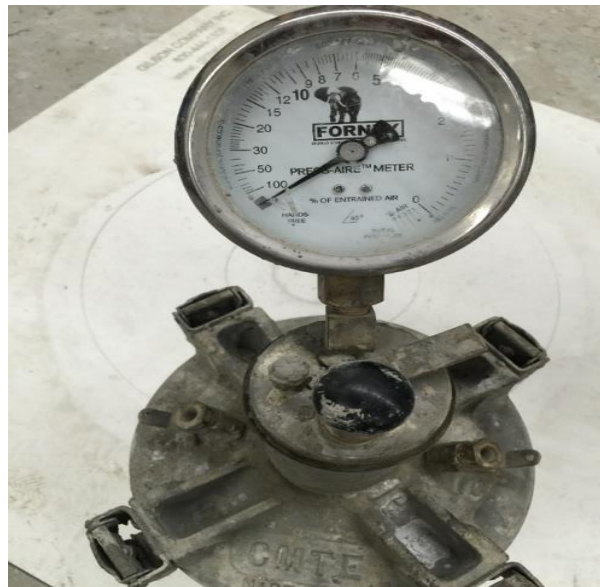
Figure 3.8 Vertical Air Chamber

The air content test was carried out in accordance with ASTM C231 using Type – B pressure meter. This method is for normal concrete and it was used for SCC and FR-SCC. The designed air content was 6%. The used pressure meter is shown in Figure 3.8.\

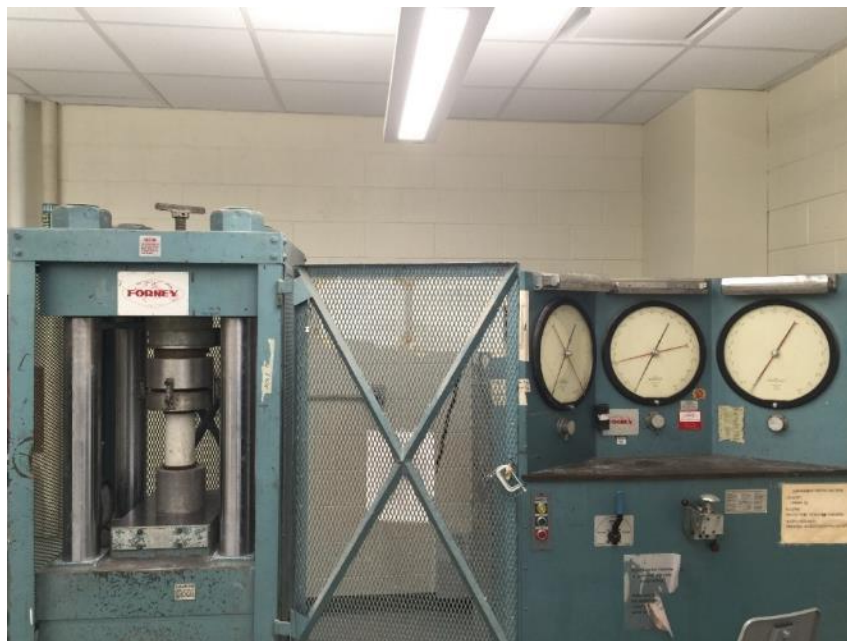
Figure 3.9 1-Million lbs. Forney Testing Machine.

The compressive strength test was made according to ASTM C 39, using 4X8 in cylinders. The compressive strength cylinders were tested using a standard testing machine with a capacity of 1 Million pounds as shown in Figure 3.9. The loading was applied at a rate of 4000 lbs each 9 seconds. The average of three specimens was recorded for each testing age.

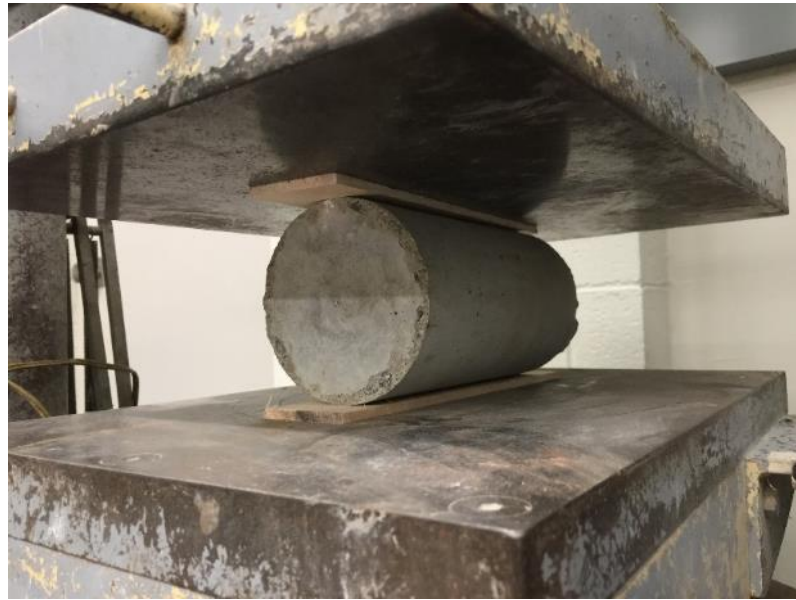
Figure 3.10 Splitting Tensile Test Setup.

The splitting tensile strength test was carried out in accordance with ASTM C496. Cylinders of 4 in diameter and 8 in height were used and tests were performed using a standard testing machine at a rate of 100 lbs per second. Figure 3.10 shows the placement of the test cylinder in the machine. The average of three cylinders was taken at each test. The following equation gives the splitting tensile strength:

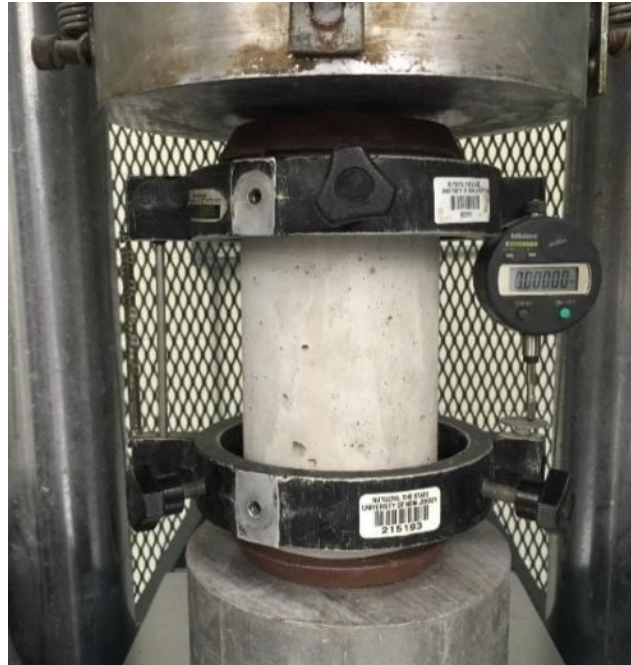
Figure 3.12 Static Modulus of Elasticity Test Setup

Based on ASTM C469, the static modulus of elasticity was conducted on 4x8 inch cylinder specimens. In this test, the specimen is loaded up to 40 percent of the ultimate compressive strength. Hence, the compressive strength was required before starting with the test. The load and deformation were recorded manually at regular intervals. The modulus of elasticity can be determined by plotting the strains against the stresses where the slope represents the modulus of elasticity. Figure 3.12 shows the setup of the test.

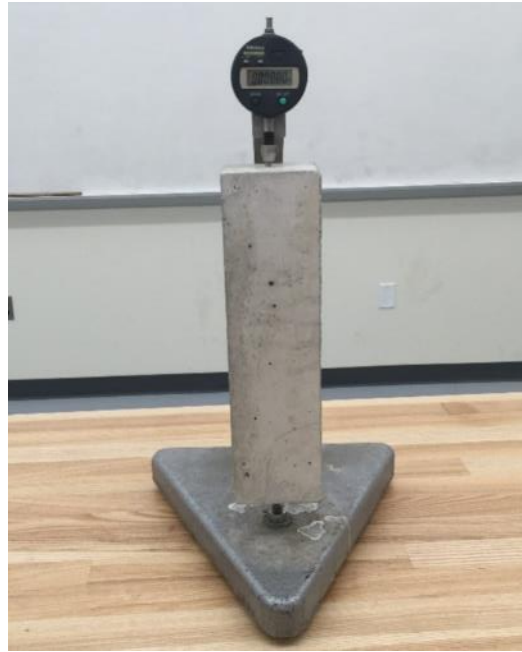
Figure 3.13 Length Change Test Setup.

This test was conducted according to ASTM C157. According to the standard, three concrete specimens measured 3x3x10 in. were needed to be sampled. Prior to cast the specimens, steel gauge studs were screwed into the plates at each end of the mold. After demolding the specimens, they were moist cured for 14 days and then moved to an environmental chamber. At each age of test, the length of the reference bar, as well as the distance between two gage studs, is measured using a length comparator as shown in Figure 3.13. The free shrinkage strain can be obtained by dividing the change in length by the original length.

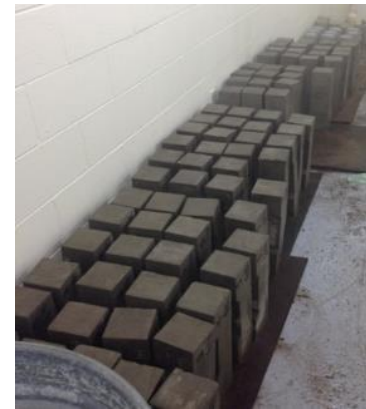
Figure 3.14 Third Point Loading Compatibility Test

prisms as the control specimen with the exception of a wide-mouthed notch 4 in. length x 4 in. width x 0.8 in. thick casting into the bottom of the composite prism (Figure 3.14a). After demolding specimens, the prisms were moist cured for 28 days (Figure 3.14b), and then the wide-mouthed notch areas were textured using a dry brushing. The rough surface textured substrate specimens were air-dry cured for 7 days before batching the notched area with the repair FR-SCC materials. The composite sections were demolded after 24 hours and cured in water for additional 28 days. After completion of the curing, the composite sections were tested in a set up for the third point loading test in accordance with ASTM C78 as shown in Figure 3.15.

b) Curing of Substrate samples

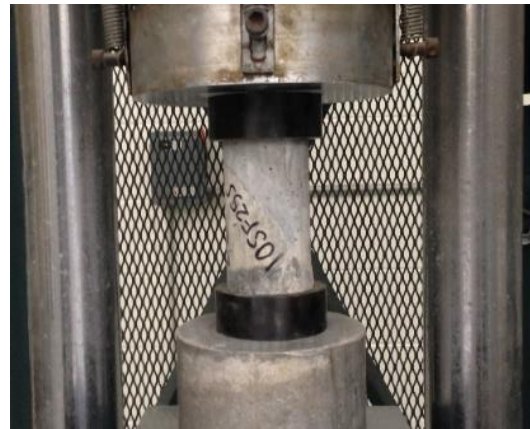
Figure 3.16 Slant Shear Bond Strength Test

The bond strength of the repair materials was determined in accordance with ASTM C882. The repair material was bonded to a substrate concrete specimen on a slanted elliptical plane inclined at 30° angle from vertical to form a 3 in. by 6 in. composite cylinder in Figure 3.16. In order to get that elliptical shape, 3 in. by 6 in. full cylinders were casted then cut by the saw. Before bonding the repair material to the substrate concrete, the slanted surface of the substrate concrete specimen was cleaned and dried. The curing procedure used was according to ASTM C882 and as explained in the third point loading composite prism test. The test is performed by determining the compressive load required to fail the composite cylinder and the bond strength was calculated by the maximum applied load divided by the area of slant surface.

b) Test Setup for Bond Test

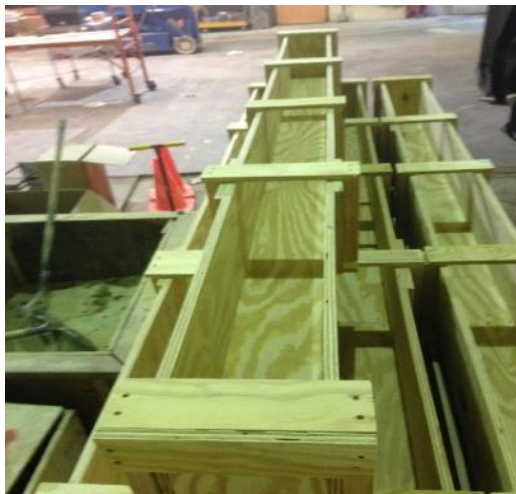
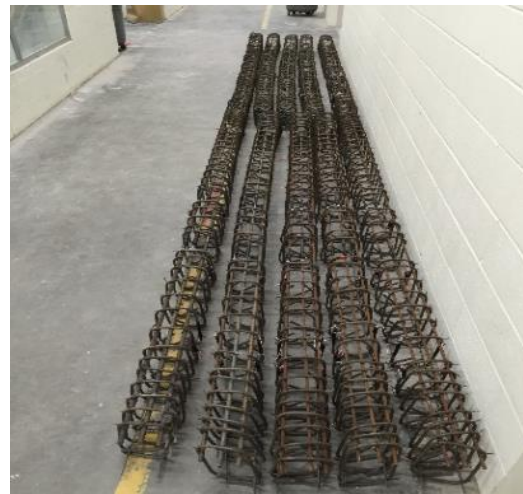
Figure 3.17 Making the Wood Forms and Reinforcement Cages

Ten wood formworks and steel cages were made as shown in Figure 3.17. Formworks were constructed using $\frac{3}{4}$ in thick plywood forming a rectangular section with 132 in long. The formwork was coated with three layers of polyurethane to protect the surface from water in concrete and to achieve a smooth finish to spot during the test easily. Before pouring concrete, the formwork was thoroughly cleaned with an air compressor to avoid any dust or particles on the surface. The sensors installation has been done according to the strain gauges' manufacturer procedure as demonstrated in Figure 3.18. The duct tape was applied to keep the main reinforcement rebar and apart from shear stirrups clean and ready for the repair process as shown in Figure 3.19.

a) Wood Forms

b) Reinforcement Cages

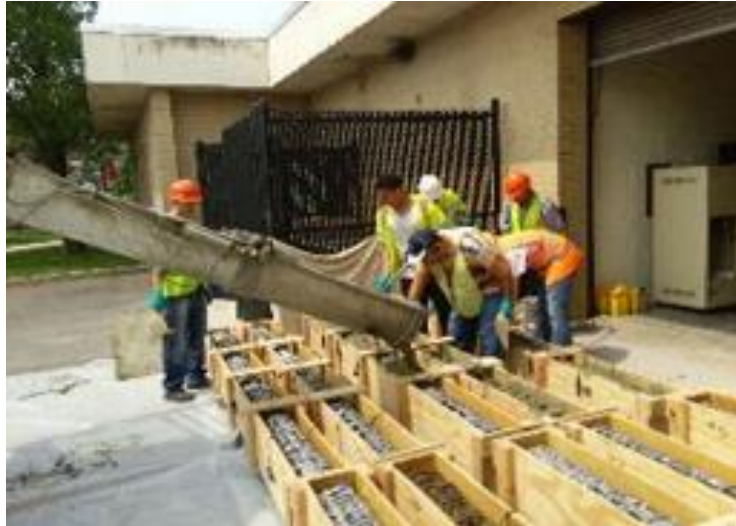
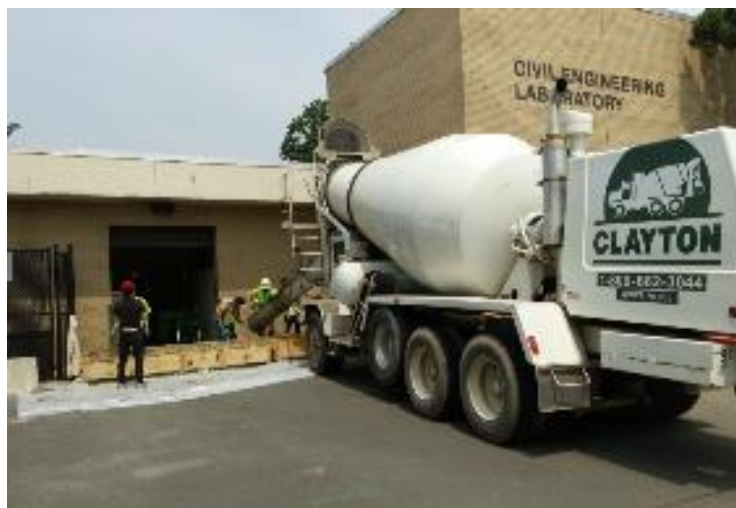
Figure 3.20 Casting the Substrate for the Eight Beams and the Two Control Beams

Two control beams and the substrate of the eight other beams were cast using a Class A concrete mixture provided by the Clayton Company as shown in Figure 3.20. The mix design and the strength test results of Class A concrete were presented previously in Table 3.9 and Table 3.10, respectively. Immediately after pouring and vibrating the substrate concrete, a surface retarder was applied to delay the setting of the surface of the substrate as shown in Figure 3.21. Beams were covered with a plastic sheet till the next day, and then a water stream was applied to remove some of the mortar and expose the aggregate to ensure a good bond of the substrate with the repair material as shown in Figure 3.22. The duct tape was removed as shown in Figure 3.23 and the beams were cured using wet burlaps for 7 days (Figure 3.24) and then continued to be air cured inside the lab until the day of repair.

a) Pouring the Concrete

b) Clayton Concrete Truck Delivering the Concrete

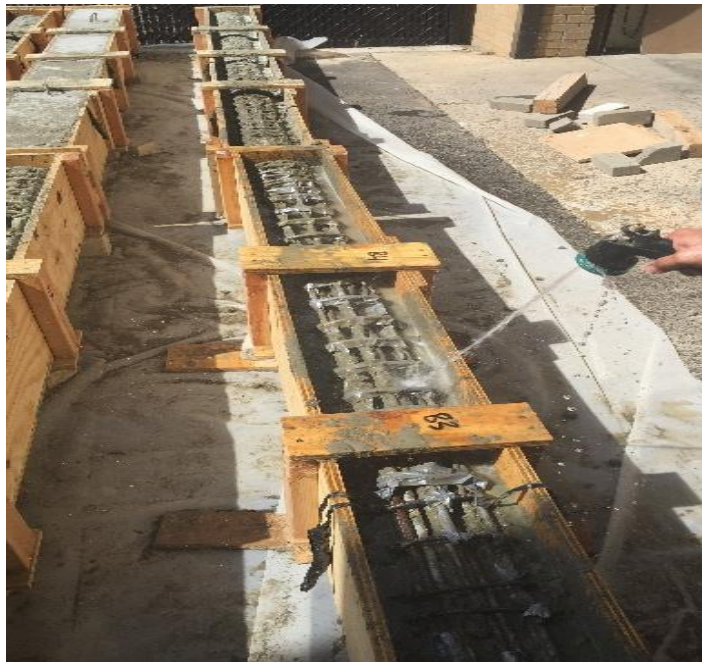
**Figure 3.22 Stream Water for Surface Roughness to Expose the Aggregate to
Ensure a Good Bond of the Substrate with the Repair Material**

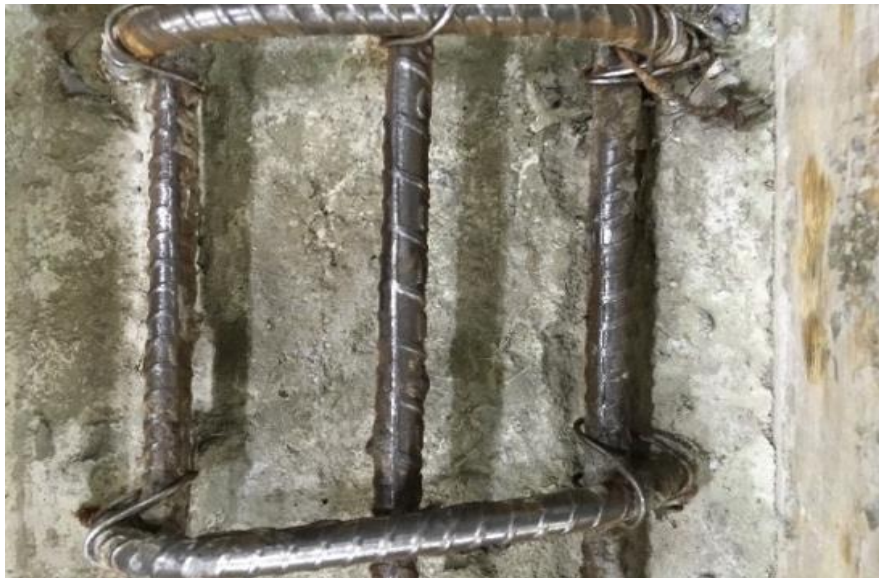
Figure 3.25 Cleaning the Rebars from any Rust

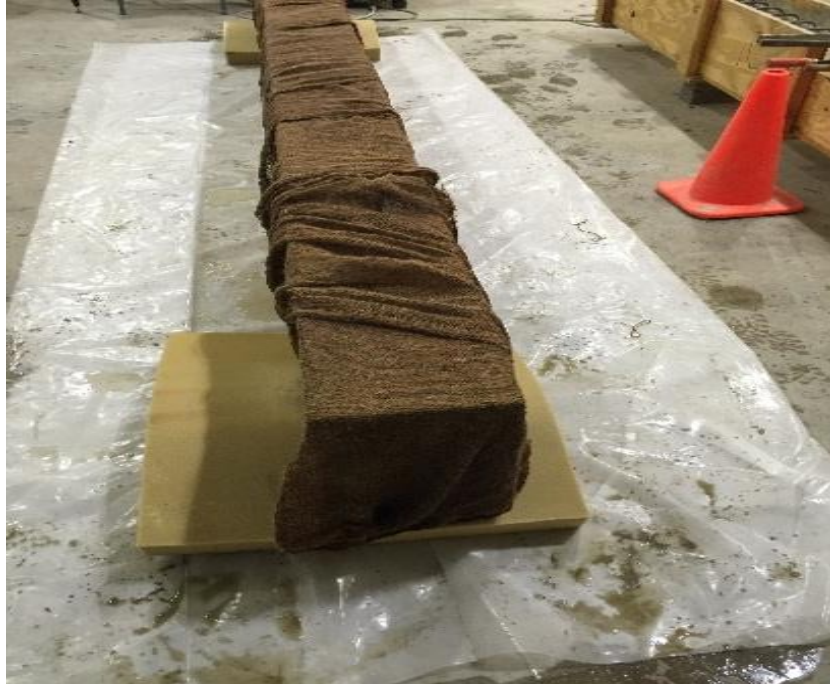
Figure 3.26 Curing the Repaired Beam

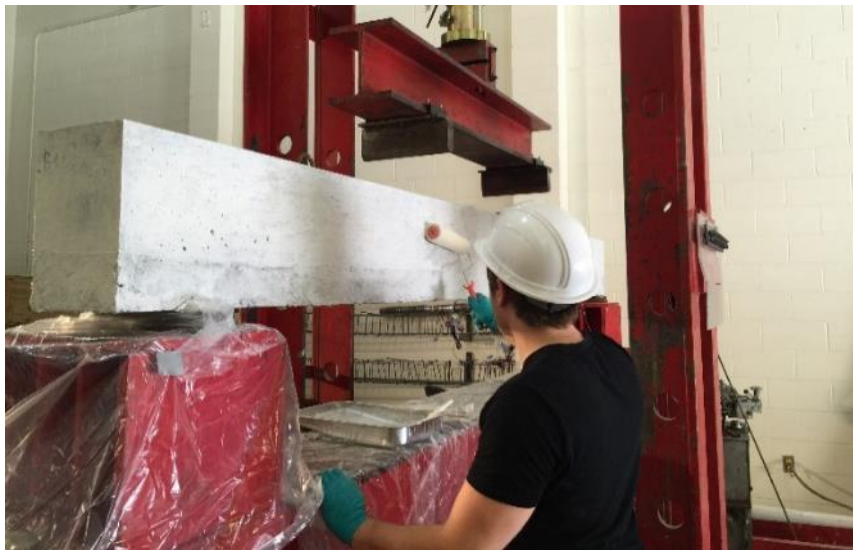
Figure 3.27 Painting the Beam with Whitewash

After 48 hours from the day of the repair, the beam was loaded in the machine, painted with whitewash, side divided into grids, and setup installed as shown in Figs. 3.27 and 3.28. After that, the beams were tested with an age of 3 days from applying the repair.

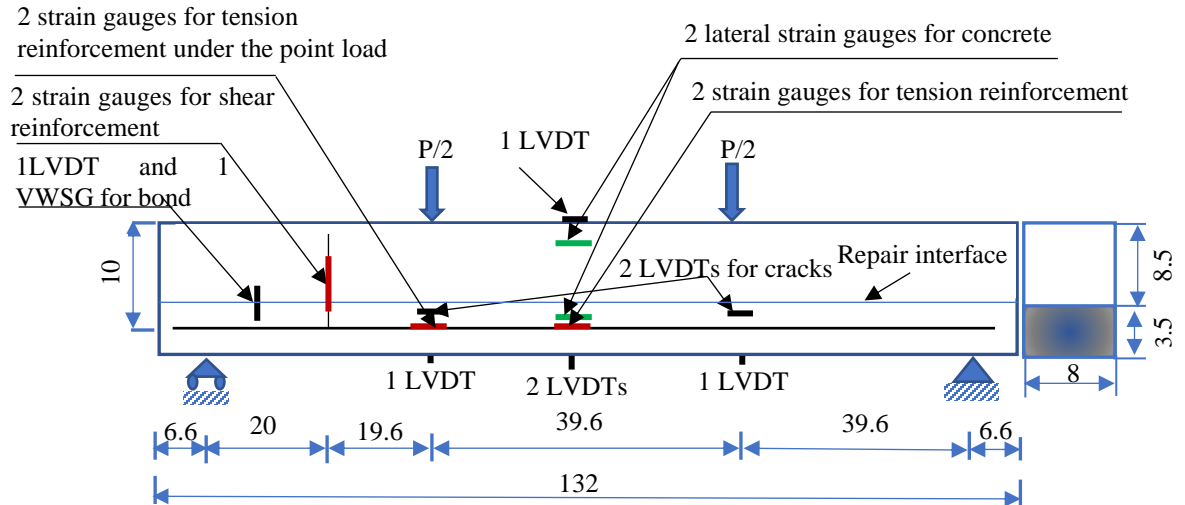
*All dimensions are in inches.

Figure 3.29 Test Setup and Instrument Locations

- 1- Two LVDTs at mid-span and at each side of the beam to monitor the maximum deflection. These LVDTs manufactured by RDP Group, type DCTH1000A.
- 2- Two high-accuracy LVDTs type DCTH400AG (linearity error $< \pm 0.5$ based on full scale) to control the crack width of the 2 first (supposed major) cracks at mid-span of the beam as shown in Figure 3.30.

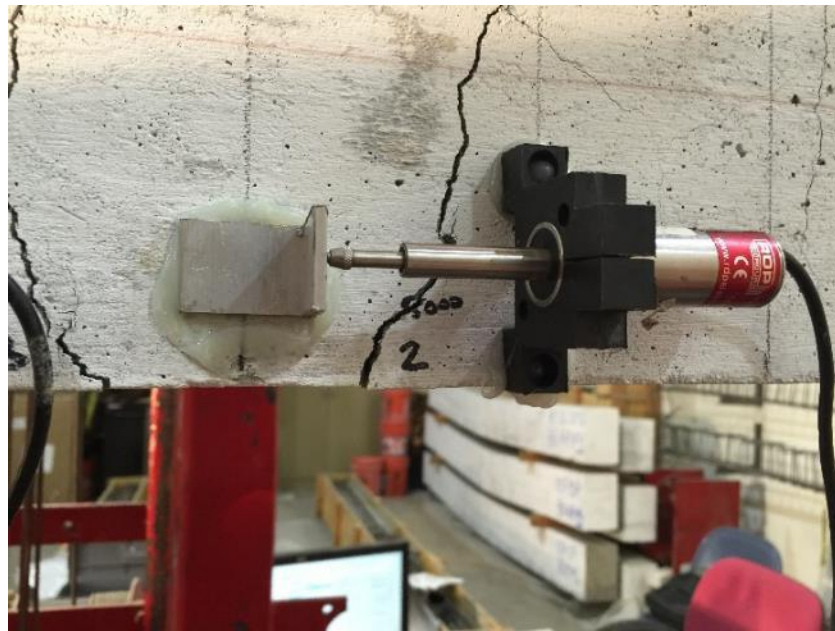
Figure 3.30 LVDT Installed to Measure Crack Width

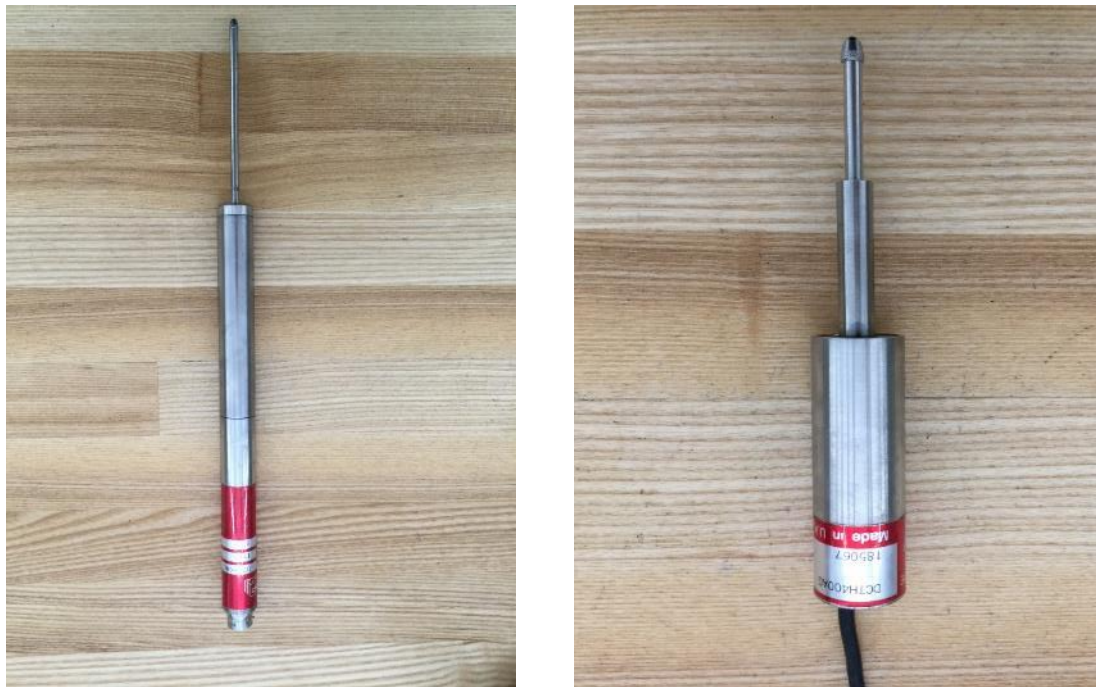
Figure 3.31 LVDT Type DCTH1000A (left) and DCTH400AG (right)

3- Two LVDTs type DCTH1000A at each third span to control the deflection profile along the beam (for quality control). Figure 3.31 shows the types of the LVDTs used throughout this work.

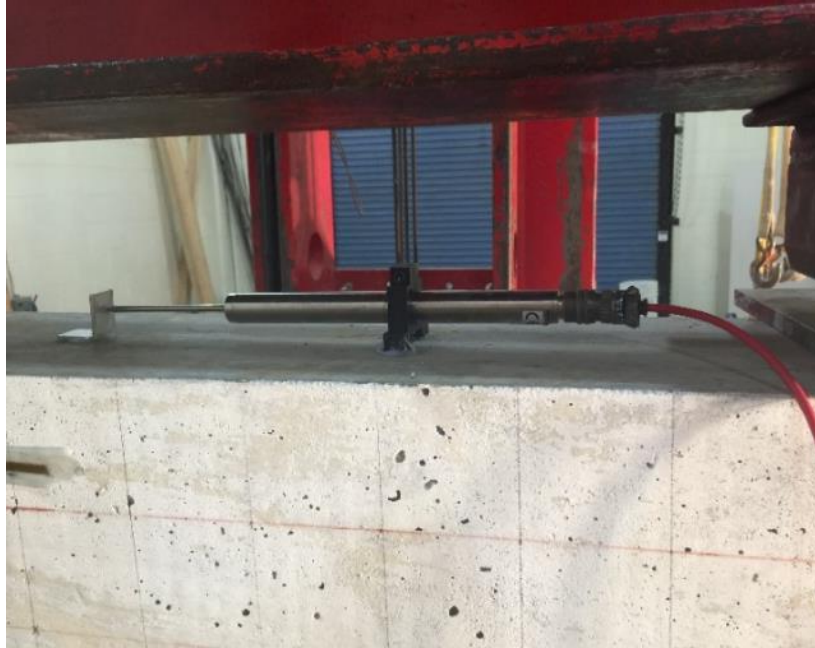
Figure 3.32 LVDT at the Top for Measuring the Compressive Strain

4- One LVDT type DCTH1000A fixed on the top surface of the beam at mid-span to measure the concrete compressive strains as shown in Fig 3.32.

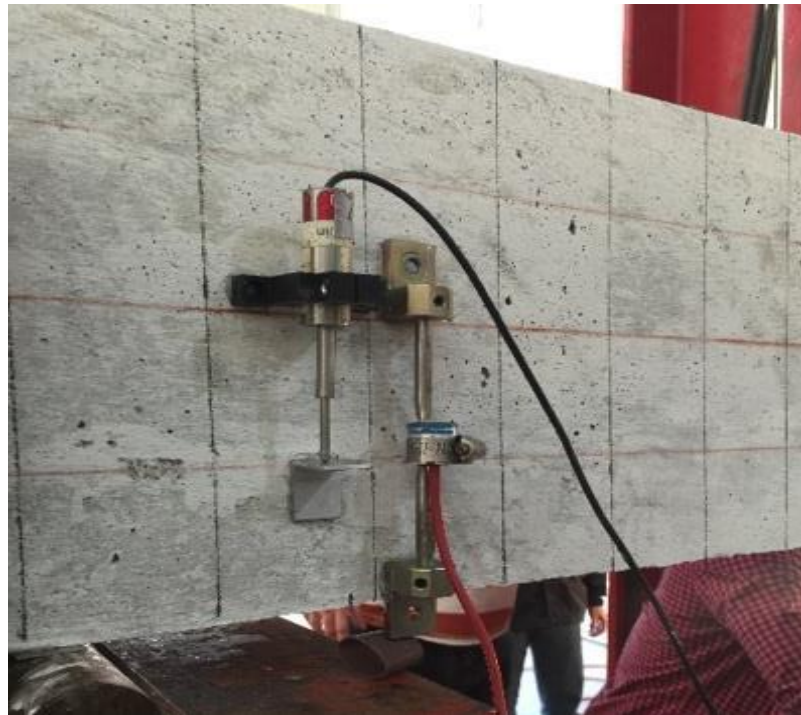
Figure 3.33 VWSG and the LVDT for Deboning Measurement

5- One small LVDT and one Vibrating Wire Strain Gauge (VWSG) to control a possible de-bond between the repair material and the substrate near the support as shown in Figure 3.33. The VWSG used is a Geokon Model 4000, shown in Fig 3.34, while the LVDT is type DCTH400AG. The VWSG is basically consist of a metal tube attached between two mounting blocks. Inside the tube, a vibrating steel wire. When the sensor encounters a small compression or tension, the frequency changes. The resonant frequency is measured by plucking the wire using an electromagnetic coil connected through a signal cable to Data Acquisition System (DAS) which measures the frequency and convert it to microstrains. The VWSG attached to the concrete by bonding the mounting blocks using high strength epoxy structural adhesive known as Devcon.

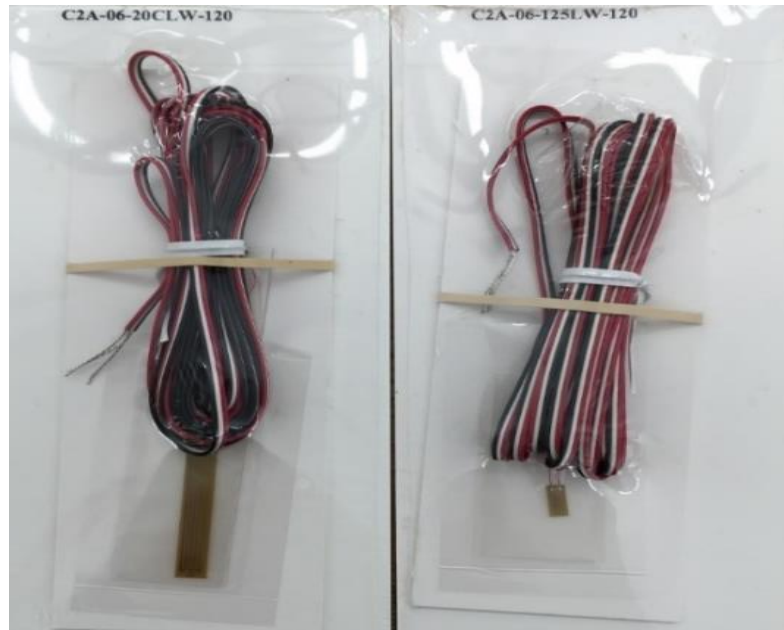
Figure 3.36 Vishay 120 Ohm Foil Strain Gauge C2A-06-20CLW-120 (left) and C2A-06-125LW-120 (right)

20CLW-120 from Micro-Measurements) as shown in Figure 3.35. The C2A-06-125LW-120 and C2A-06-20CLW-120 strain gauges are shown in Fig 3.36.

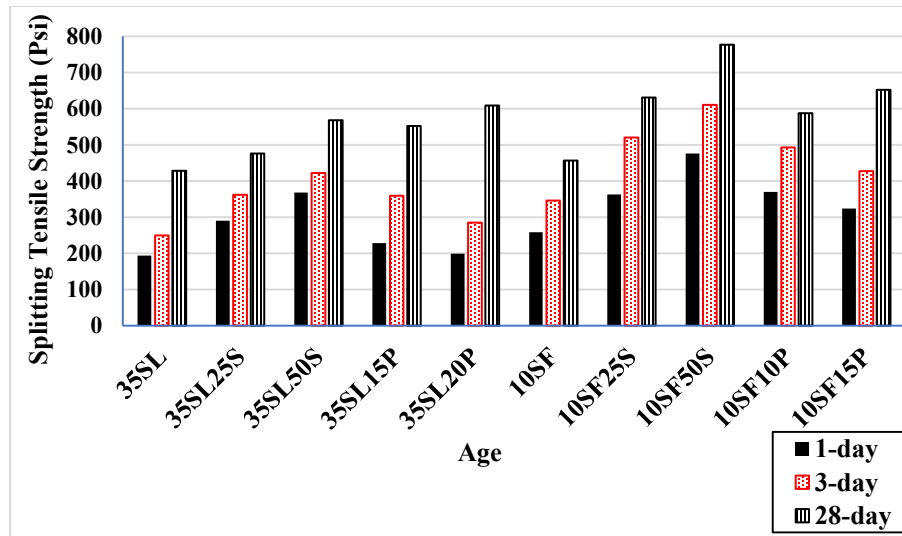
Figure 4.2 Splitting Tensile Strength at Different Age

The effect of the curing ages on the splitting tensile strength for all types of concrete is presented in Figure 4.2 and Table 4.3. The results indicated that, in general, all types of concrete exhibited continuous increase in splitting tensile strength with time. The addition of steel fibers to concrete increases the splitting tensile strength of concrete significantly. The percentage increase in splitting tensile strength was found to be increased with the increase in fiber content. This behavior is attributed to the mechanism of steel fibers in arresting crack progression. Where the presence of fibers in concrete restrains the development of internal microcracks and thus contributes to an increased tensile strength [Kumar et al., 1993]. Thus, the increase in fiber content leads to increase the tensile strength of concrete.

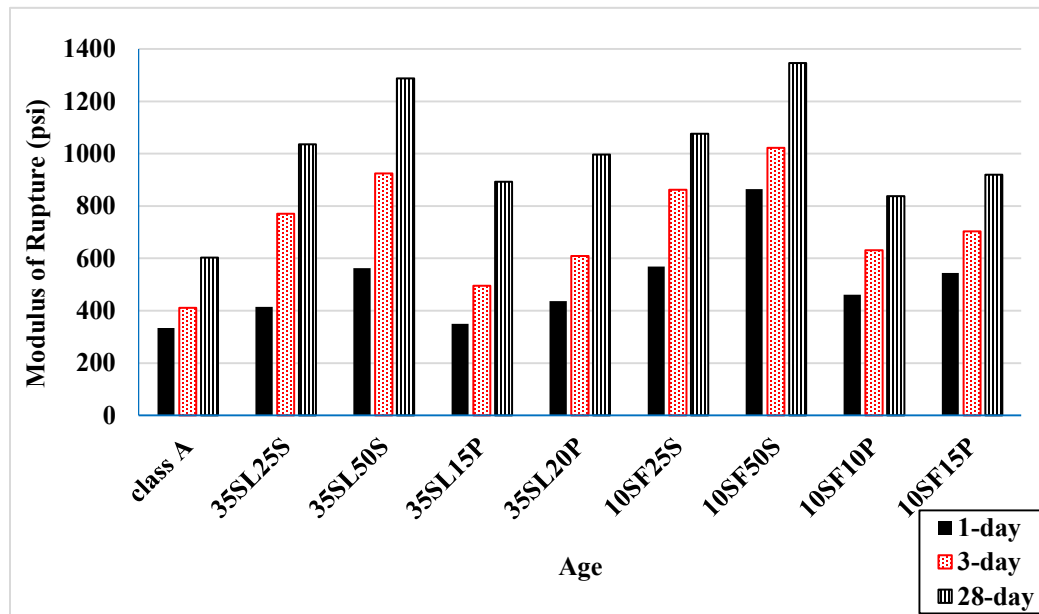
Figure 4.3 Flexural Strength at Different Ages

The results of the flexural strength for various types of concrete specimens are presented in Figure 4.3 and Table 4.4. The results indicated that with the progress of curing ages all concrete specimens showed a continuous gain in flexural strength. The modulus of rupture increases with the increase of fiber percentage. This behavior is mainly attributed to the role of steel fibers in releasing fracture energy around crack tips which is required to extent crack growing by transferring it from one side to another side [Teng and Shah, 1986]. The results also showed that mixtures with SF showed better flexural strength than mixtures with SL.

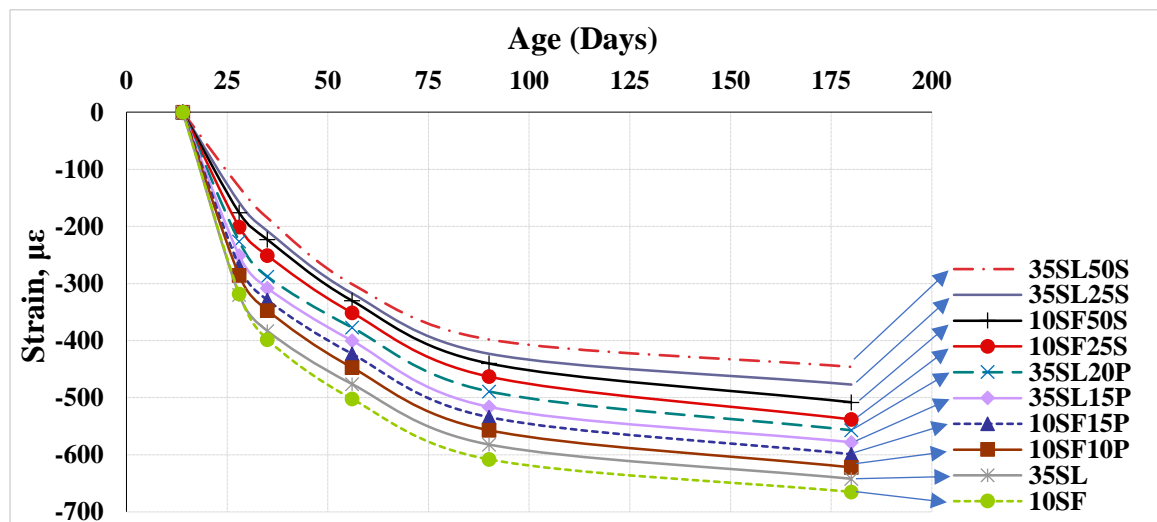
Figure 4.6 Free Drying Shrinkage Behavior for Various Mixtures

Figure 4.6 illustrates the free shrinkage test results. Mixtures included SL showed lower shrinkage than mixtures included SF in it. This is mainly attributed to the high fineness of the SF material. The results also demonstrated that the incorporation of both types of fiber reduced the shrinkage significantly comparing with mixtures without fibers. It is good to mention that 35SL50S mixture showed the lowest shrinkage with 37 % reduction comparing to 35SL at 56 days. Emmons et al., 1993 has pointed that if the repair material shows a drying shrinkage exceed of 0.05 and 0.1 % for moderate and high level respectively, an early failure will happen. The drying shrinkage results for the mixtures under study were ranged between 0.0131 and 0.032 % at 28 days which is below the moderate level.
