**EXPERIMENTAL AND ANALYTICAL STUDY OF FIBER-
REINFORCED SELF-CONSOLIDATING CONCRETE AS A
REPAIR MATERIAL**

A dissertation submitted to the

Rutgers, The State University of New Jersey

Doctor of Philosophy

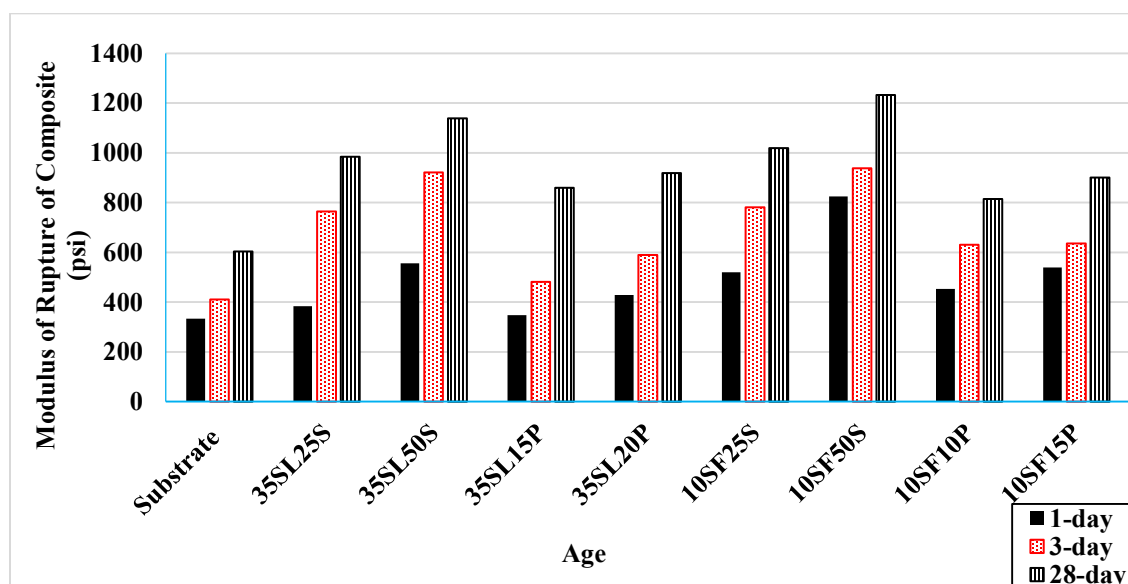
Figure 4.7 Results of Third Point Loading Composite Prism Test

inducing tensile stresses in the repair material. The values of flexural strength compatibility for the various types of concrete at different curing ages are presented in Figure 4.7 and Table 4.6. The substrate which is Class A concrete flexural strength results were 334, 411, and 603 psi for 1, 3, and 28 days, respectively. Results indicate that all composite prisms exhibited higher flexure strength compared with the substrate with a maximum increase of 147, 128, and 104 % at 1, 3, and 28 days, respectively. In general, the failure location was in the middle which indicates a good compatibility. Depending on the point of failure determined through this test, a concrete sample's compatibility with a repair material is determined. Czarnecki et al., 1999 has found that if a failure crack appears through the repair material and the substrate, or through only the substrate, the two materials are compatible. If, however, a failure crack appears through the bonded area between the substrate and repair, the two materials are incompatible Figure 4.8 shows the two types of failure mode observed. The good compatibility of the optimized repair mixtures during this study is mainly due to the low drying shrinkage of these materials.

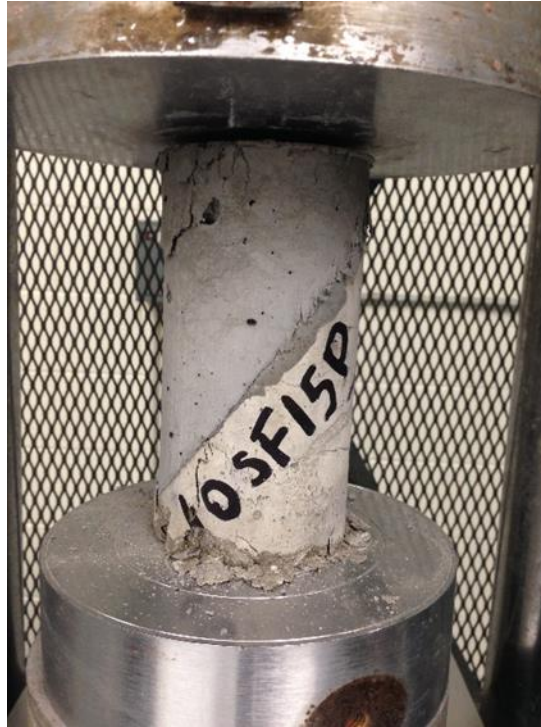
Figure 4.10 Example of the Failure in both Substrate and Repair Material

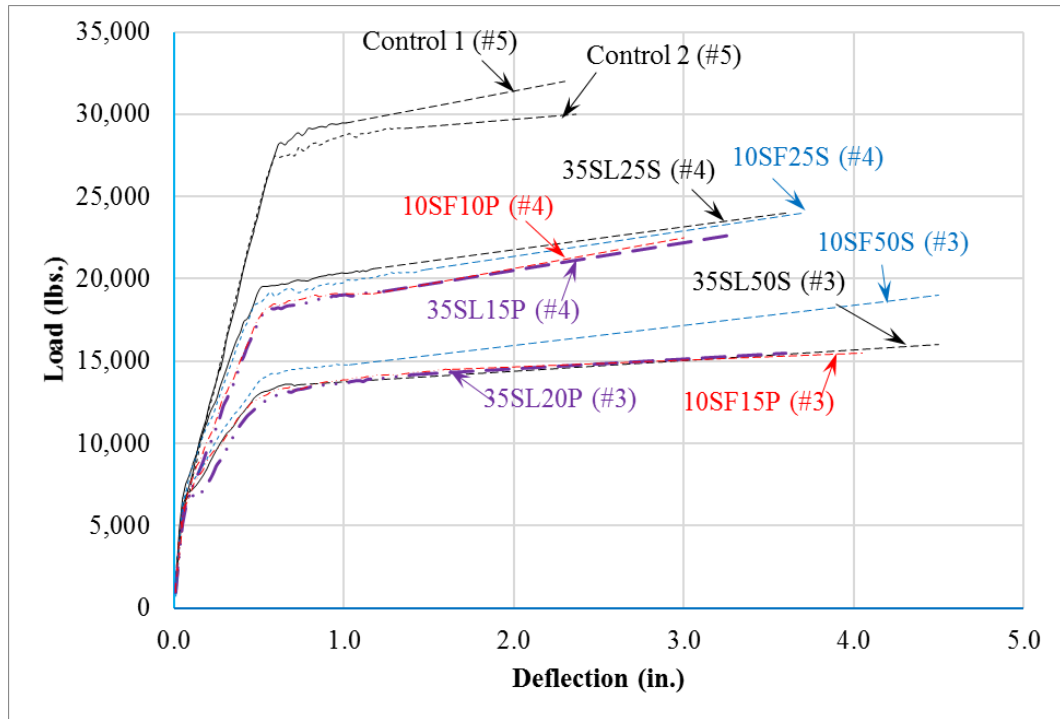
Figure 4.12 Deflection at Midspan for all the Beams

In general, the beams repaired with STF mixtures have shown a better flexural strength behavior than the one repaired with PPF mixtures. Naaman [1996], has proven that the flexural behavior is a function of fibers length and their bond strength. Hence, the better behavior of the beams repaired with STF mixtures comparing to the one repaired with PP mixtures is mainly attributed to the longer fibers length, higher bond and stiffness. Also, the shape of the STF providing an additional increase in bond. The longer fibers will provide bridging stresses across the crack resulted in coalesce of the microcracks [Shah et al., 1996]. Therefore, the toughness of the concrete mixtures was increased as shown in Figure 4.12.

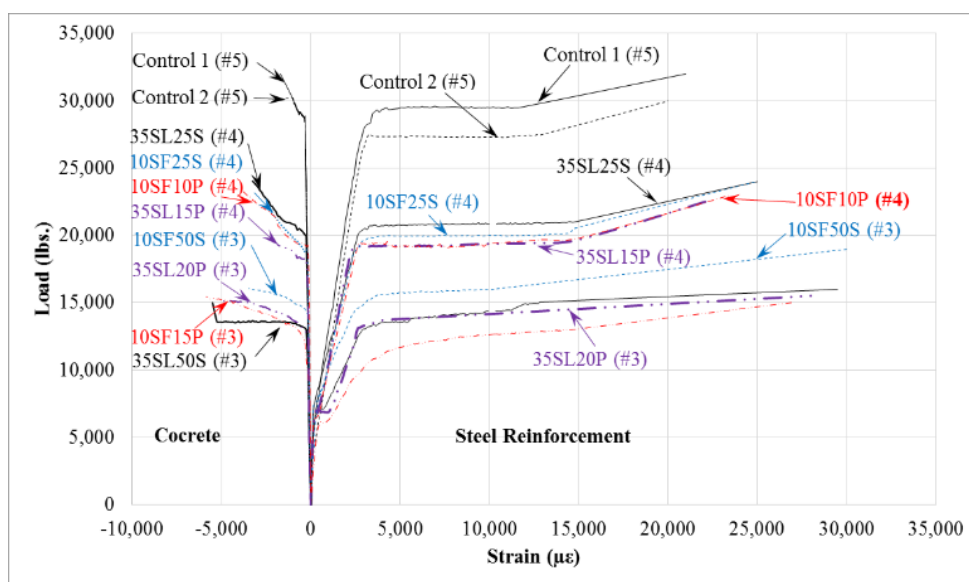
Figure 4.14 Relationship between applied Load and both Rebar Tensile Strain and Concrete Compressive strain for all Beams

The strain in the main steel reinforcement was measured by using foil strain gauge; while, the strain on the concrete top fiber was measured using LVDT as explained in Chapter 3. The LVDT initial gauge length was recorded before starting the test, and the strain is measured by dividing the change in the LVDT reading to the initial gauge length. It can be seen from Figure 4.14 that when the load increases, both steel reinforcement and concrete strain are increased. It can be also seen that the main steel reinforcement exceeded its yield strain and also reached its hardening portion in both control and repaired beams. The maximum service strain in the main steel reinforcement were 3500 and 3900 microstrains for control and repaired beams, respectively. In general, beams repaired with STF showed higher service strain than the other beams for the same rebar size. Such increase in the strain value is mainly attributed to the higher concrete strength for the repair mixtures containing STF in it. In addition, to the high-volume fraction of the STF used comparing to PPF.

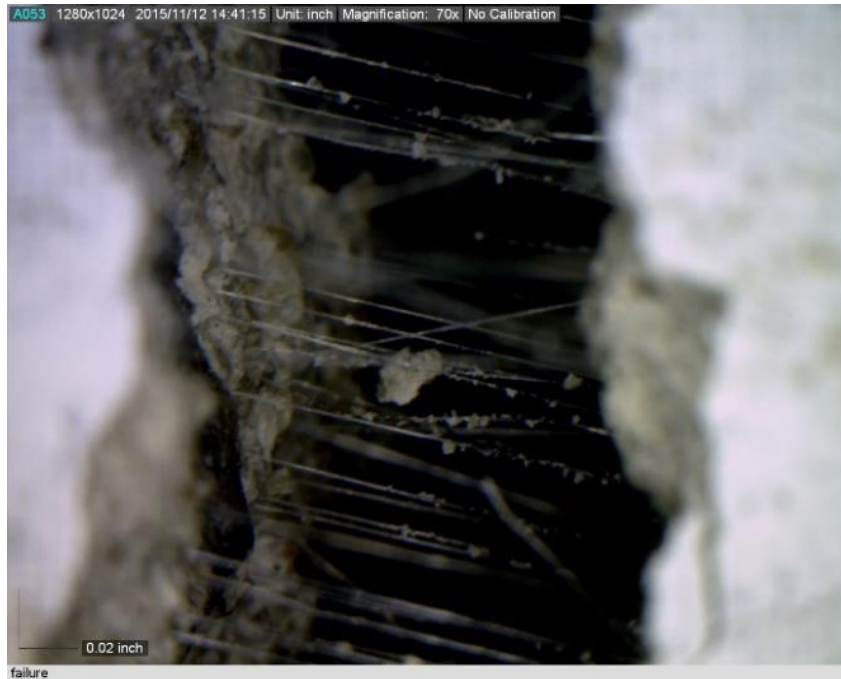
**Figure 4.15 Picture Taken Using Digital Magnifier Camera at 70x Magnification
Showing Major Crack at Midspan in 35SL20P Repaired Beam at Failure**

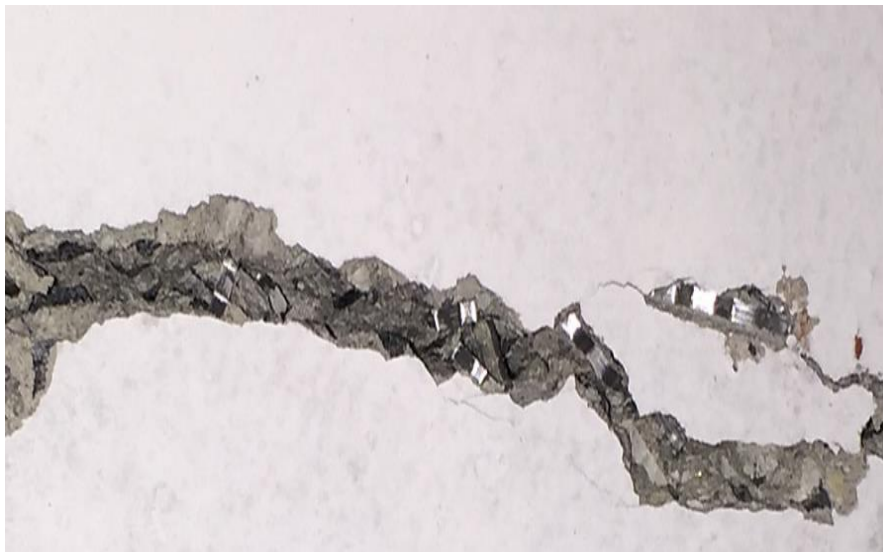
Figure 4.16 Crack at Failure in 10SF50S Repaired Beam

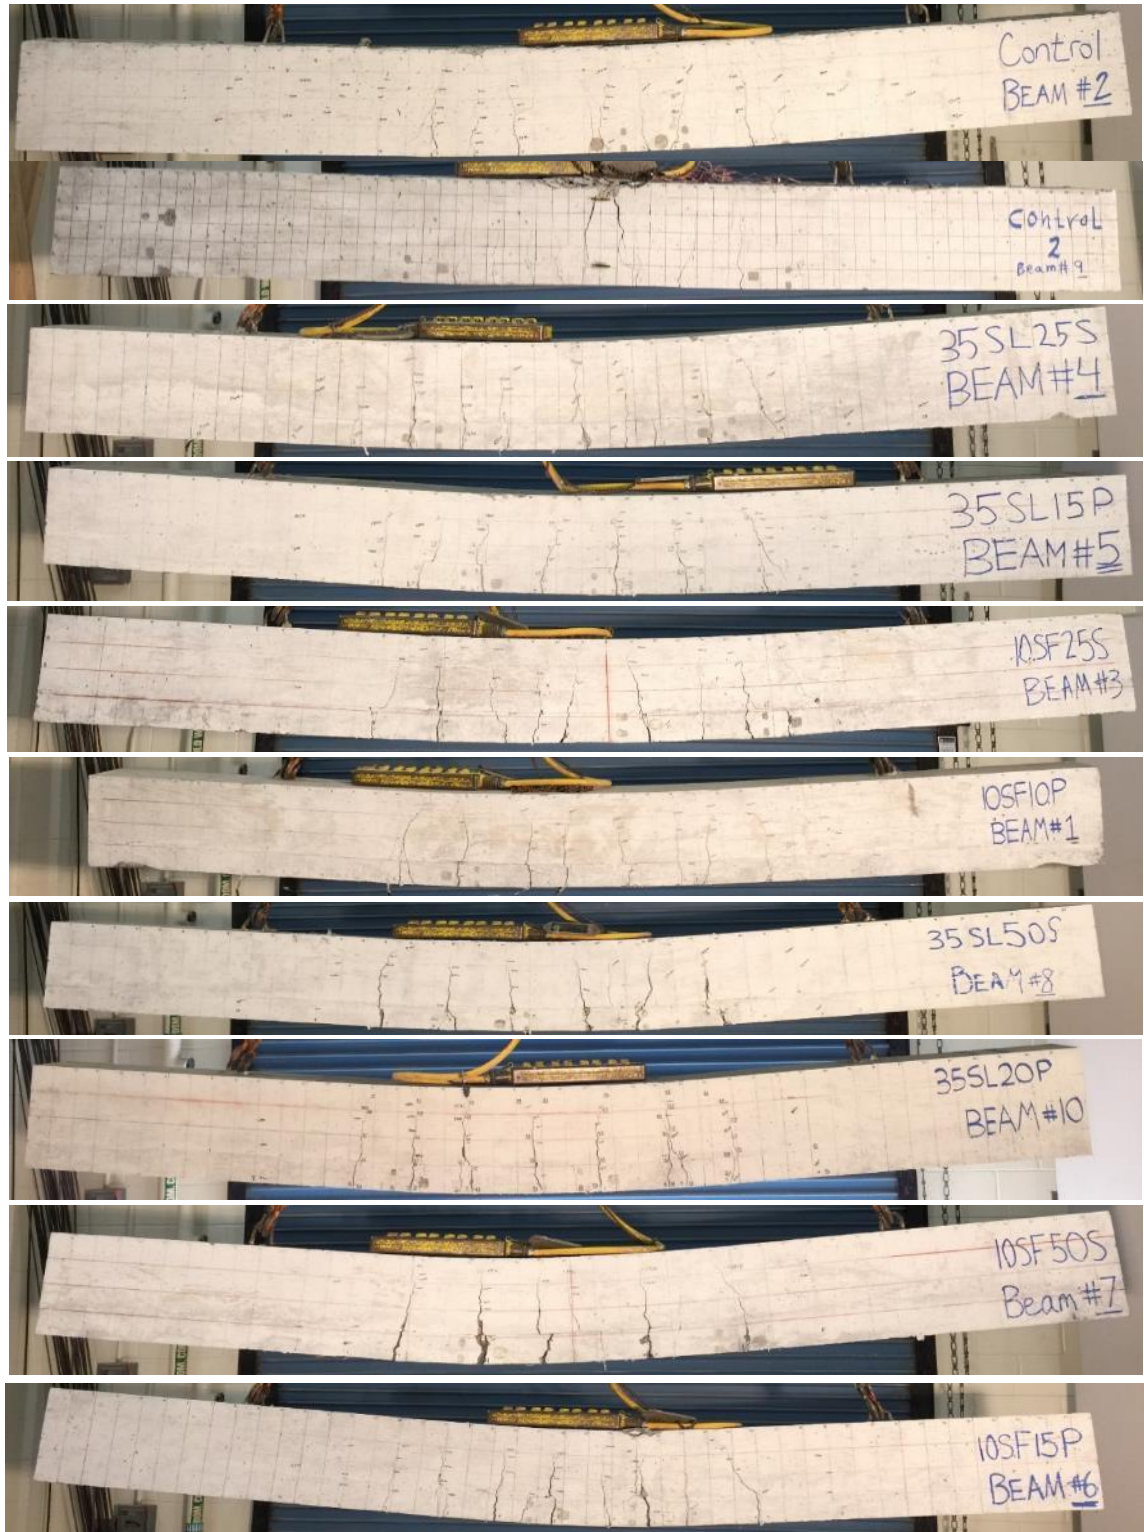
Figure 4.17 Mode of Failure of Beam Specimens

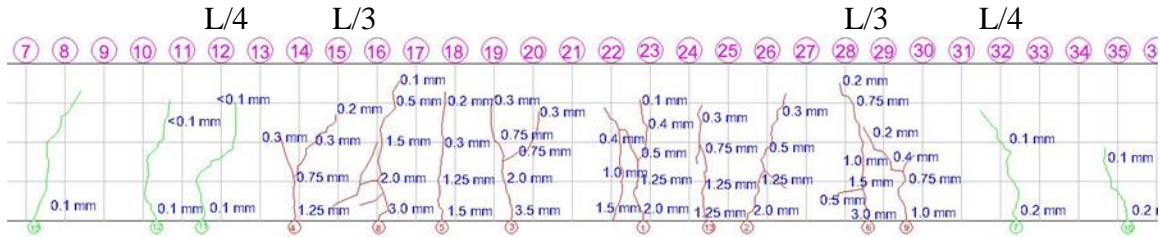
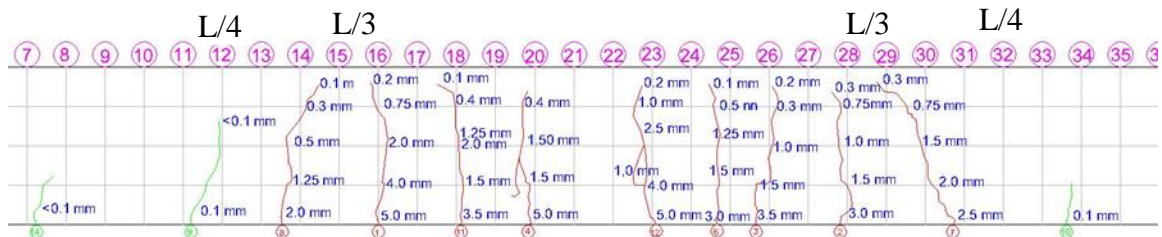
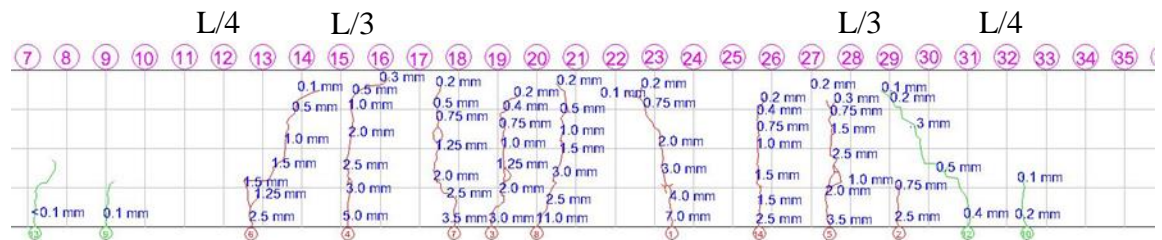
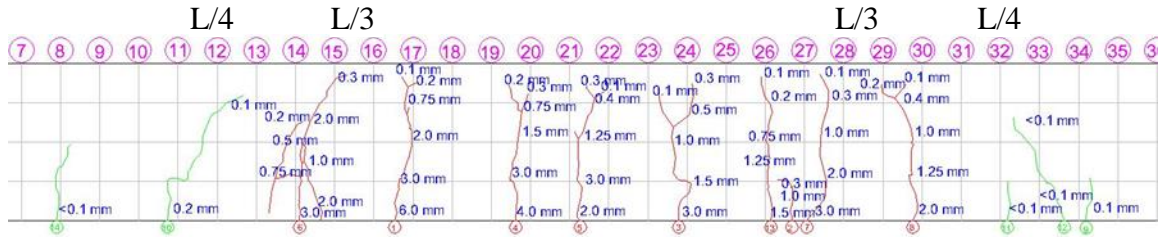
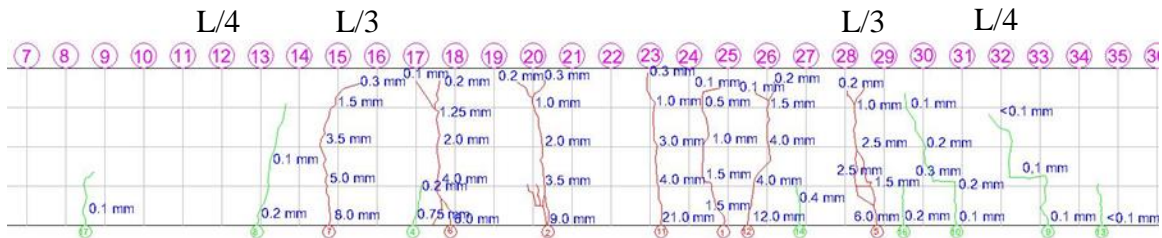
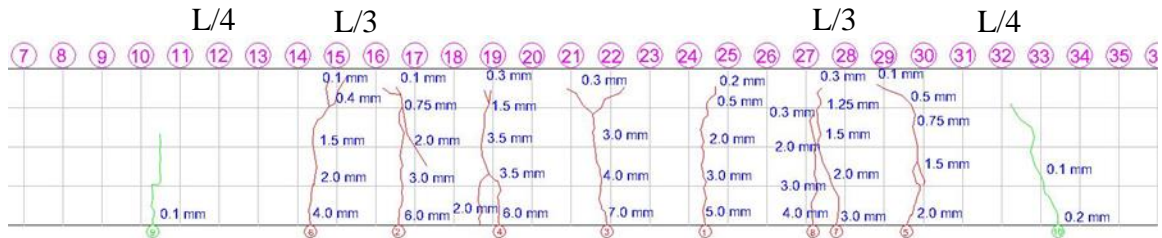
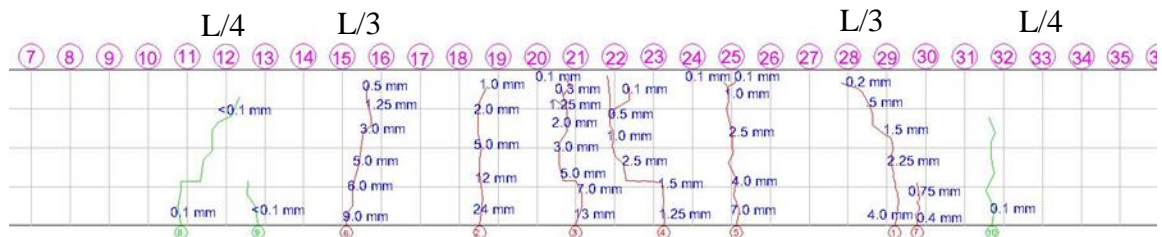
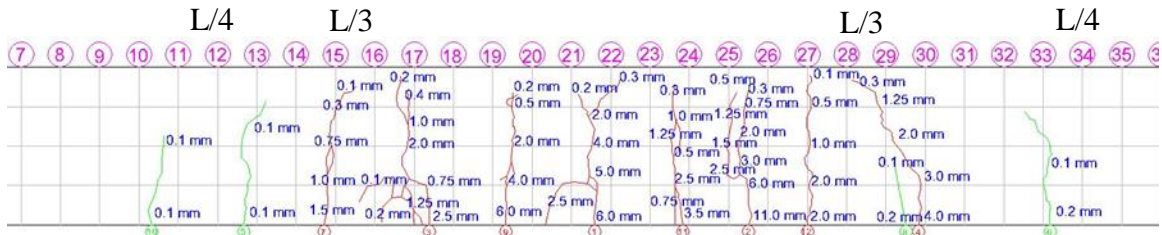
Figure 4.18 Crack Patterns and Width at Failure for all the Beams

Table 4.9 shows the number of cracks and the average crack spacing for all the beams. The average crack spacing is taken as the average spacing of flexure cracks between two loading points (i.e. constant moment zone). It was observed that the average crack spacing decreases with increased fiber content when comparing the repaired beams having the same rebar size. For beams contain #3 rebar size, the average crack spacing decrease in the following order (10SF15P, 35SL20P, 35SL50S, and 10SF50S) as shown in Figures 4.18-g through 4.18-j. While for the beams contain #4 rebar size, the decreasing in the average crack spacing is in the following order (10SF10P, 35SL15P, 35SL25S, and

10SF25S) as shown in Figures 4.18-c through 4.18-f. It was also observed that the number of cracks also increases when increasing the rebar size, and more flexural crack initiated beyond the maximum moment region. Figures 4.18-a through 4.18-b for beams contain #5 rebar have shown 8 cracks, while Figures 4.18-c through 4.18-f for beams contain #4 rebars and Figures 4.18-g through 4.18-j for beams contain #3 rebars have shown number of cracks of 7 and 6, respectively. Table 4.9 also illustrates the percentage of crack density at the cracking load for each beam. It was calculated by using Equation 4.1.

a) Control 1 (#5 rebar)

c) 35SL25S (#4 rebar)

e) 10SF25S (#4 rebar)

f) 10SF10P (#4 rebar)

g) 35SL50S (#3 rebar)

h) 35SL20P (#3 rebar)

i) 10SF50S (#3 rebar)

j) 10SF15P (#3 rebar)

The failure mode observed for all the beams was due to the crushing of concrete. The cracks first initiated at flexural zone in the mid third of the beam between the two points load. These cracks were propagated vertically due to the pure bending at the beginning stage of the loading. Then, due to the increase in the load, shear stresses were increased, and the crack direction became inclined towards the nearest point load. When the load increased and the beams reached their yield capacity, the concrete at the compression zone crushed and the beams failed. It is good to mention that there was no visible horizontal crack at the interface layer between the concrete substrate and the repair layer for all of the repaired beams. At failure, it was noticed a very thin horizontal crack at the interface layer. The LVDT and VWSG at the interface layer were constant. Thus, there was no de-bonding. Figures 4.15 and 4.16 show fibers in the cracks at failure for beams repaired with PPF mixture and STF, respectively. These two figures show how the fibers randomly distributed and how they are bridging the crack. The mode of failure of beam specimens and crack patterns are shown in Figures 4.17 and 4.18, respectively.

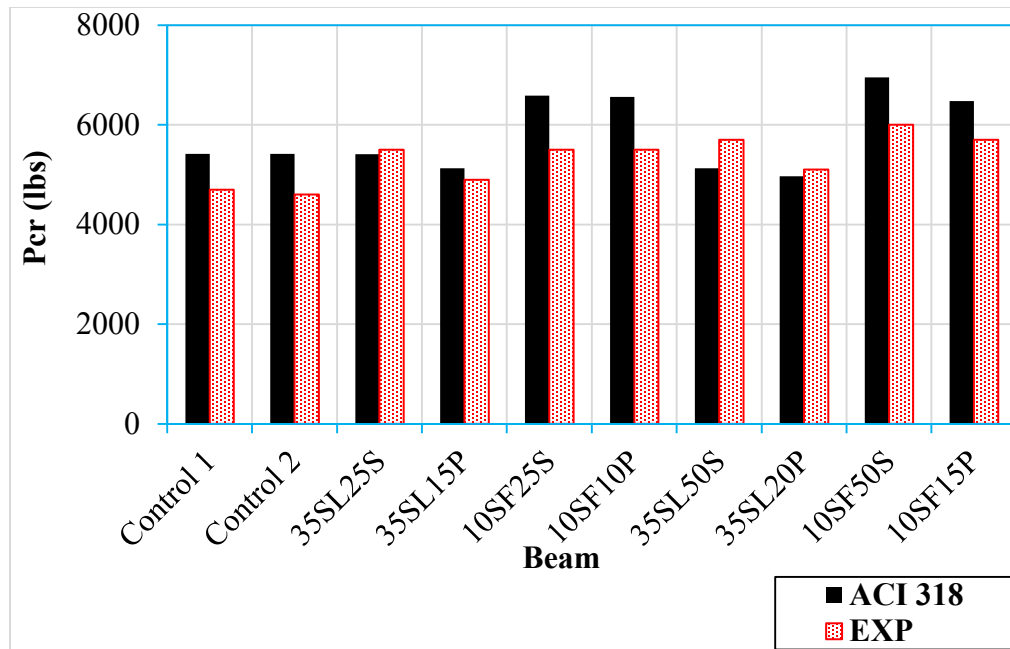
Figure 5.2 Comparison of Prediction of Cracking Load Using ACI 318 [2014] with the Experimental Results

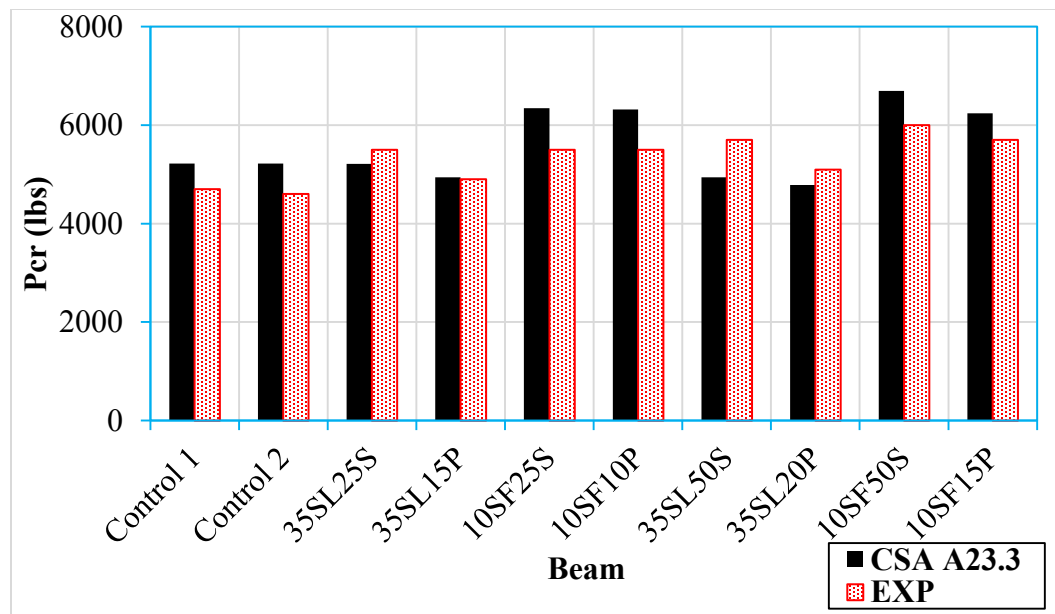
Figure 5.3 Comparison of Prediction of Cracking Load Using CSA A23.3 [2004] with the Experimental Results

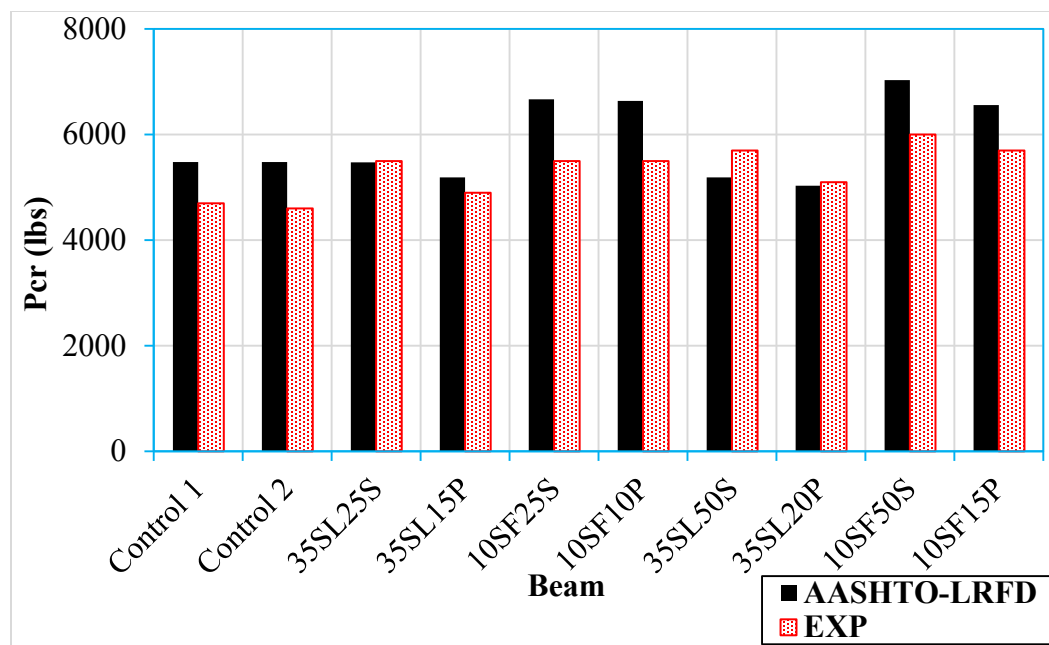
Figure 5.4 Comparison of Prediction of Cracking Load Using AASHTO-LRFD [2012] with the Experimental Results

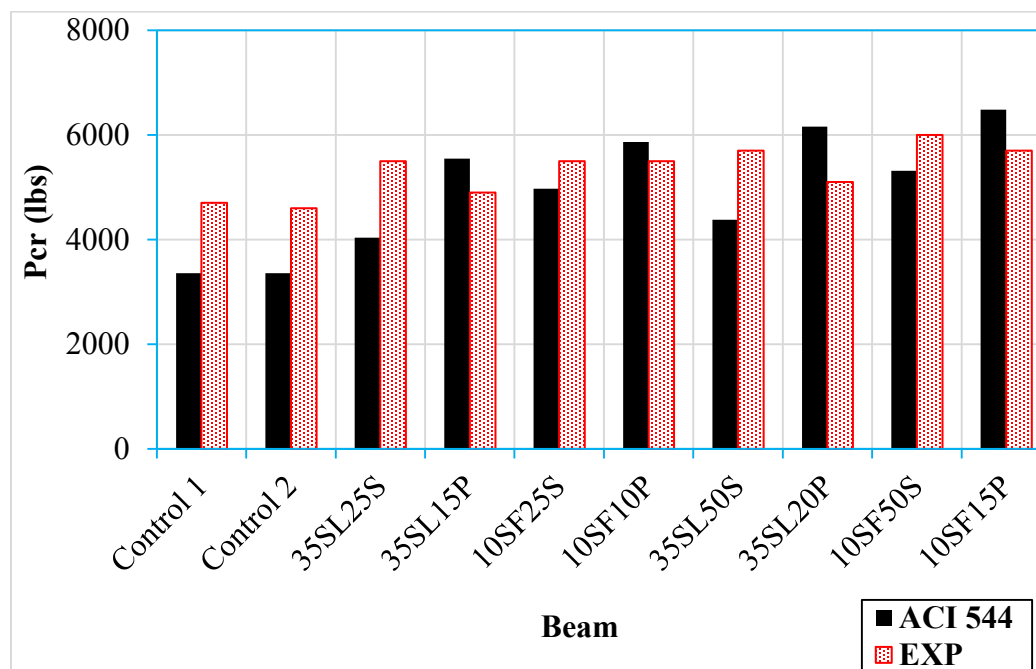
Figure 5.5 Comparison of Prediction of Cracking Load Using ACI 544 [2011] with the Experimental Results

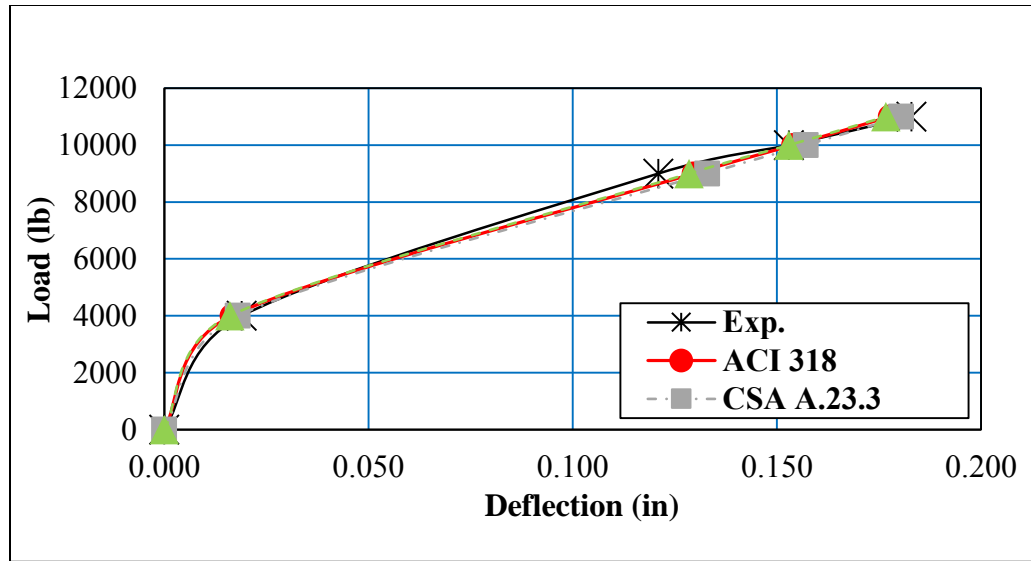
Figure 5.9 An Example of the Correlation between the Predicted Load-deflection for the Studied Code with Experimental for a Repaired Beam

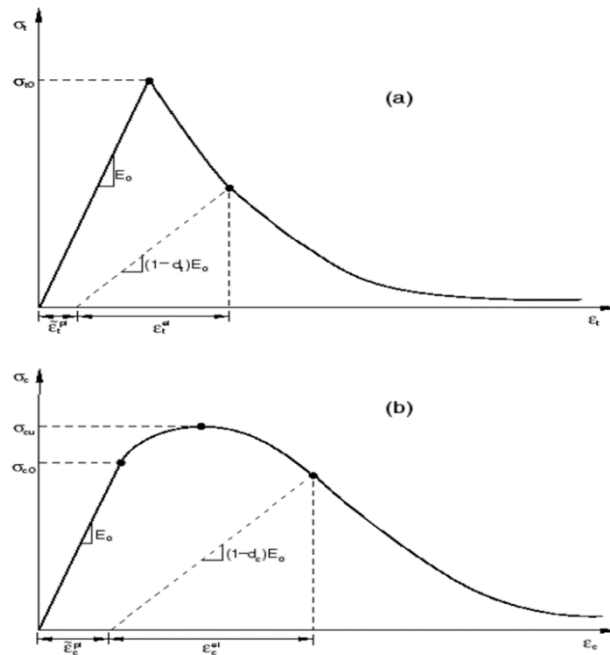
Figure 5.13 Response of concrete to uniaxial loading in tension (a) and (b) compression [ABAQUS, 2011]

This section essentially follows the development given in the ABAQUS 6.11 manual work to explain the constitutive material model used briefly. The Concrete Damage Plasticity (CDP) was used for both substrate and repair layers. The CDP is a continuum, plasticity-based, damage model for concrete. It assumes that the main two failure mechanisms are tensile cracking and compressive crushing of the concrete material. Two hardening variables control the evolution of the yield or failure surface, $\tilde{\varepsilon}_t^{pl}$ and $\tilde{\varepsilon}_c^{pl}$, linked to failure mechanisms under tension and compression loading, respectively. $\tilde{\varepsilon}_t^{pl}$ and $\tilde{\varepsilon}_c^{pl}$ as tensile and compressive equivalent plastic strains, respectively. The model assumes that the uniaxial tensile and compressive response of concrete is characterized by damaged plasticity, as shown in Figure 5.13.

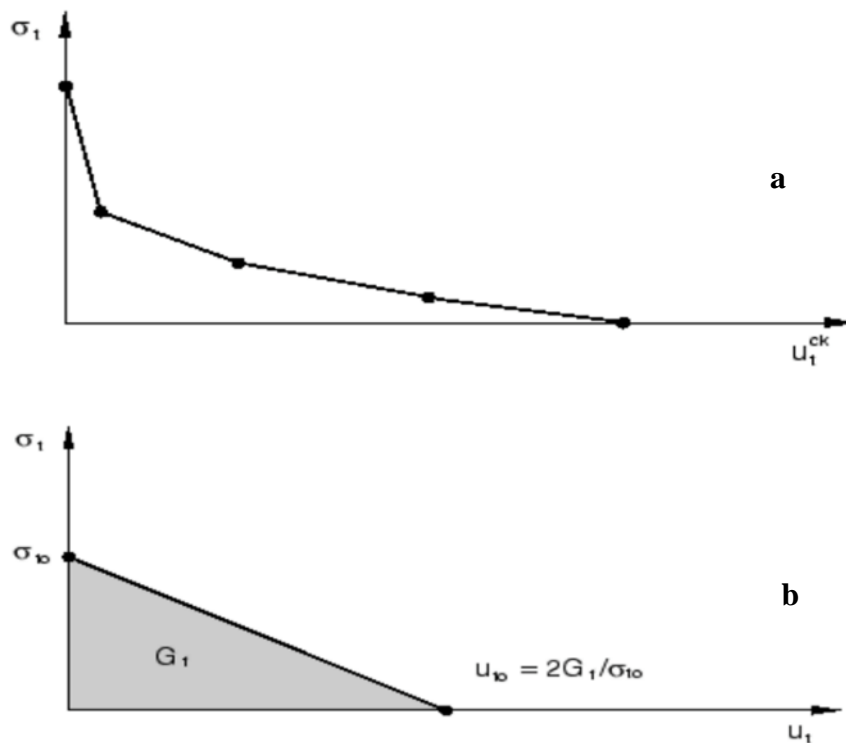
Figure 5.14 Post-failure Stresses Relationship: a) Post-failure Stress-displacement Curve; b) Post-failure Stress-fracture Energy Curve [ABAQUS, 2011]

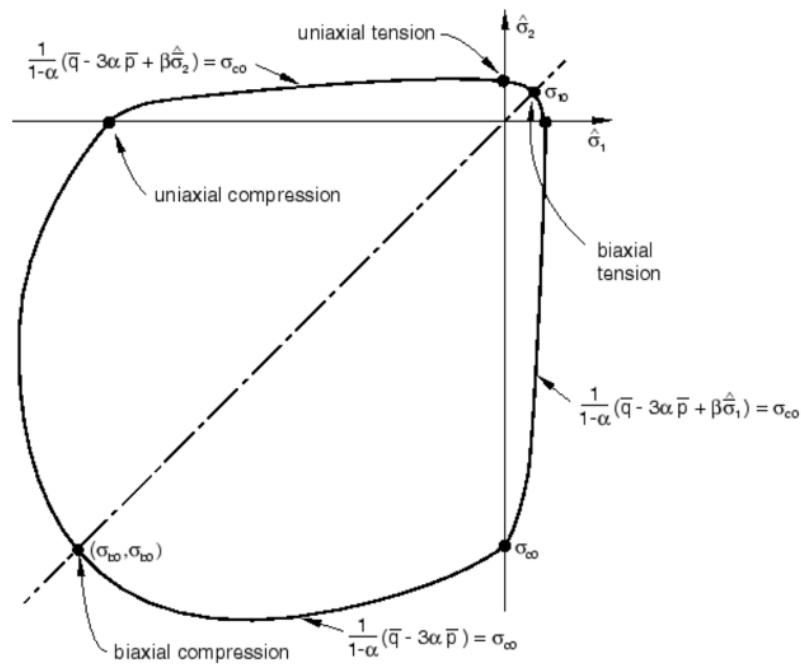
Figure 5.15 Yield Surface in Plane Stress [ABAQUS, 2011]

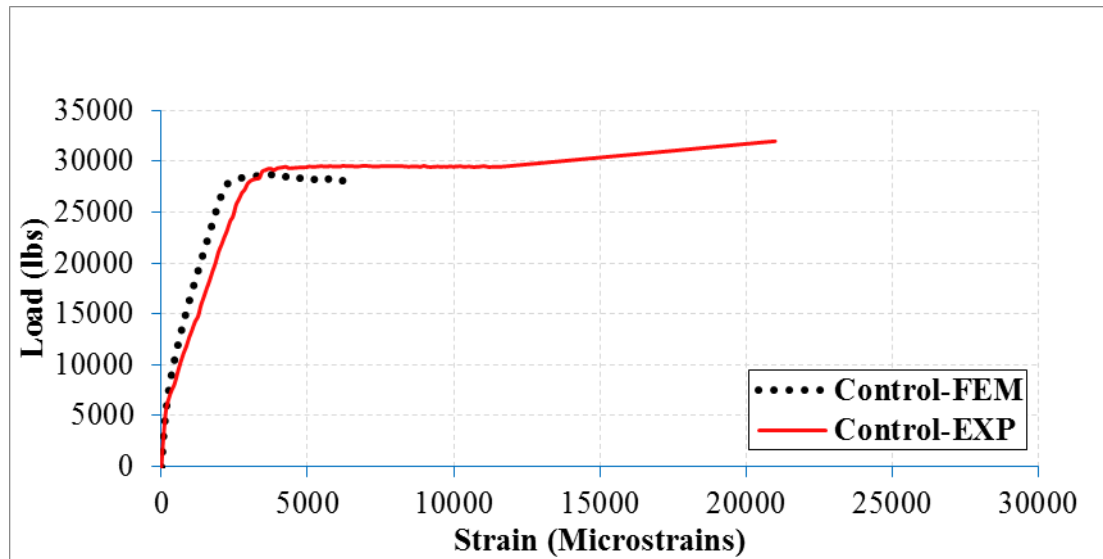
Figure 5.23 Applied Load and Rebar Tension Strain Relationship at Middle at Center for Control Beam Contains #5 Rebars ($A_s = 0.93 \text{ in}^2$): Comparison between FEM and Experimental Results

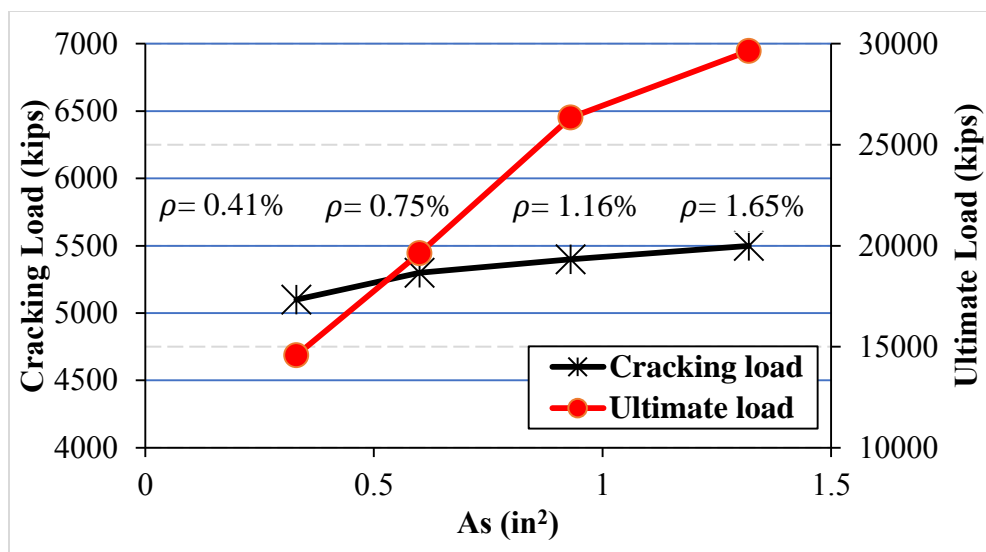
Figure 5.28 Effect of Variation of (A_s) on Cracking and Ultimate Loads

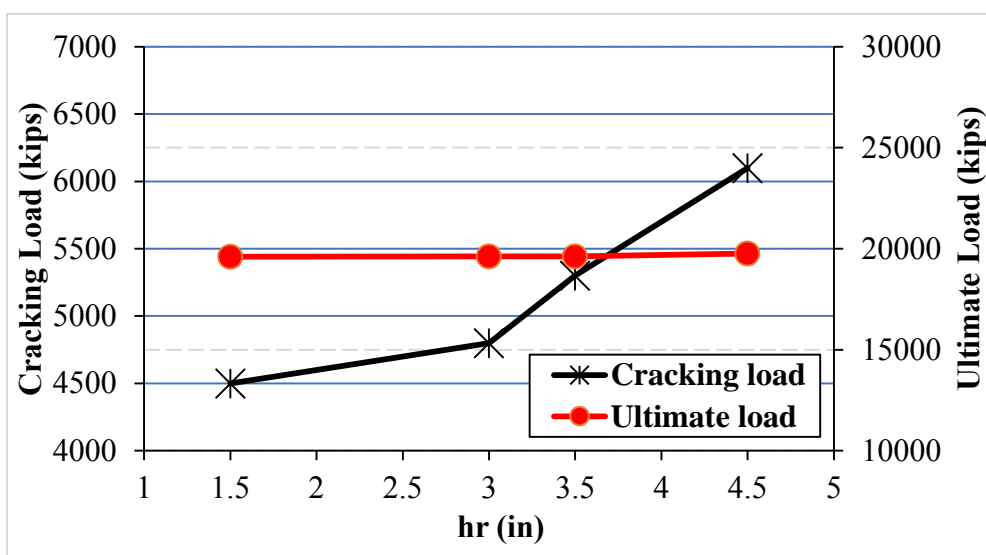
Figure 5.29 Effect of Variation of (h_r) on Cracking and Ultimate Loads

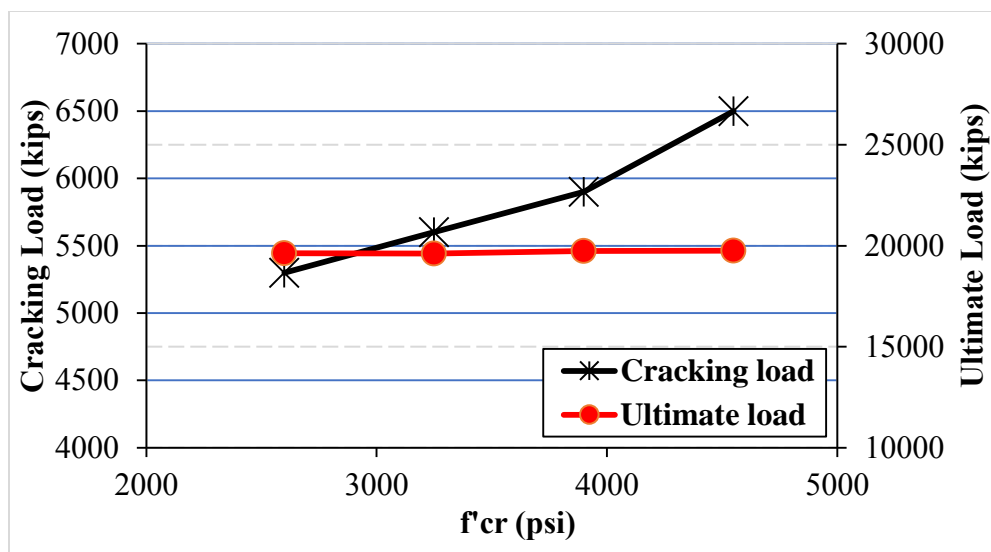
Figure 5.30 Effect of Variation of (f'_{cr}) on Cracking and Ultimate Loads

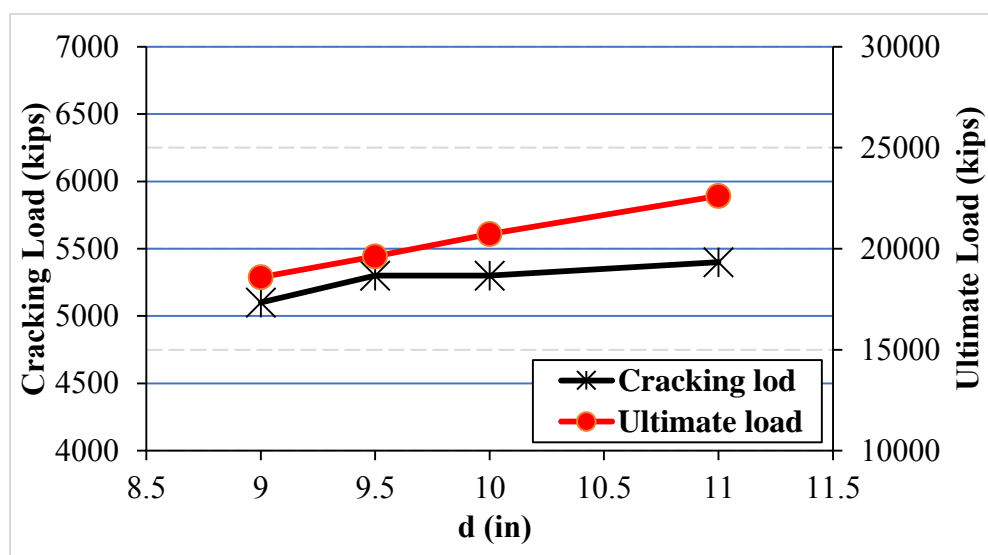
Figure 5.31 Effect of Variation of (d) on Cracking and Ultimate Loads
