THE LOWER RARITAN WATERSHED: A RESIDENT'S GUIDE TO
STEWARDSHIP

Rutgers, The State University of New Jersey

Master of Landscape Architecture

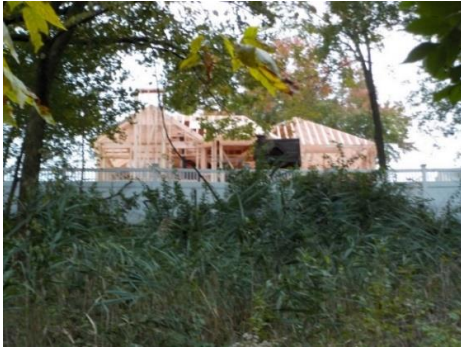
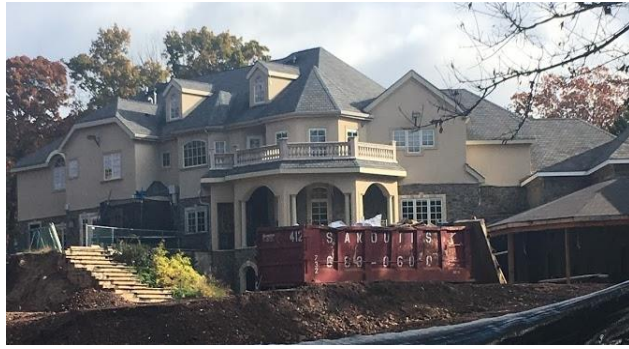
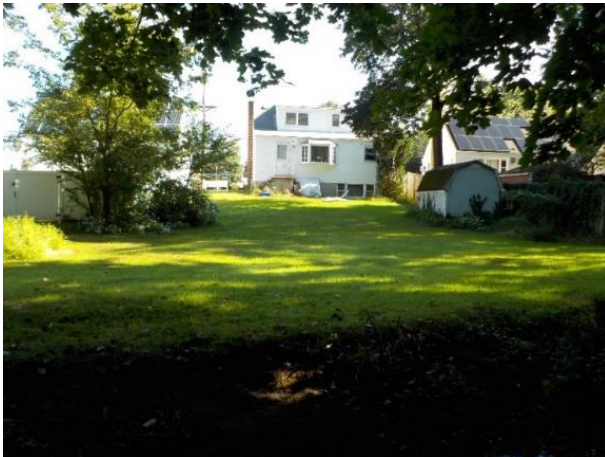
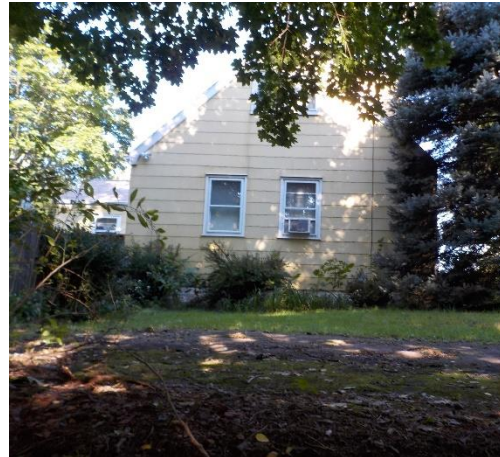
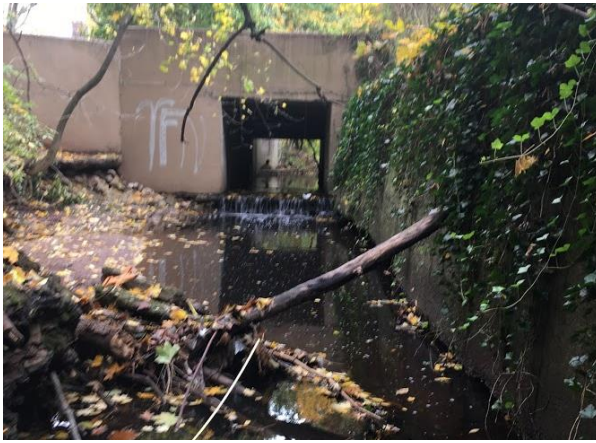
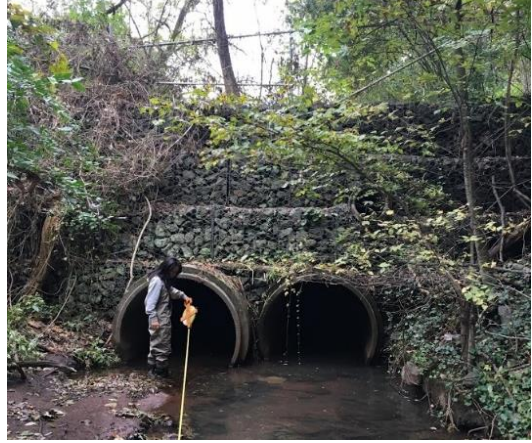
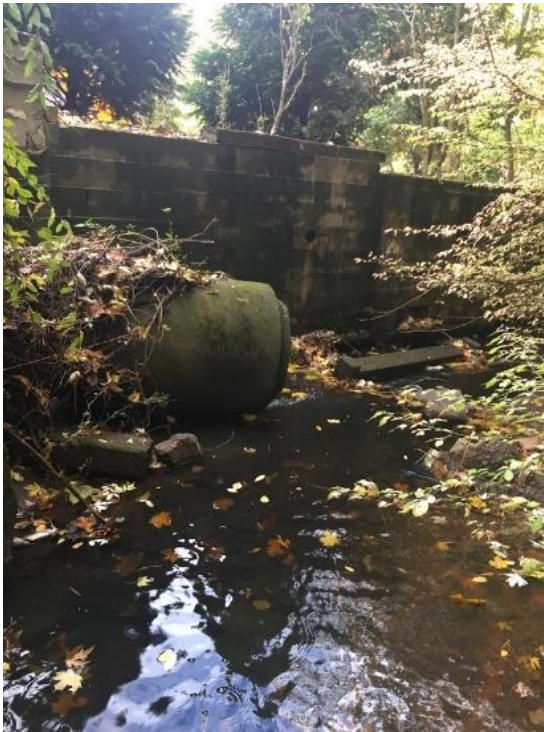
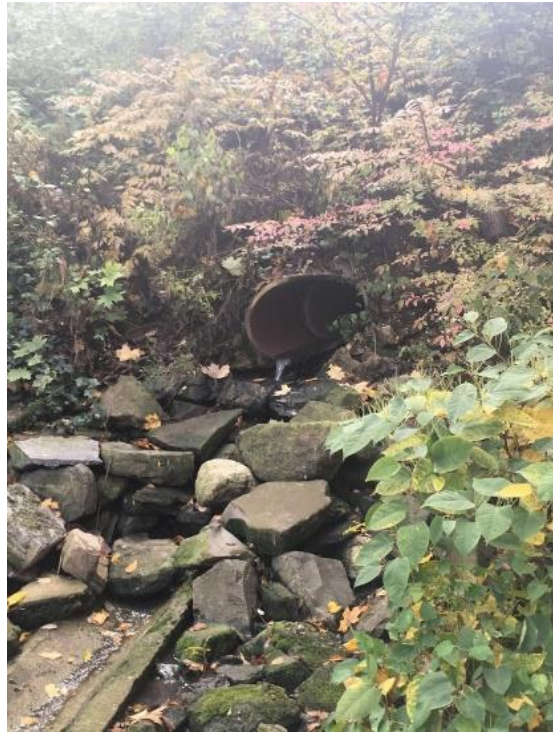
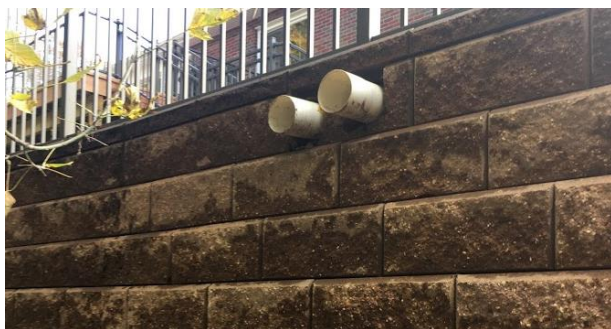
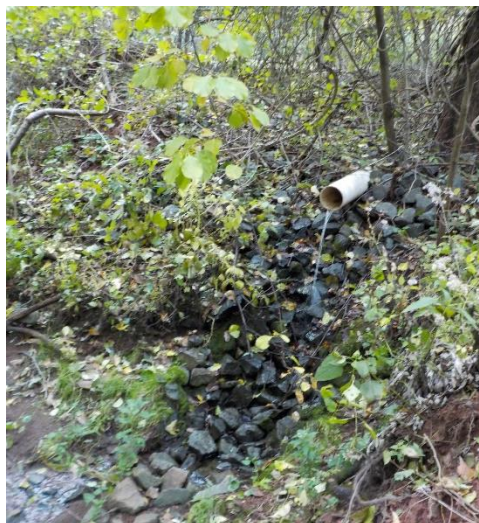
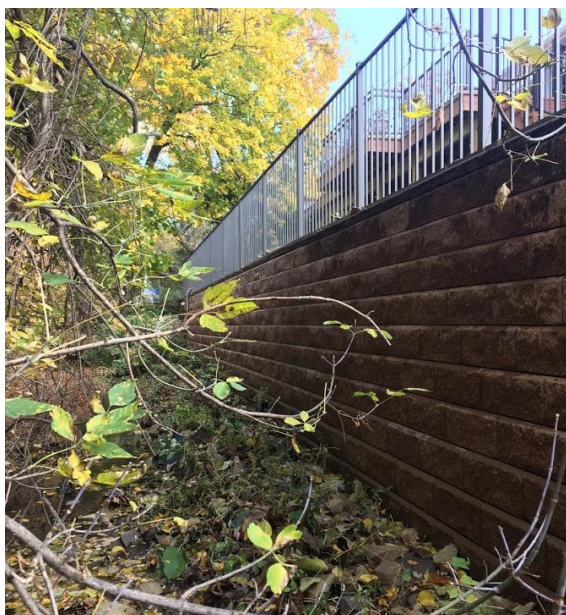
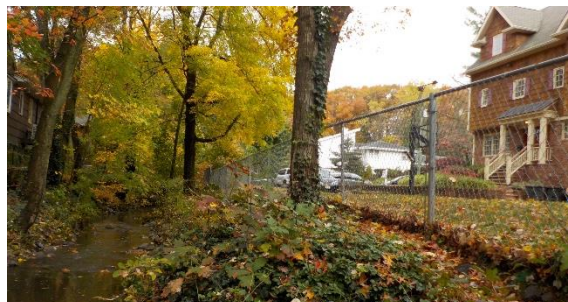
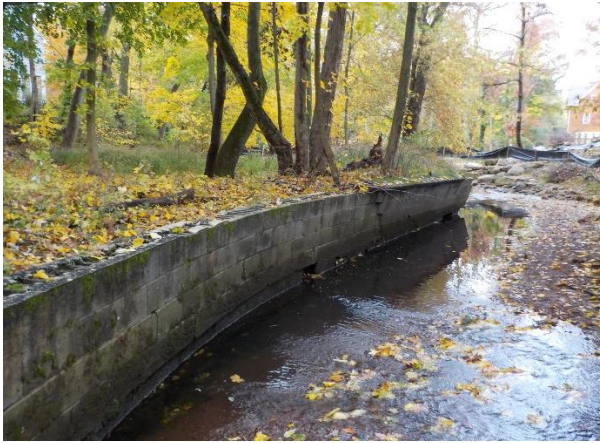
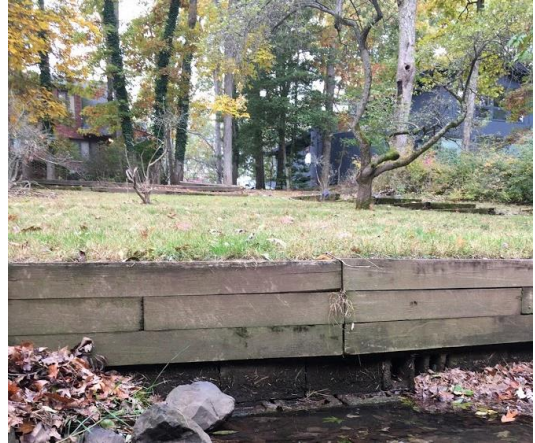
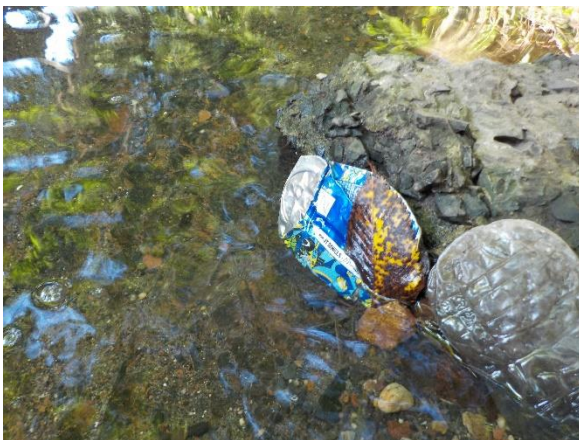
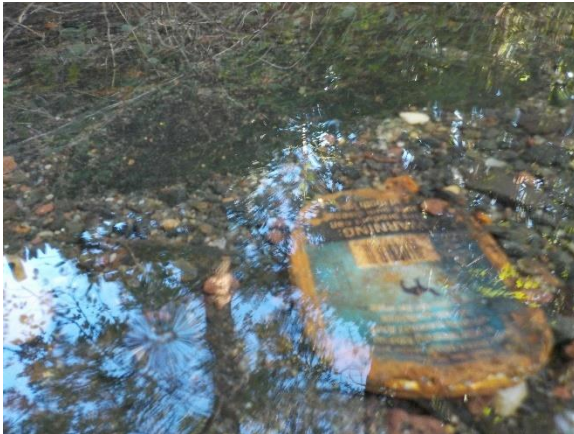
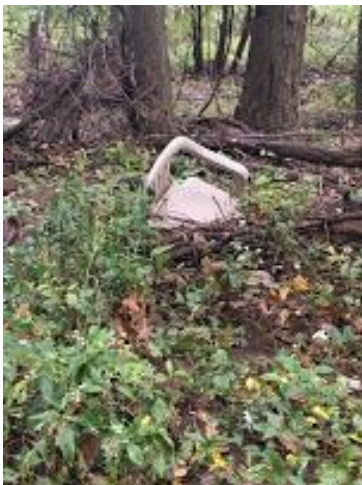
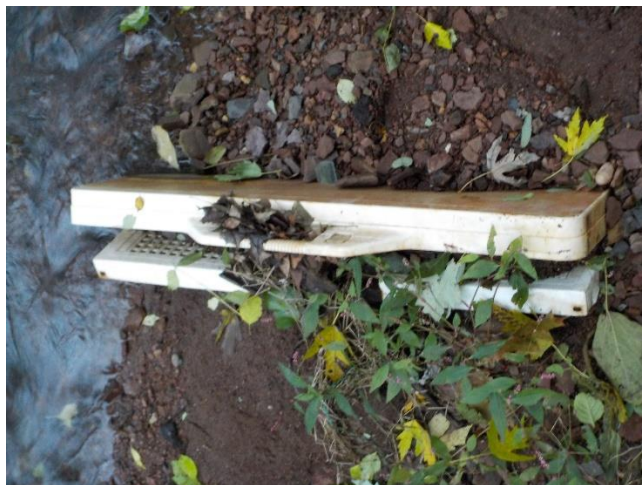
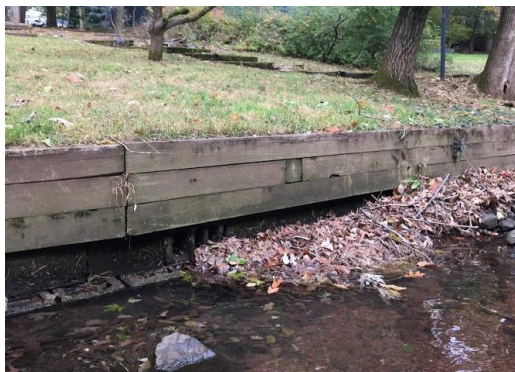
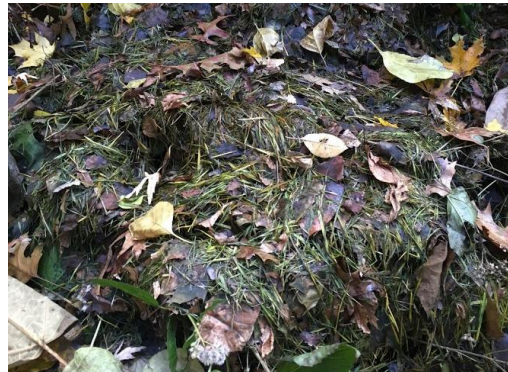
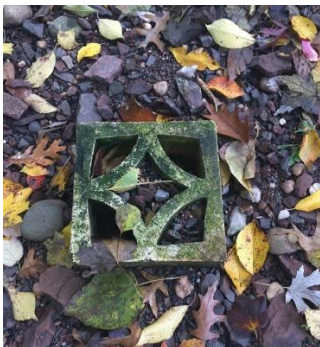
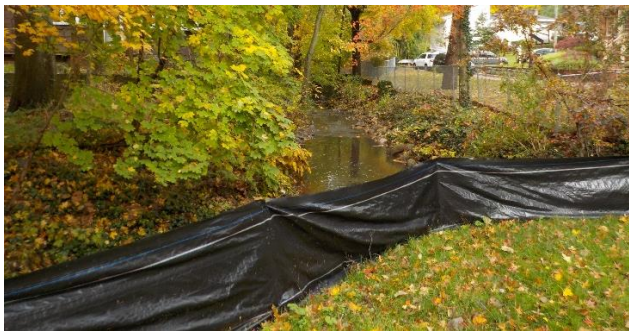
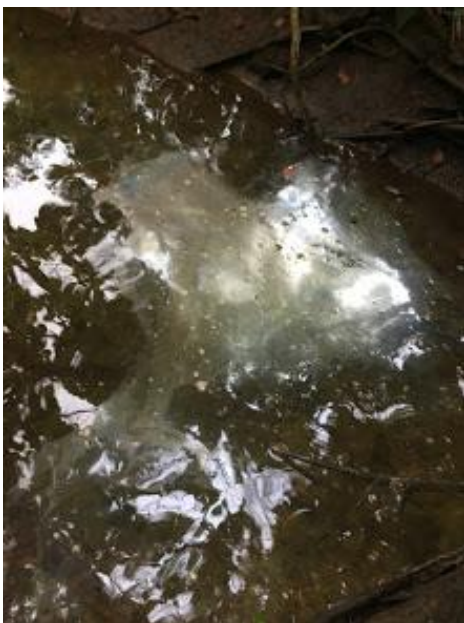
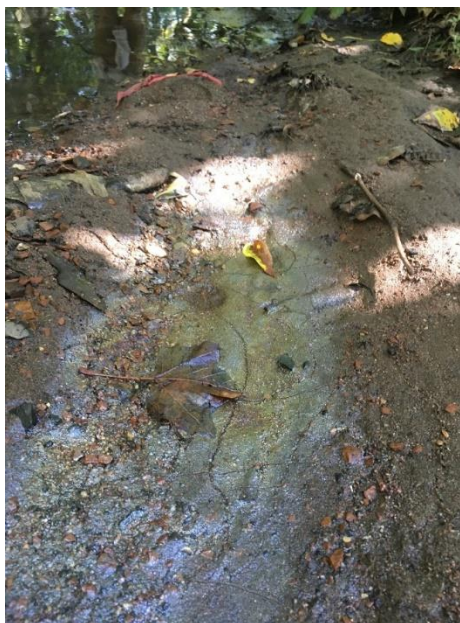
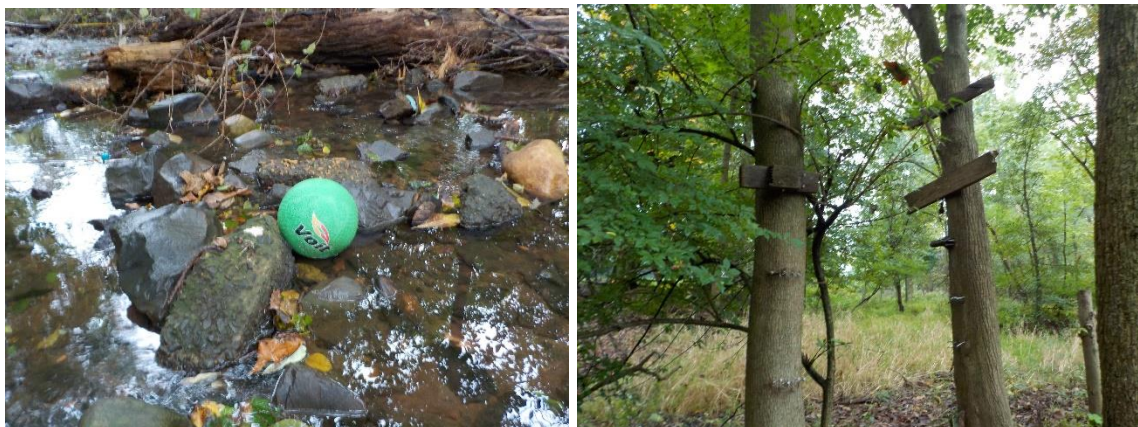
Figure 2.9: Examples from each category of anthropogenic activity seen during the Mill Brook Assessment, labeled a. through n.

As seen in Table 2.9, the most common type of anthropogenic activity noted in the pictures taken within the five-day study period was buildings, specifically homes seen a total of 22 times. Following buildings on the list are retaining walls, which were seen in many variations, such as gabions, wood, stone, and concrete. Out of all the trash found, plastic was the most common refuse in or near the stream. The miscellaneous group consisted of items that did not necessarily fit into a specific category and consisted of items such as playing balls from a nearby elementary school, hunting posts on trees, a

treehouse, and furniture, such as a carpet. The images below show examples of each category from Table 2.9.

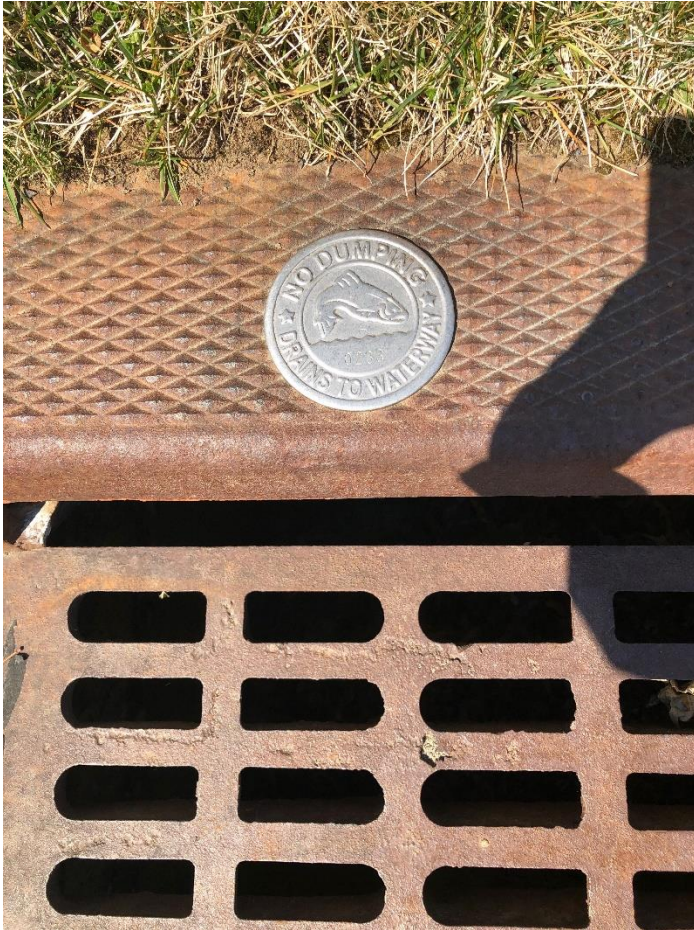
Figure 3.2: Storm drain leading to local waterways

The accumulation of waste and trash in our waterways is not only visually unappealing but contributes to flooding and excess algae growth (City of Westfield Public Works Department, n.d.). Yard waste, along with inorganic waste like plastics and metals, can overwhelm waterways, clog culverts and storm drains and lead to flooding in our neighborhoods. Grass clippings, leaves and branches are high in nitrogen and phosphorus, acting as a natural fertilizer. When these organic waste items end up in the water, they create algal blooms, depleting the oxygen content in the water and killing aquatic life, ultimately disrupting the water’s ecological habitats.

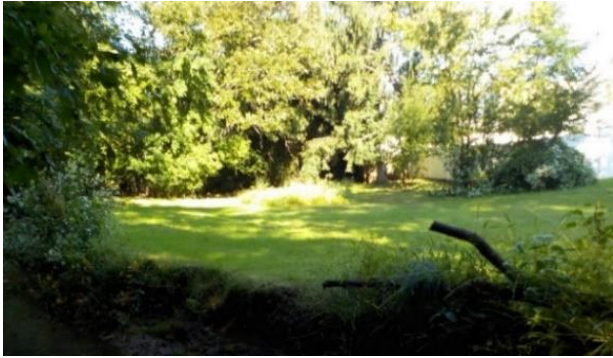
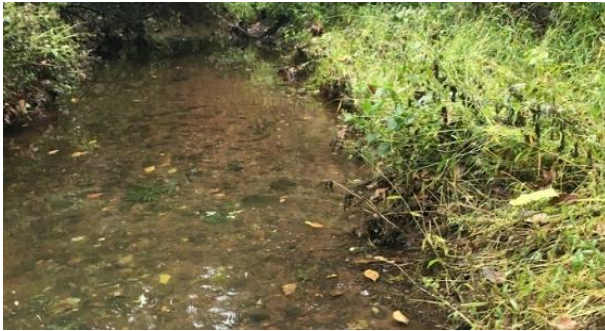
Figure 3.4: Before and after of a stream buffer.

The top image shows a lawn mowed directly up to the edge of the stream, while the bottom shows a stream with a more protective riparian buffer

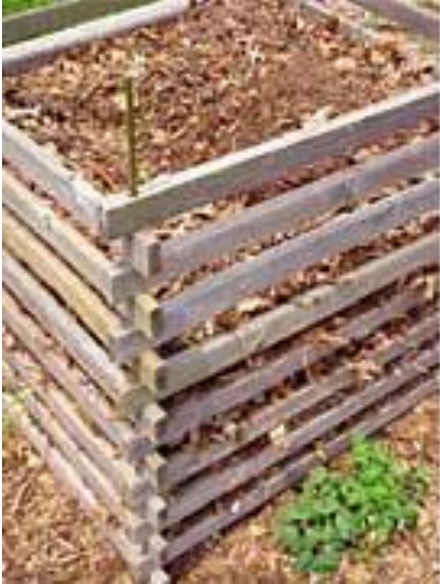
Figure 3.5: Example of a homemade compost bin

Figure 3.6 below demonstrates the factors that contribute to healthy compost. There are two types of compost; slow harvested compost, made by adding layers of waste over several months, is ready in 12 to 18 months, while fast harvest, made by adding equal parts of green and brown materials at once, is ready in 5 to 15 weeks (Forsell, et. al., 2003). Examples of green and brown materials can be seen in Figure 3.7 below. To be used as mulch, one to three inches should be incorporated into vegetable and flower beds before planting to help kill weeds, keep the roots moist and prevent soil erosion. Compost can also benefit as a soil conditioner or be made into potting mix. In Middlesex County, residents can view demonstration compost bins at Davidson's Mill Pond Park in South Brunswick. Tours or demonstrations may be available.

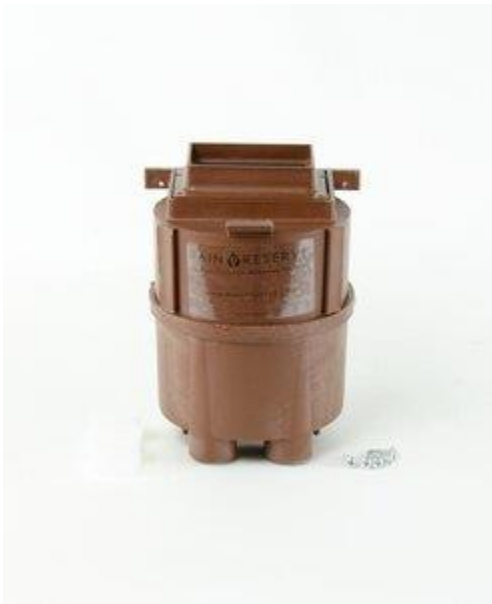
Figure 3.9: Downspout diverter
Image credit: Wayfair.com

diverted or extended to, such as a rain barrel, a raingarden, or bioswale, all discussed below. First, determine whether a downspout extender or diverter is needed, depending on where the water is being redirected. The following images show what these items look like, and ideas of how to divert or extend your downspout.

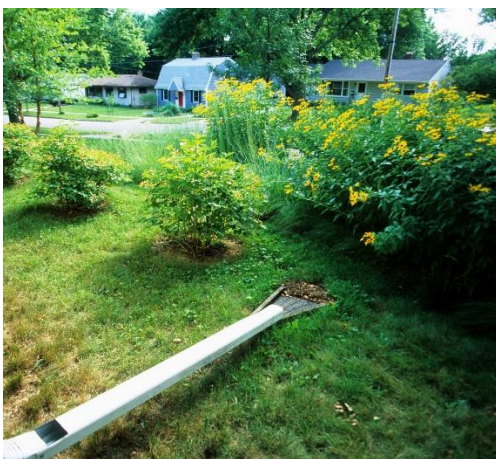
Figure 3.11: Example of a downspout extended to a rain garden

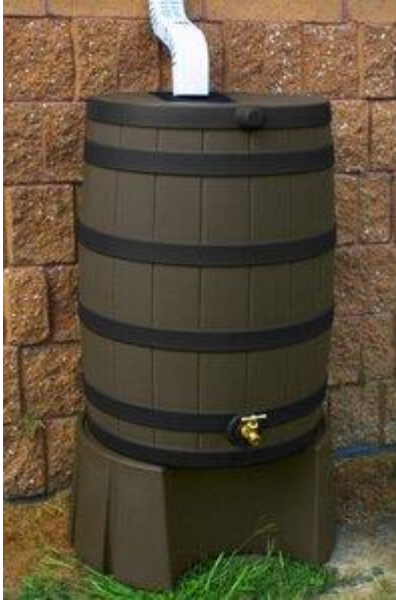
Figure 3.12: Downspout diverted to a rain barrel

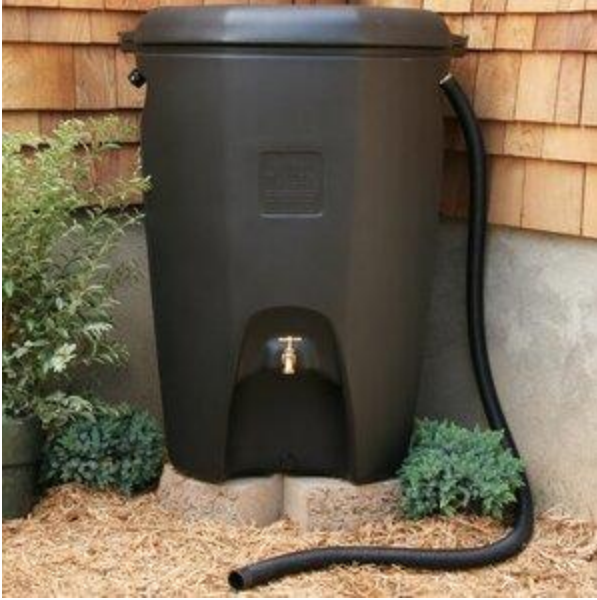
Figure 3.13: A pre-fabricated rain barrel

Since most residential property is covered with some impervious surface, one way to reduce runoff is to divert your downspout to a rain barrel (Obropta, 2014). Rain barrels can be hooked up to a hose and used to water your lawn and other plants and shrubs. This is an easy way to save money. Rather than paying to use water from the hose or sink, hundreds of gallons of water can easily be collected each year, for free. The water is safe to use on indoor and outdoor plants, front and backyards, filling a birdbath, or even washing cars. Rain barrels are typically made from 55-gallon food grade plastic drums. Wooden barrels can be used as well, or pre-fabricated rain barrels can be purchased from a retailer. It is important that the barrel is elevated in order to create adequate water pressure. Also, there should always be a screen over the opening to prevent mosquitos from breeding, as well as a mosquito dunk to deter them.

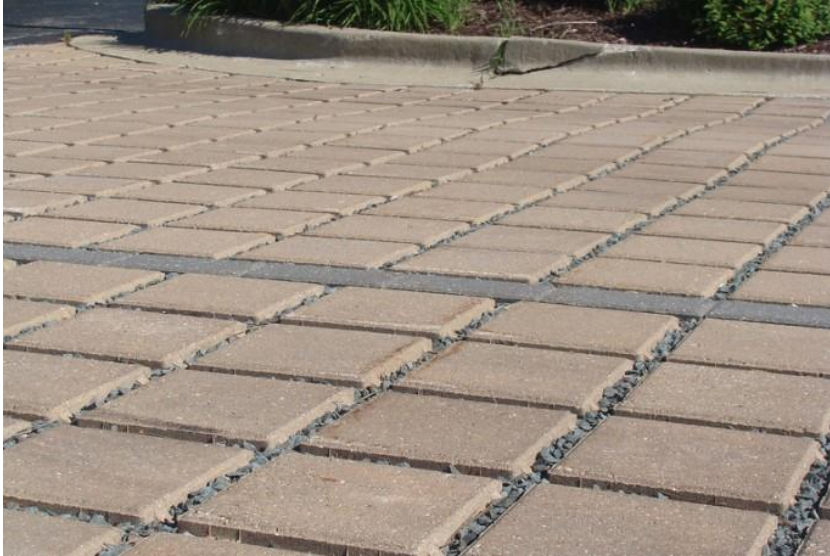
Figure 3.15: Permeable pavers

Permeable pavers can also be used to take advantage of the benefits listed above. These hybrid hardscapes are comprised of brick or stone separated by joints, or gaps, where gravel, sand, or a perennial ground cover are laid over aggregate stones (Alliance for the Chesapeake Bay, n.d.). Water can be absorbed into these gaps and is stored underneath the surface, where it can then filter back into the soil. These pavers can be used to create walkways, patios, or driveways. Yearly upkeep is minimal, and less salt is needed during winter months since water no longer collects and freezes on the surface. Figure 3.16 demonstrates each layer of a permeable pavement system.

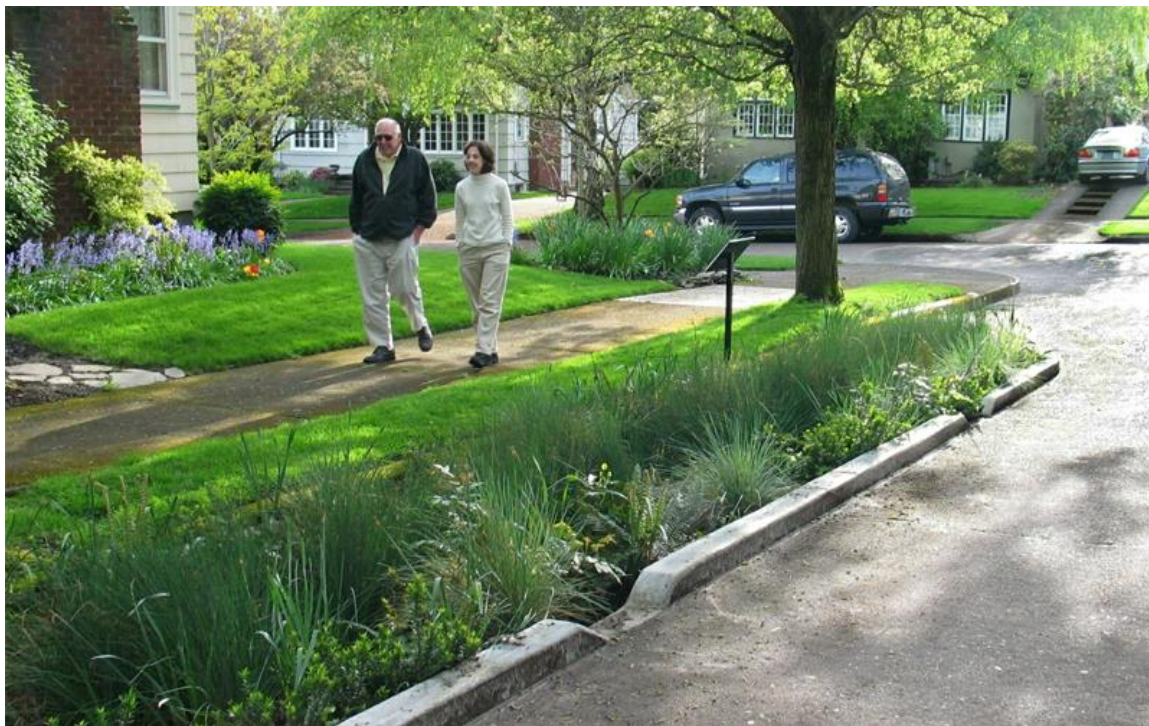
Figure 3.21: A bioswale in a residential neighborhood in Portland, Oregon.

overwhelming Portland's combined storm/sewage system. Below, is the landscape architect's work, seen in Figure 3.21.
