COMPREHENSIVE DAMAGE ASSESSMENT AND ANALYSIS OF DAMAGE
MECHANISMS FROM HURRICANE HARVEY

Graduate Program in Civil and Environmental Engineering

Comprehensive Damage Assessment and Analysis of Damage Mechanisms from
Hurricane Harvey

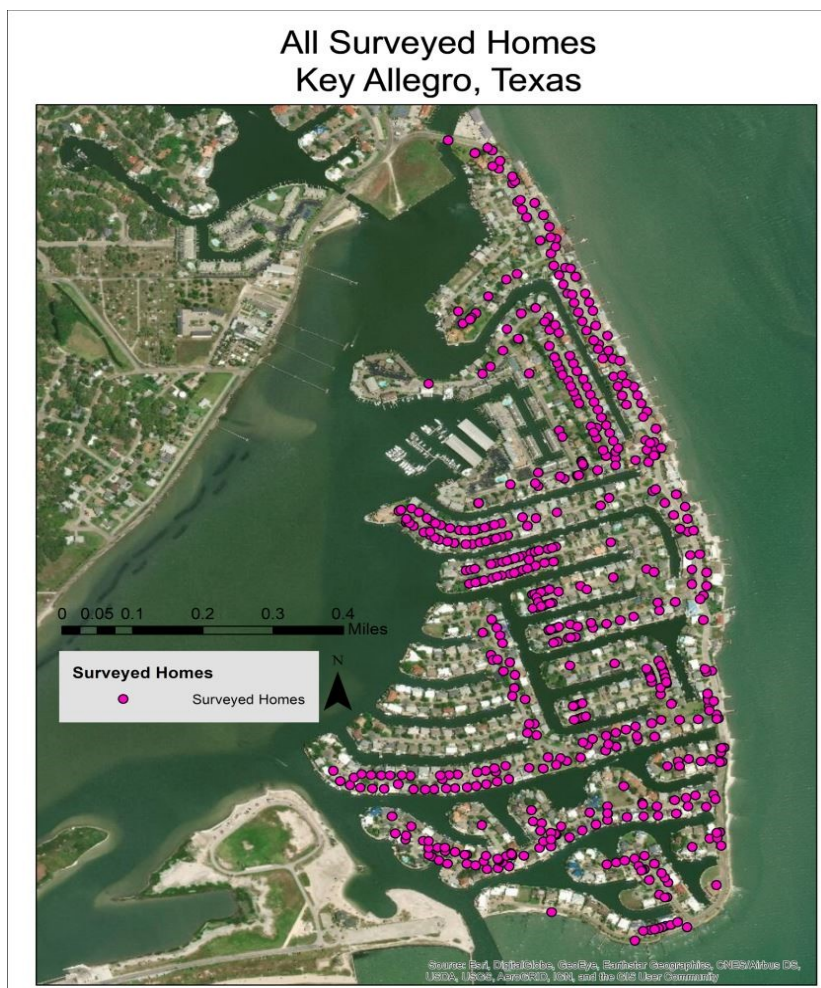
Figure 21: Location of all surveyed homes in this study, Key Allegro, Rockport, Texas.

Over 1,000 homes were assessed between Key Allegro and nearby community, Holiday Beach. 553 structures were used during analysis, found in **Figure 21** (Kijewski-Correa, 2018). Of the analyzed homes, 551 were single-family residential structures and 2 were used for commercial purposes. Most homes were single level, and all structures were wood framed. The average home value was approximately \$655,000 in July 2017, just before Hurricane Harvey struck (**Figure 22**). The most expensive home in the study area was \$3.2 million in July 2017 (Zillow, n.d.).

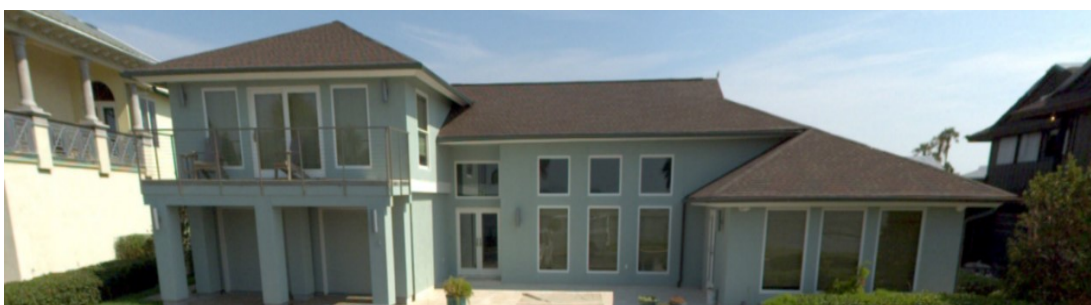
Figure 25: Example of Intersecting or Overlapping roof shape in Key Allegro.

Roof shape is can impact damage, especially when the damage mechanism is wind (Crandell, 1998). Examples of common roof shapes are shown in Error! Reference s
ource not found. **Figure 25**, **Figure 26**, and **Figure 27**. Roof shapes vary in this study, with the highest frequency in combination and hip roofs (**Figure 28**). Combination roofs exhibit characteristic shapes of multiple roofs at once.

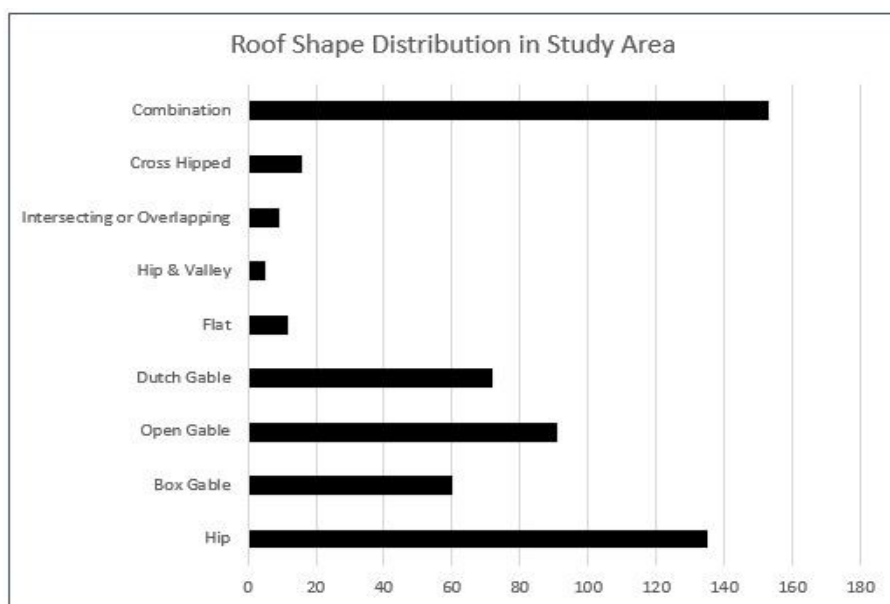
Figure 28: Roof shape distribution in study region.

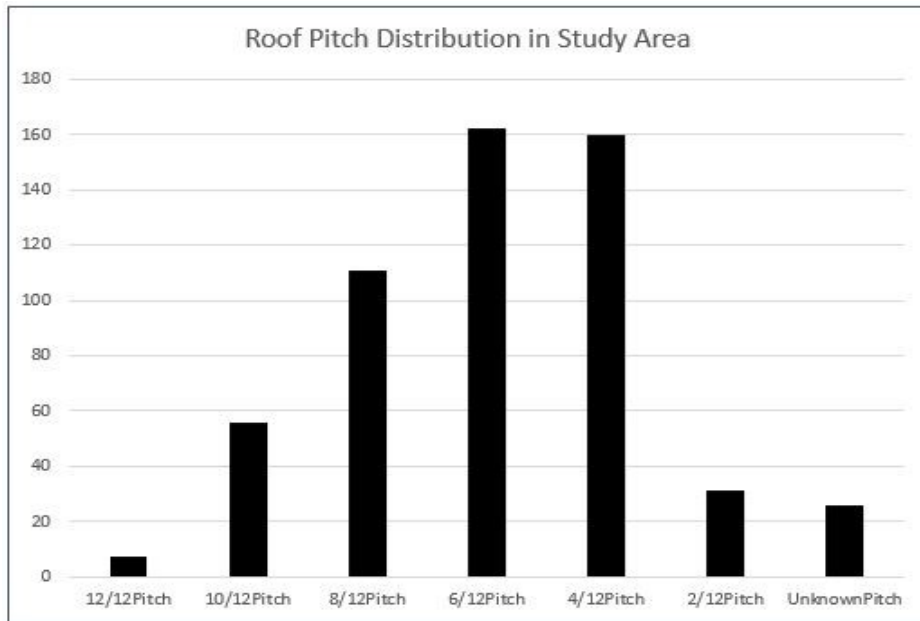
Figure 29: Roof pitch distribution in study region.

the panoramic photos collected during the damage survey period. Most homes had a slope of either 6/12 or 4/12 (**Figure 29**).

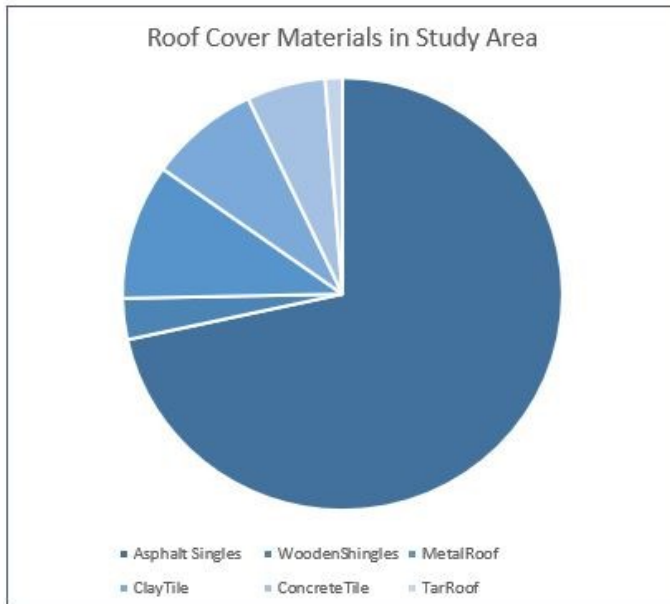
Figure 30: Roof cover materials in study area.

The roof and wall covering can be the first line in defense against damage during a hurricane. Most structures in Key Allegro had asphalt shingles as roof cover (**Figure 30**). Most homes utilized wood for siding, whether in panels or shingles (**Figure 31**). Wooden siding is a common wall covering in other coastal towns.

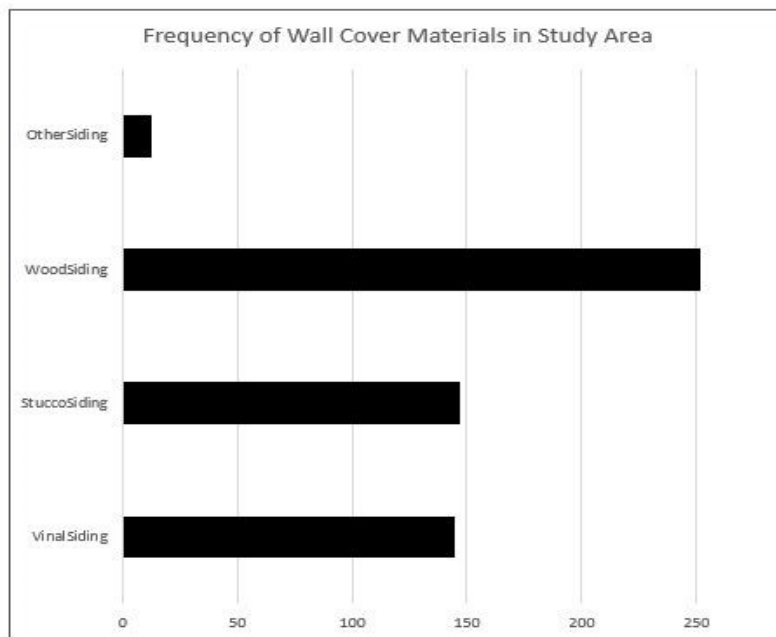
Figure 31: Wall cover materials in study area.

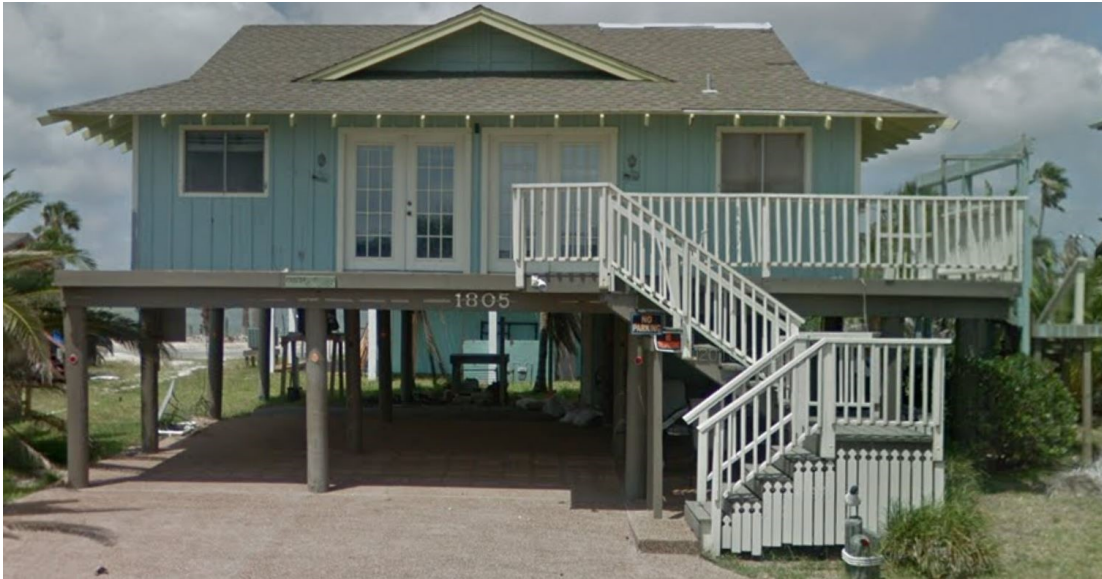
Figure 35: Example of an elevated home using a wet-proofed method of elevation (Google Street View).

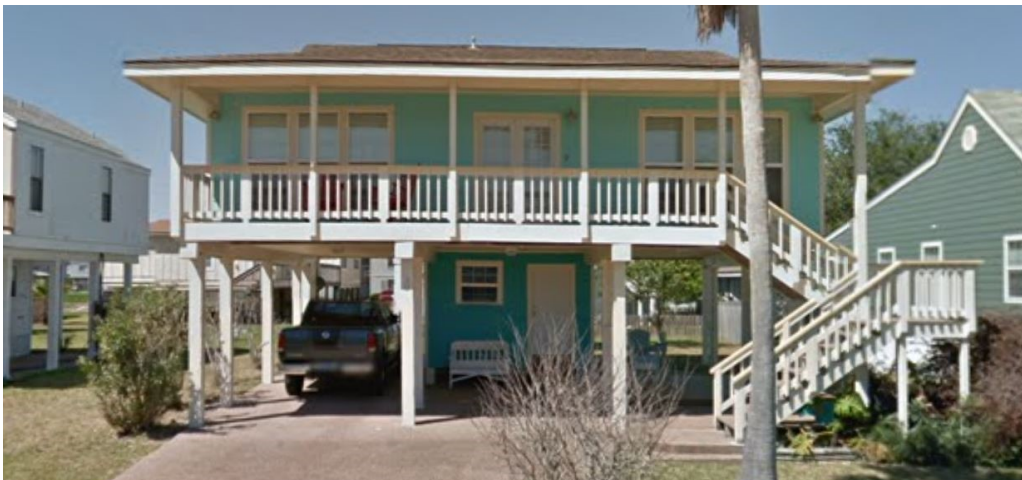
Figure 36: Example of an elevated home that is wet-proofed but has a portion that is enclosed (Google Street View).

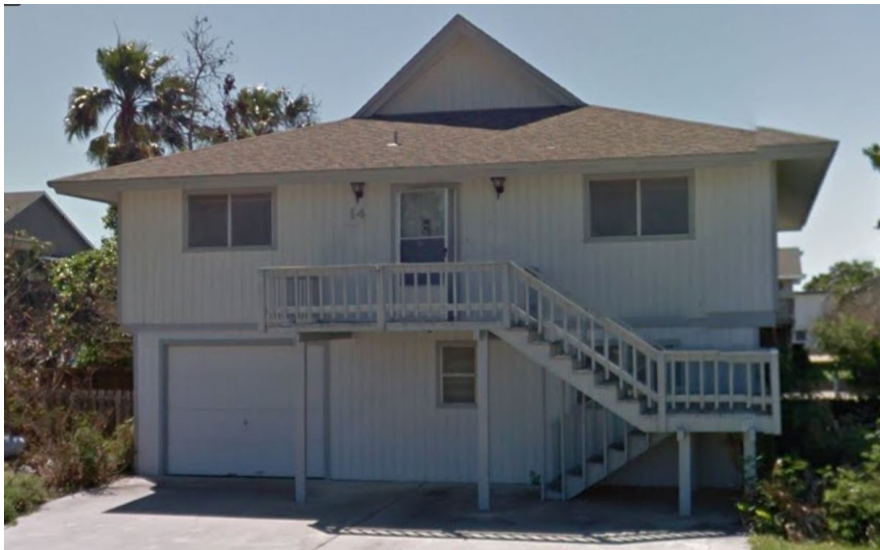
Figure 37: Example of a home that is elevated using the dry-proofing method (Google Street View).

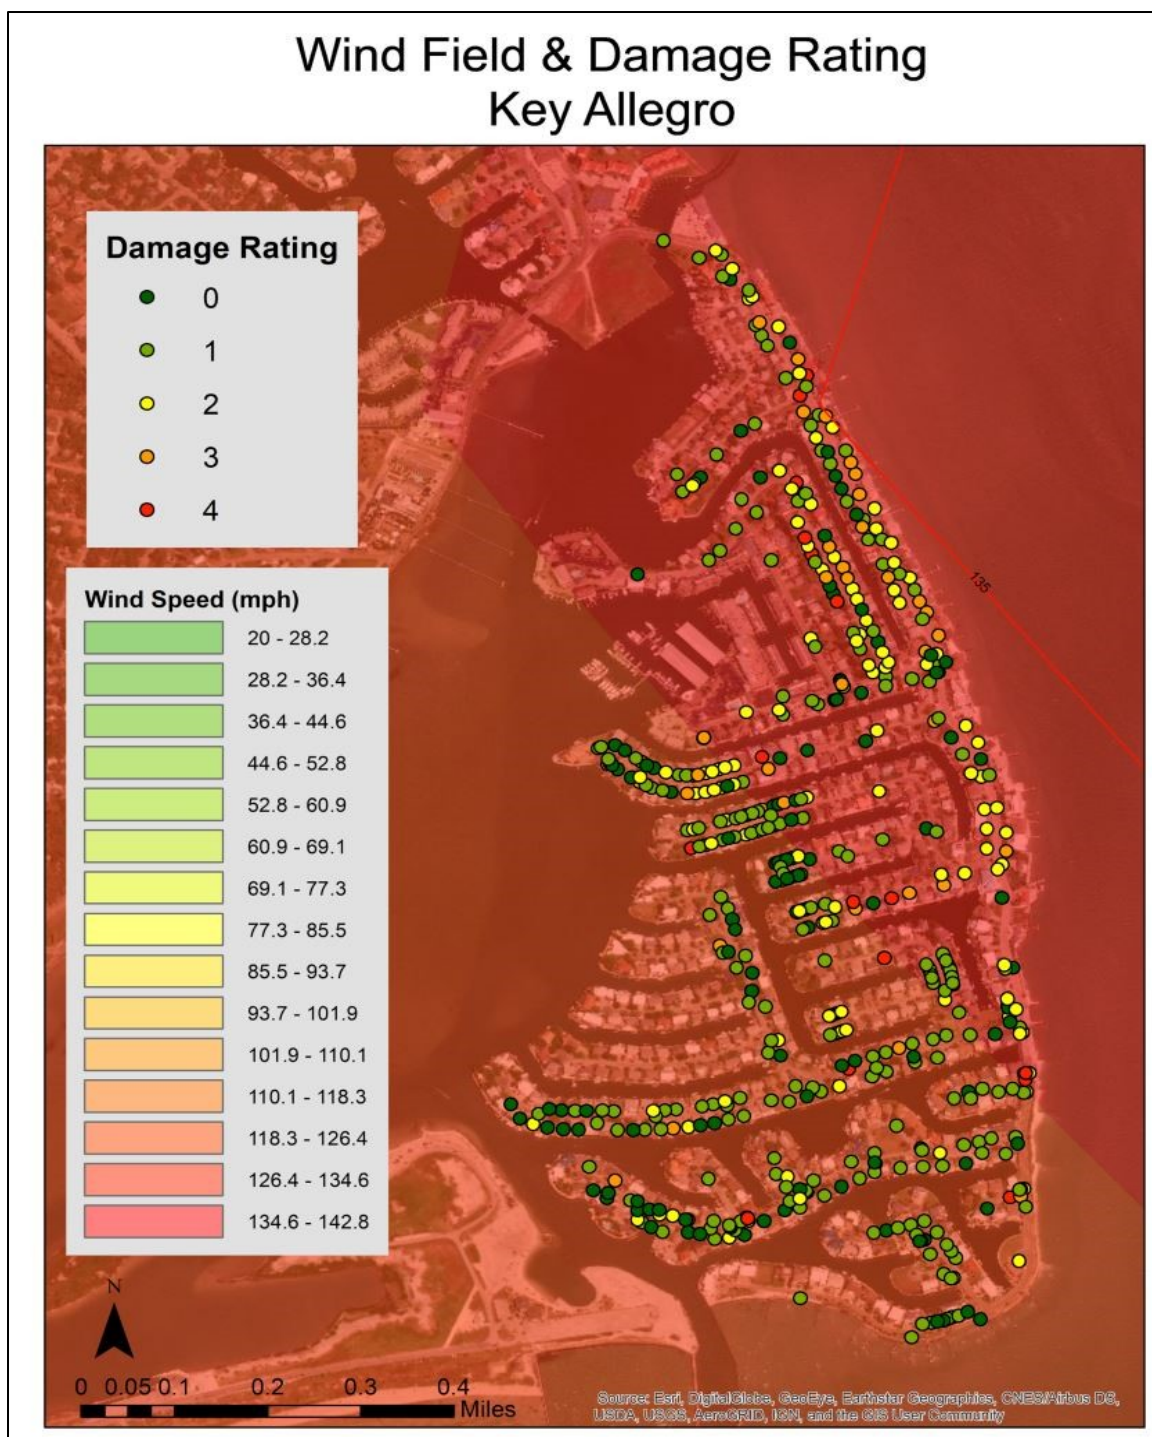
Figure 46: Key Allegro damage ratings overlaid with Hurricane Harvey wind field. Note the damage ratings are higher on northern portion of the community, where wind speed was higher during Hurricane Harvey (ESRI, 2018; Vickery, 2017).

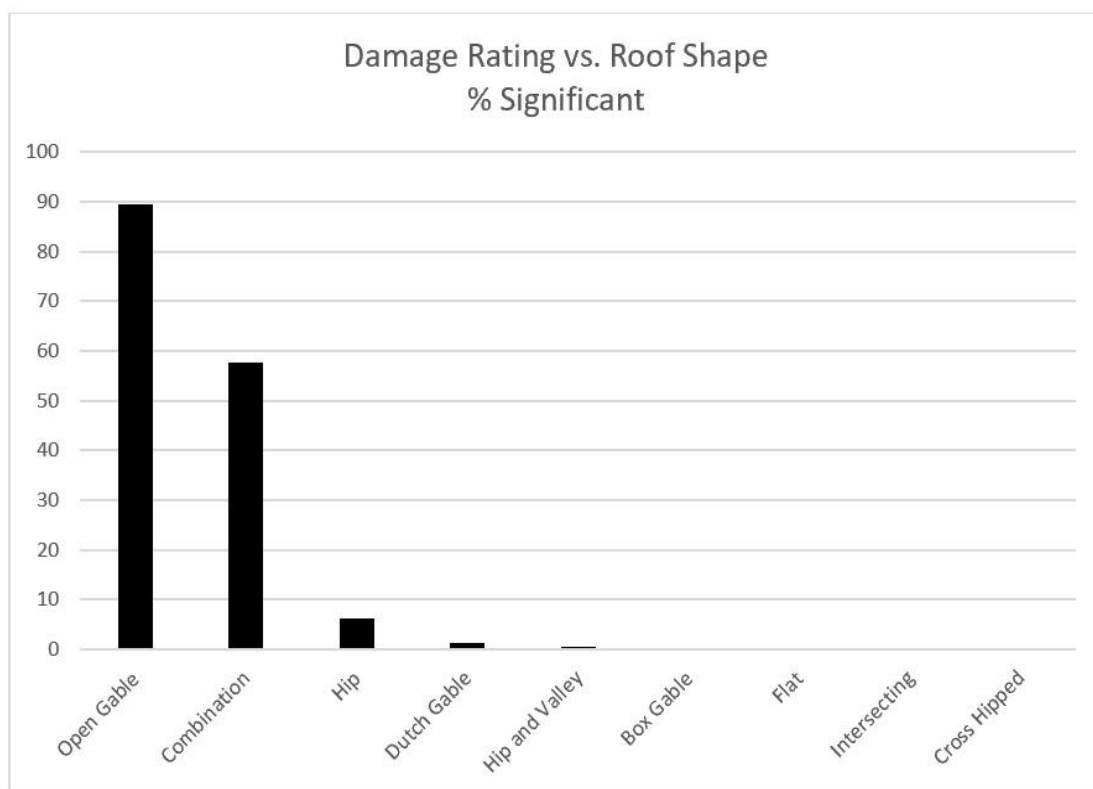
Figure 55: Significance of Roof Shape variables in exploratory regression, when predicting Damage Rating.
