# **COMPARISON OF LOAD RATING METHODS FOR COMPLEX BRIDGES**

JOSEPH R. STRAFACI, PE

A dissertation submitted to the

Rutgers, the State University of New Jersey

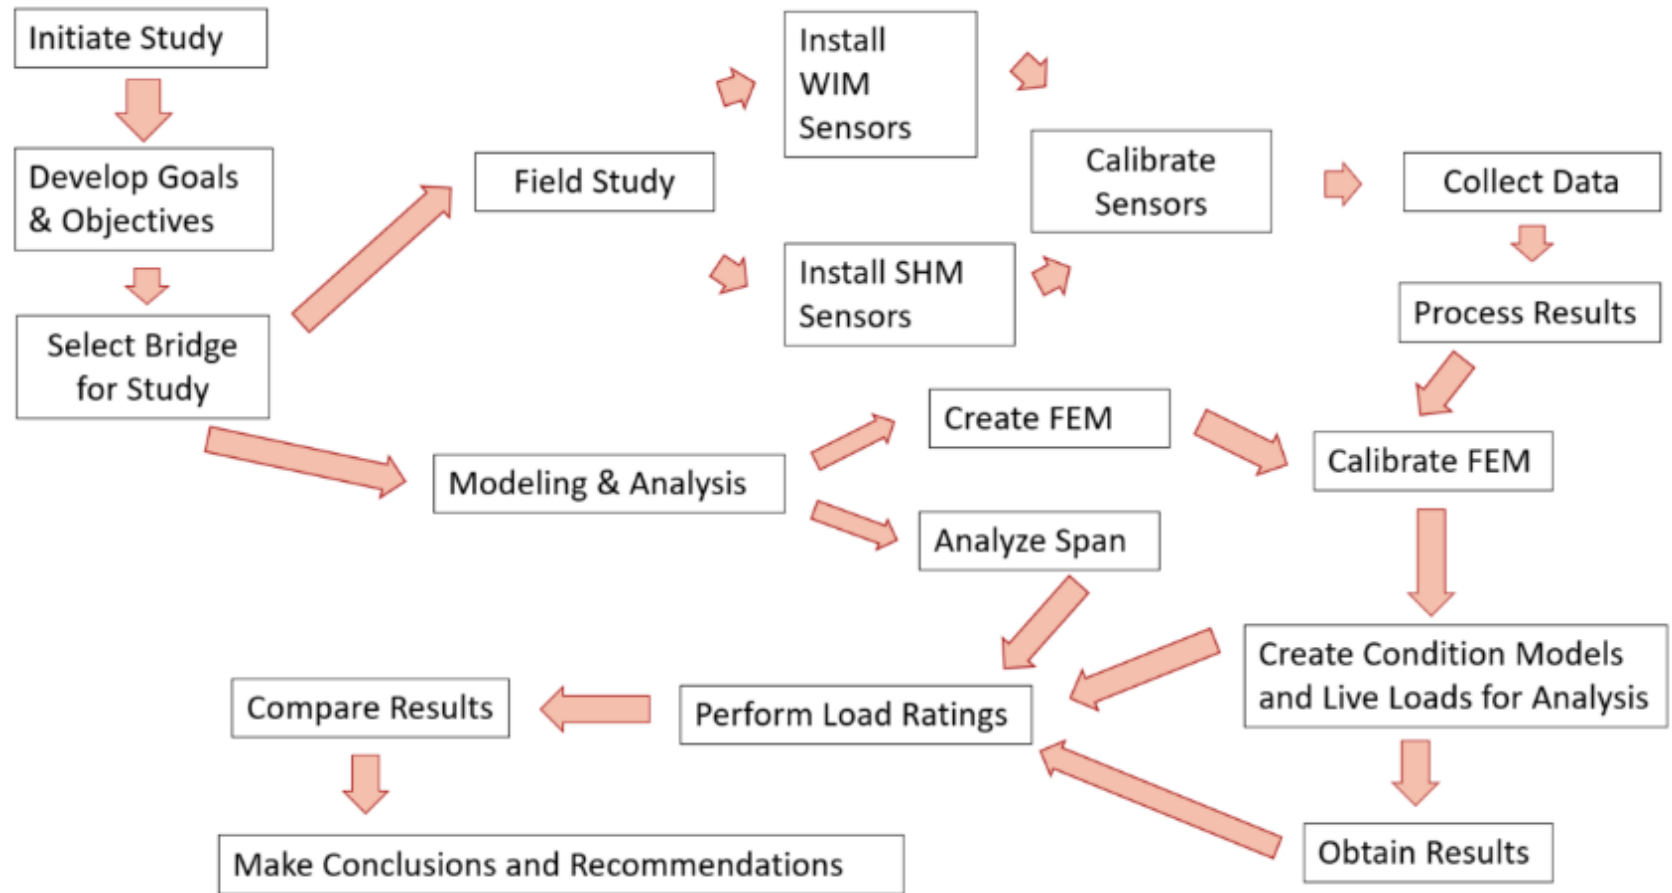
Figure 1.3 - Flow Chart for Proposed Analytical Study

The primary objective of this research is to develop a procedure for the evaluation of complex bridges. Additionally, a comparison of the current load rating methodologies, the Load Factor Resistance Rating (LRFR) and the Load Factor Rating (LFR) method which has been mainly utilized on bridges designed under the previous Allowable Stress Design Criteria. It is the goal that at the end of this dissertation, we will have established the benefits of using the LRFR method for complex bridges in particular despite the code the bridge it was designed for. A flowchart for this dissertation is included below:

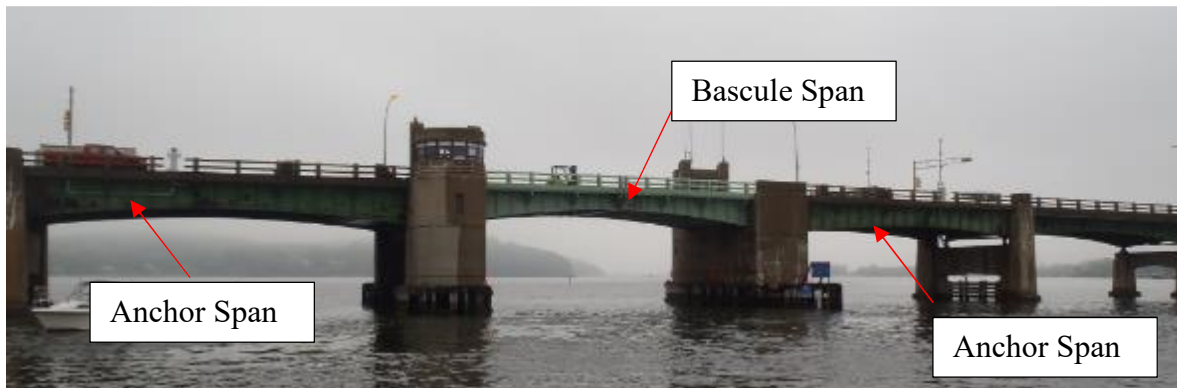
**Figure 2.4 - Oceanic Bridge Main Bascule & Anchor Spans**

movable dual leaf bascule span in the center. The bridge is founded on reinforced concrete piers, which are supported on timber piles (2017 NBIS Inspection Report).

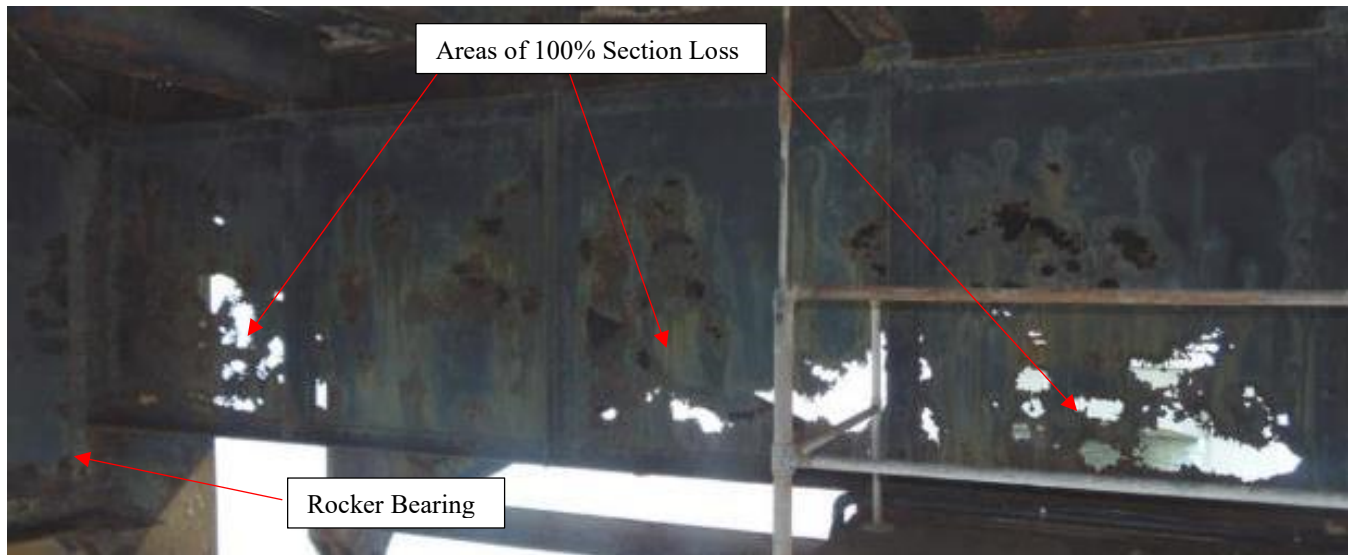
As we can see from Figure 2.6, the section loss is so severe that it appears the load path had been compromised and was being transferred to the supporting bearings via the steel stiffening angles. Given that the floor beam was directly above the pier, it made the beam susceptible to shear. Furthermore, the anchor span ties directly into the main bascule span, and failure of this span would directly affect the movable span.

**Figure 2.6 - Span 28 (Looking Northwest) Floor Beam 2013 Condition**

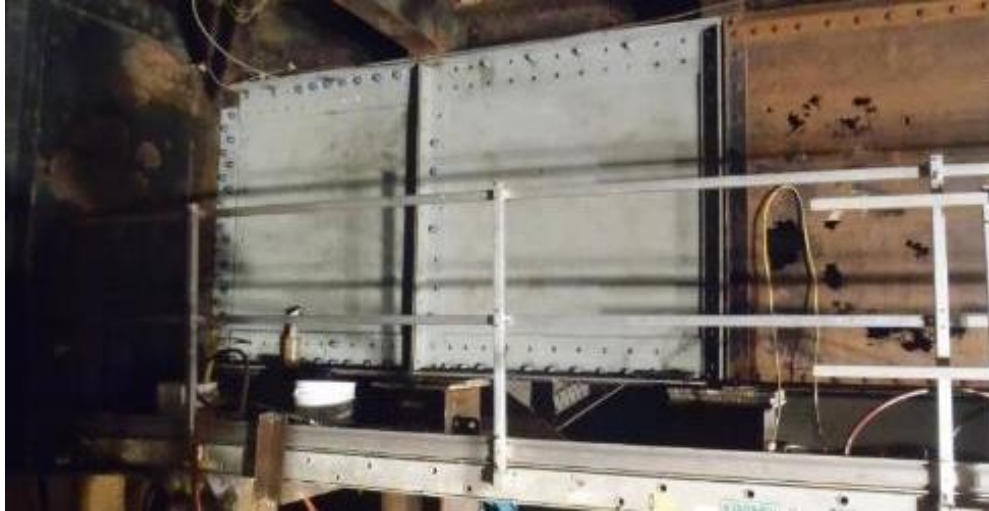
**Figure 2.7 - Floor Beam at Anchor Span Mid-Repair**

As we can see from the above photo, the method of rehabilitation involved the contractor retrofitting the existing floor beam with new plates and stiffeners. Considering the roadway needed to be open to traffic each morning, the contractor was only allowed to replace rivets one panel at a time and need to secure the area before each morning. Additionally, new angles were installed to add to the rigidity of the member. The figure below shows the completed repaired member. This repair addressed the issues noted in the 2013 emergency notice and as such, the posting was adjusted back to 15 tons.

The repair plans included concrete repairs to the bridge deck, as well as, steel repairs throughout the entire structure, with repairs to Spans 28 and 30 being the most critical area of concern. During construction, the scope increased to include additional steel repairs, as well as, repairs to the southern trunnion steel supports, which were also found to be in critical condition. Figure 2.7 shows an in-progress photo of the floor beam at one of the flanking spans being repaired.

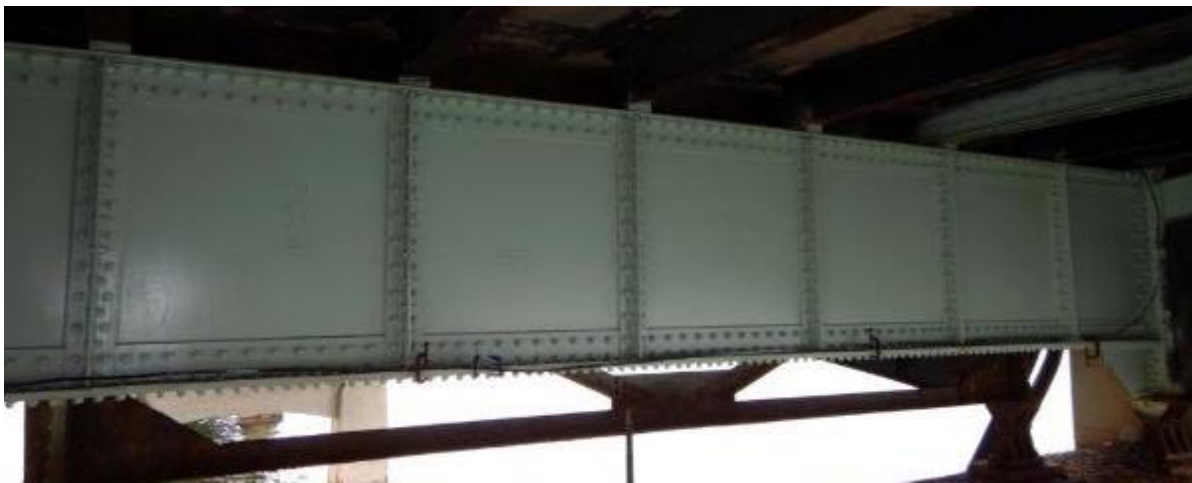
**Figure 2.8 – Span 28 (Looking Northeast) Floor Beam 2016 Condition**

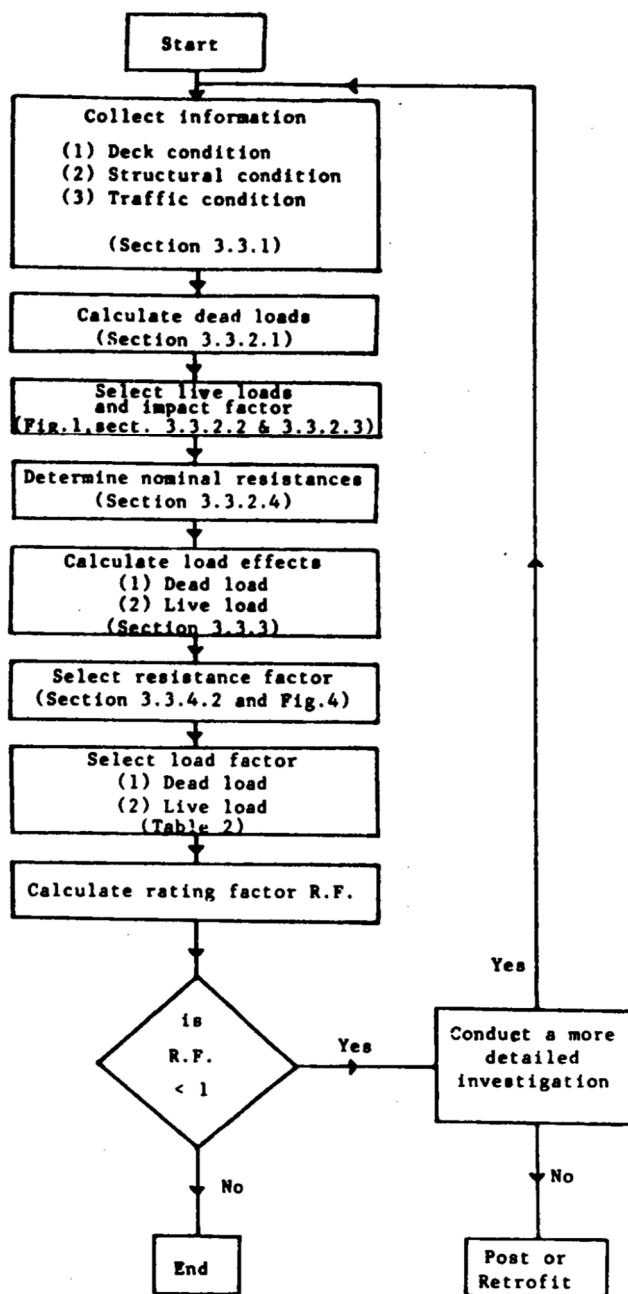
Figure 2.9 - Flowchart to evaluate an existing structure (NCHRP Report 301, 1987)

motion data, mixed with field performance data to provide a detailed evaluation of a structure in its existing condition. While most of the report presents information that has now become the basis of our design codes, one of the more important contributions the report makes in relation to this report is the inclusion of a flowchart which gives us the evaluation process.

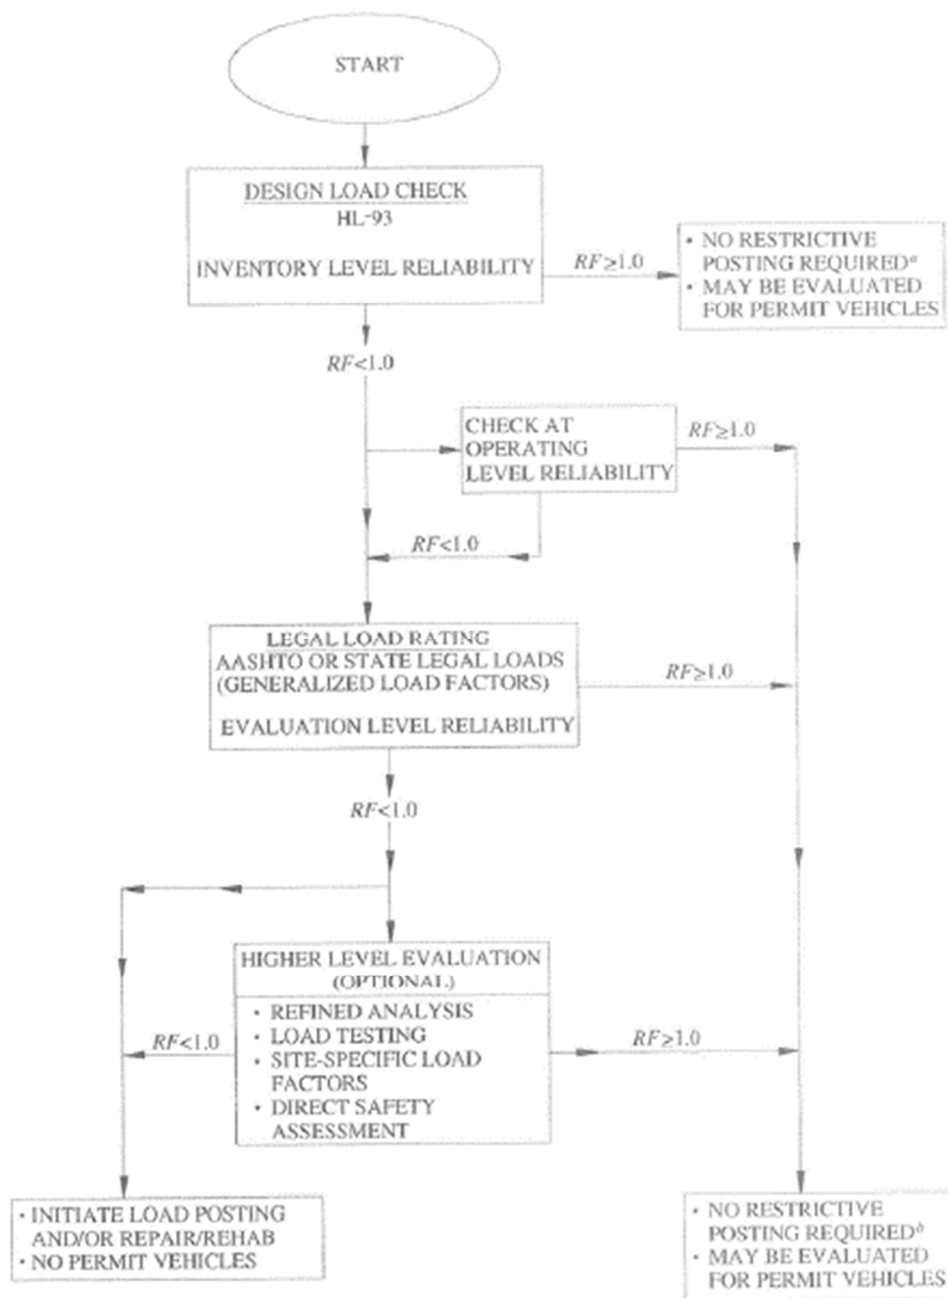
A flow chart which describes the various checks of a load rating is shown below. Note that this chart which is taken from the 2018 MBE was refined for the current LRFR method. However, this flow chart may also be applied to the LFR and ASR methods as well.

Figure 3.1 - LRFR Rating Flow Chart (2018 MBE, Section 6)

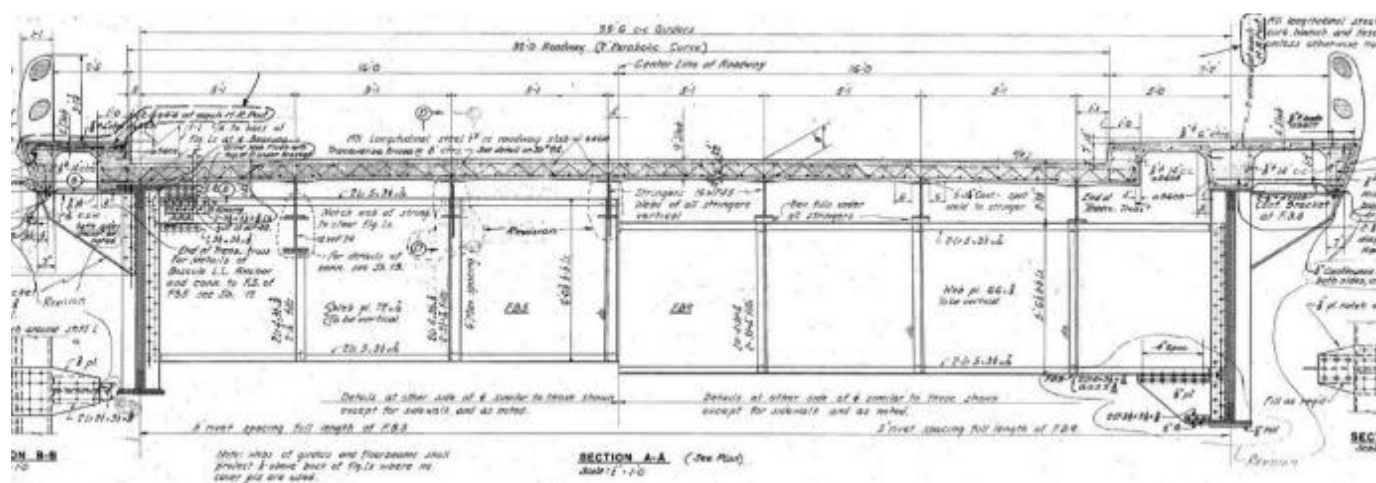
Due to this configuration, all structural steel spans for this bridge are classified as both non-redundant and fracture critical in accordance with NBIS guidelines. To better understand the configuration of the flanking span, a cross section as provided in the original 1939 construction plans is provided below.

**Figure 4.2 - Original 1939 Cross Sectional Plan for Flanking Spans 28 and 30**

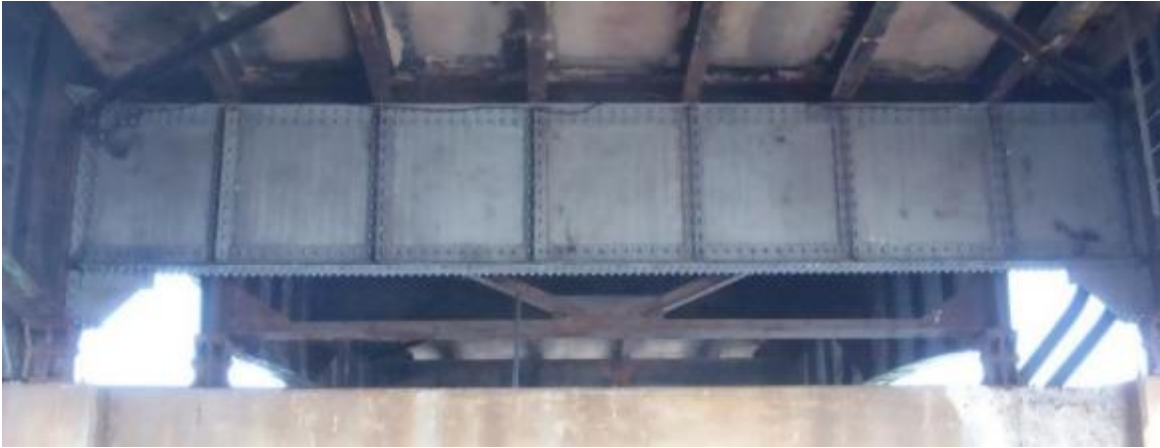
For the fascia girder, it consists of a built-up member supported by multiple cover plates. On the outer end, the girder is supported by a simple rocker bearing, while on the other end, the beam is completely fixed and ties directly into the bascule pier trunnion system. Due to the deterioration of the main floor beam located at Piers 28 and 30, a rehabilitation contract was implemented in 2015. This project, completely rehabbed these members accounting for the lost section due to corrosion. A photo of the repaired member is provided below.

**Figure 4.5 - Floor Beam following 2015 Rehabilitation**

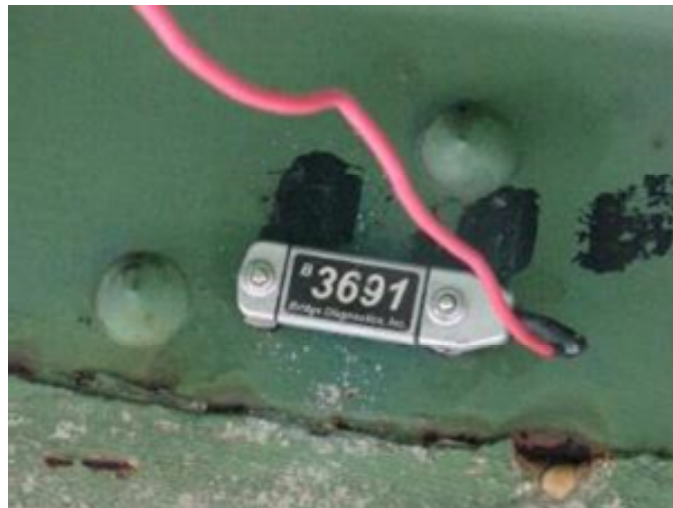
The strain transducers and accelerometers were attached to the structural steel using an epoxy glue. Cables were held using a series of clamps and were connected to the data acquisition device located near the parapet. A photo of an attached strain transducer used for this work is shown in Figure 4.11 below.

**Figure 4.11 - Strain Transducer attached to the top flange of the Fascia Girder**

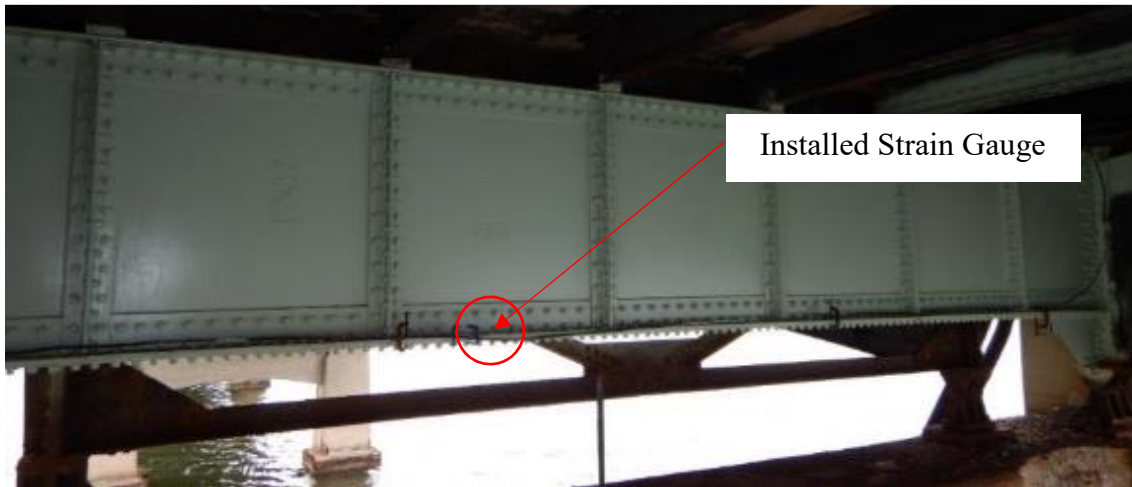
**Figure 4.14 - Strain Gauge Placement on Repaired Floor Beam at Span 30**

As discussed, both floor beams at Spans 28 and 30 were repaired as a part of the 2015 Repair Project. To better understand the placement of the above sensors, Figures have been provided below.

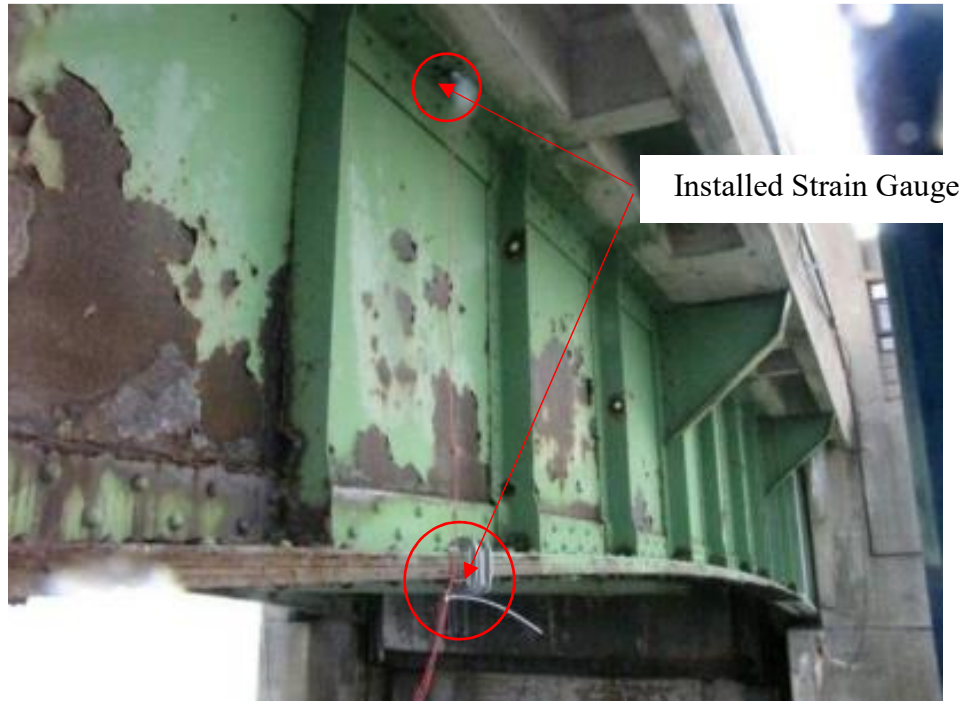
**Figure 4.15 - Strain Gauge Placement on top and bottom flange of Fascia Girder**

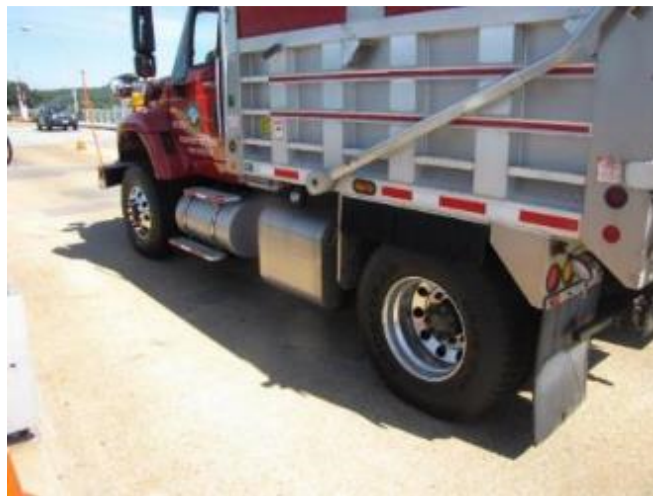
For the diagnostic testing performed, two types of truck were utilized for the testing performed. As discussed, there is a 15-ton limit on the bridge. Therefore, great care was taken to ensure the weight restriction was not exceeded. This was done by weighing the truck (each axel) and loading it to approximately the posting. These weigh tickets were also important as it provided us with additional information for the finite element model calibration. The figure below shows the truck utilized for the 2018 testing.

**Figure 4.16 - Truck used for 2018 Testing (Side View)**

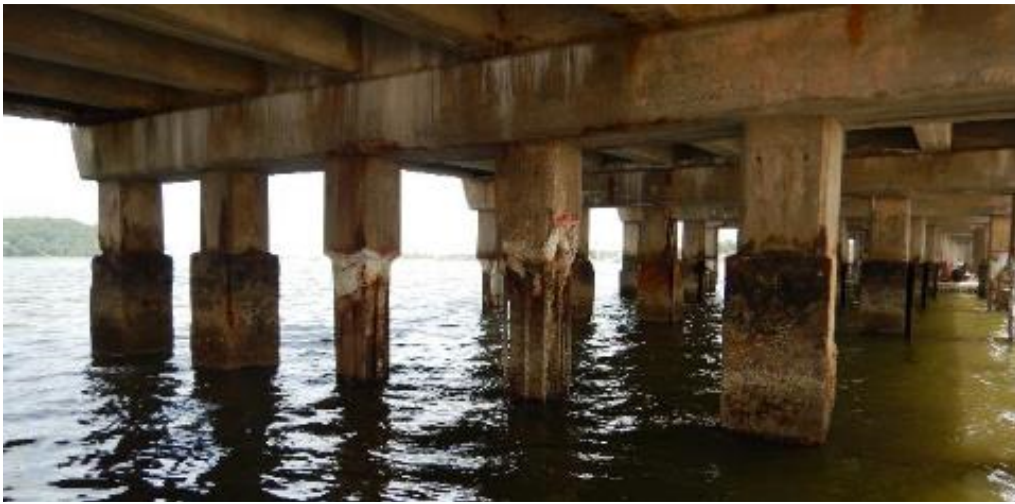
**Figure 5.1 - Spalling of Pile Bents (Approach Spans)**

The Oceanic Bridge is subjected to varying degrees of section loss throughout the entire bridge. Section loss/spalling ranges from corrosion of the concrete piers due to tidal fluctuations, to complete section loss to the supporting pile bents at the concrete T-Beam Approaches, to even spalling of the concrete deck. While these losses have a direct effect on the performance of the oceanic bridge, none quite affect the loading capacity like the condition of the structural steel.

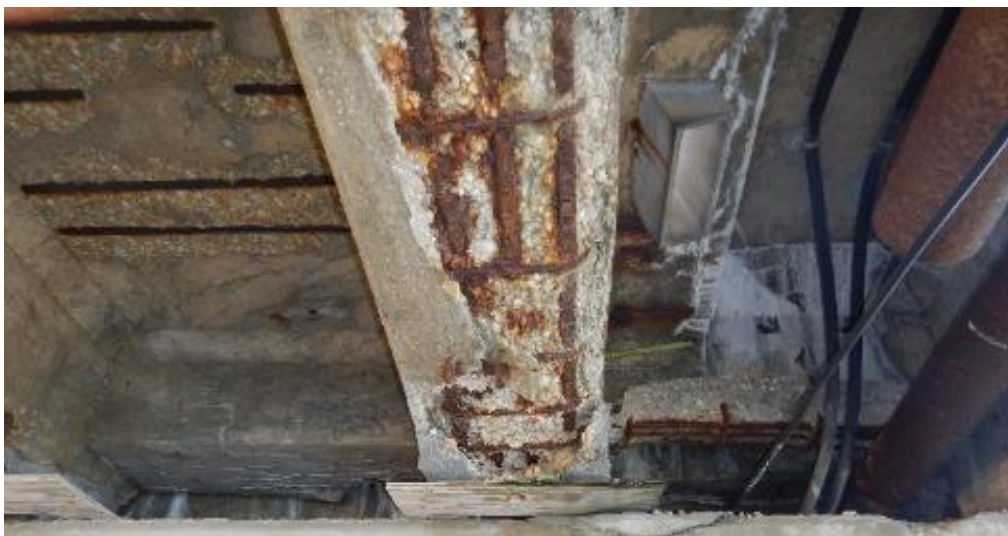
**Figure 5.2 - Spalling of Concrete Deck and T-Beams (Approach Spans)**

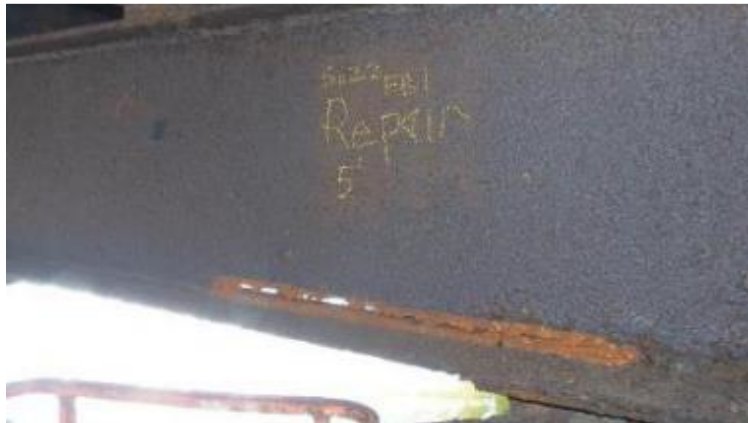
**Figure 5.3 - Span 22 Floor beam 1 - 5 LF of Section Loss along Bottom Flange**

The structural steel superstructure supports some of the most critical spans of the Oceanic Bridge. Additionally, it makes up the majority of all the long spans. These spans as discussed vary from continuous to the simply supported flanking span, which tie indirectly to the dual leaf steel bascule span. All spans are comprised of the same configuration, a stringer floor beam system. The original paint on the bridge was lead. No re-painting of the steel has ever been performed due to the level of containment it would take to remove the paint. As a direct result, we see some extreme cases of section loss throughout each of the steel spans. Examples of this section loss can be found in some of the below figures.

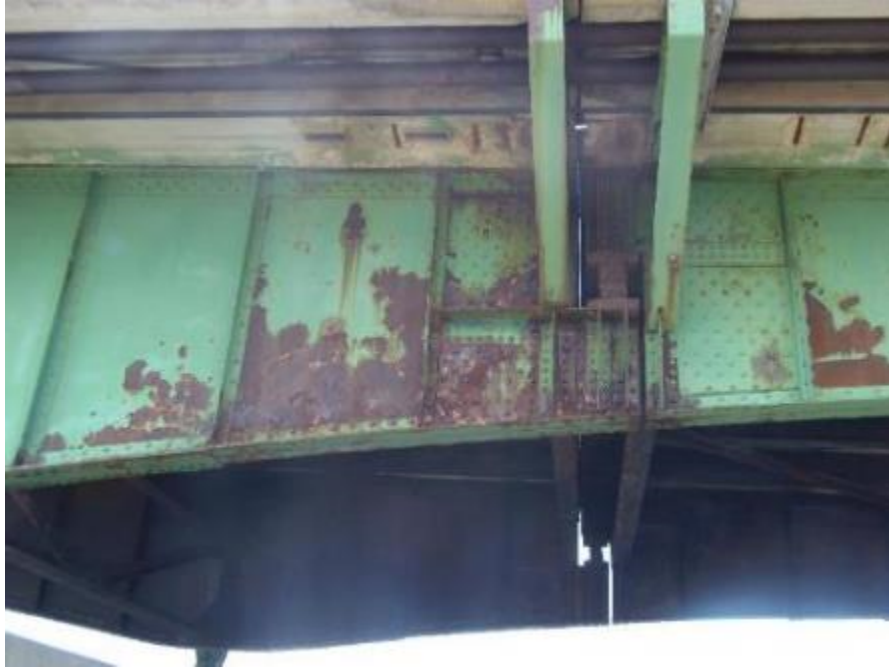
**Figure 5.5 - Section Loss and Corrosion at Rocker Bearing Connection**

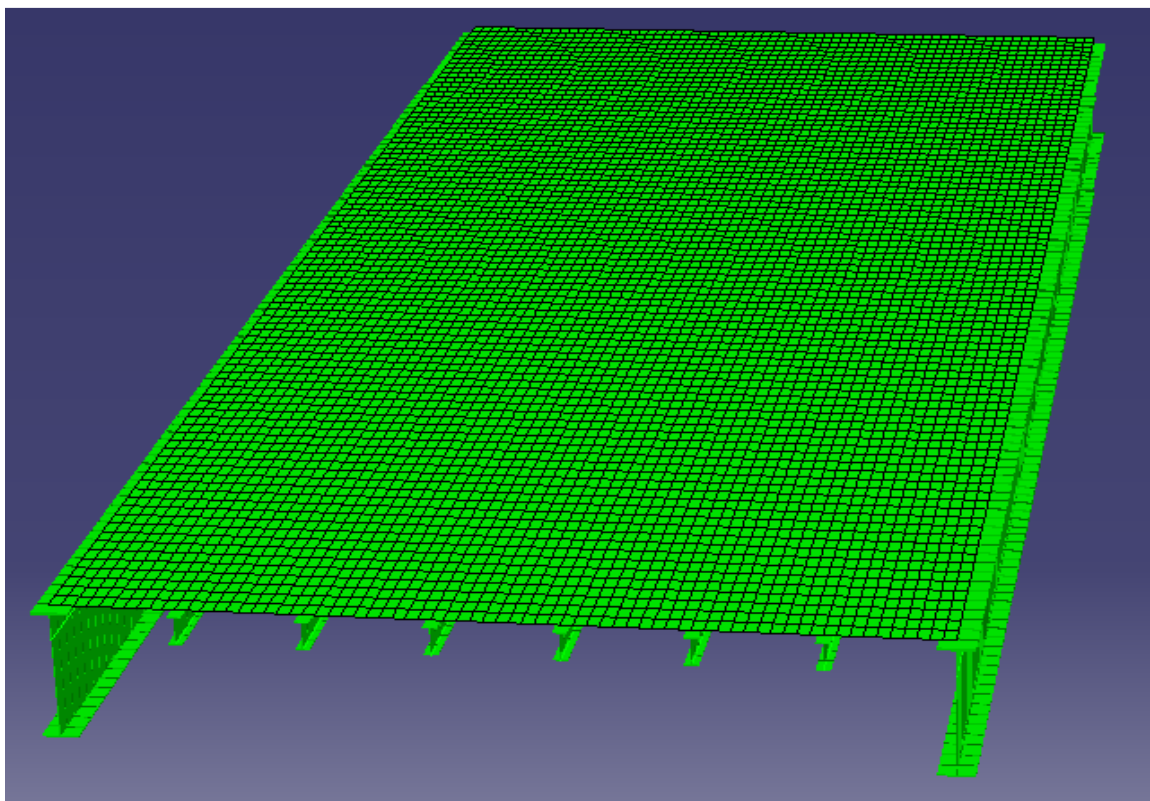
Finite element modeling provides a series of benefits, including enhanced analysis; better insight into the redundancy of the flanking span system; and ease of analyzing the flanking span under different loading conditions. The model also allowed for the analysis of the flanking span under different physical conditions. The model developed can be seen in the figure below:

**Figure 5.6 - Finite Element Model of Spans 28 and 30**

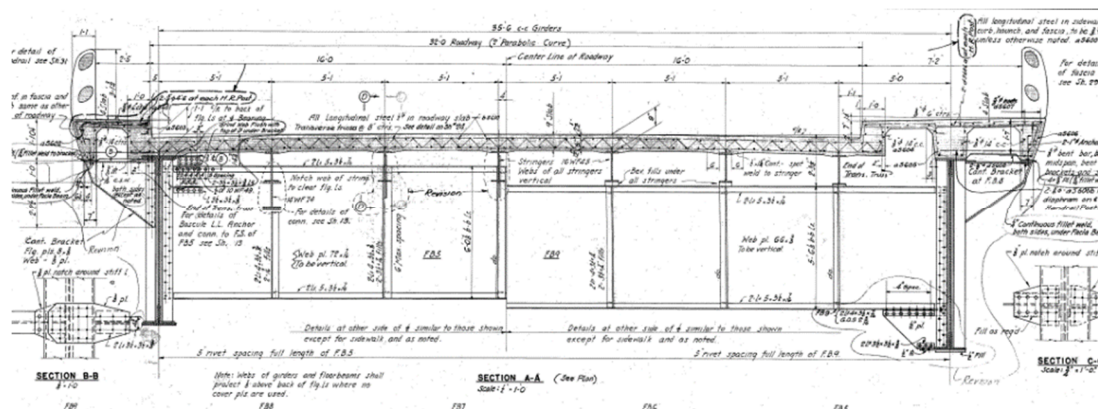
It also served as a mid-point comparison for the floor beam to see what changes exist between the rehabilitated member and the original floor beam member. This model considers all elements to be in good working condition.

**Figure 5.7 - As-Built Plan Utilized to develop 1939 Model**

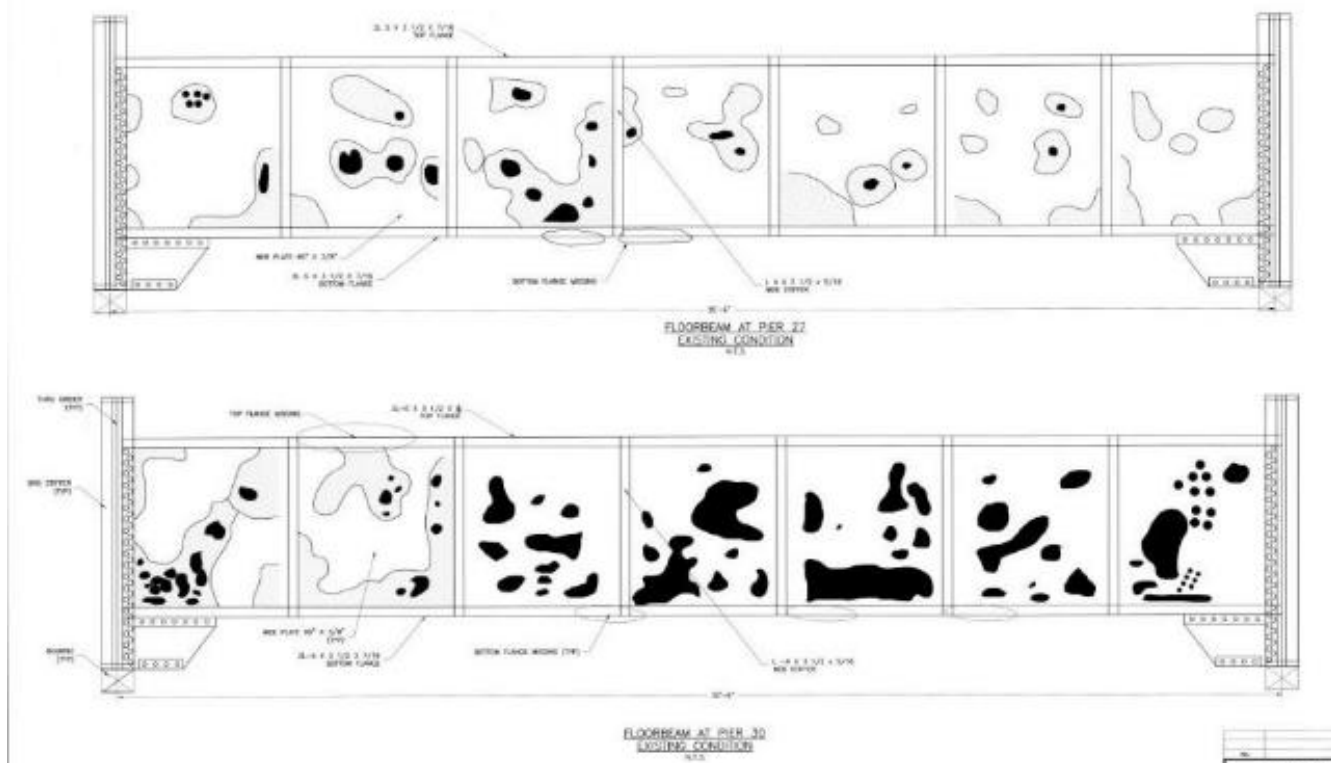
The purpose of this model was to determine whether the 5-ton priority posting was valid, and if a relationship could be determined for pre and post repairs. It also allowed for us to understand the internal redundancy of the span further and determine the effects section loss of the floor beam had on the remaining members of the span.

Figure 5.8 - Plans from 2014 Rehabilitation Repair to determine Section Loss to Floor Beam 9

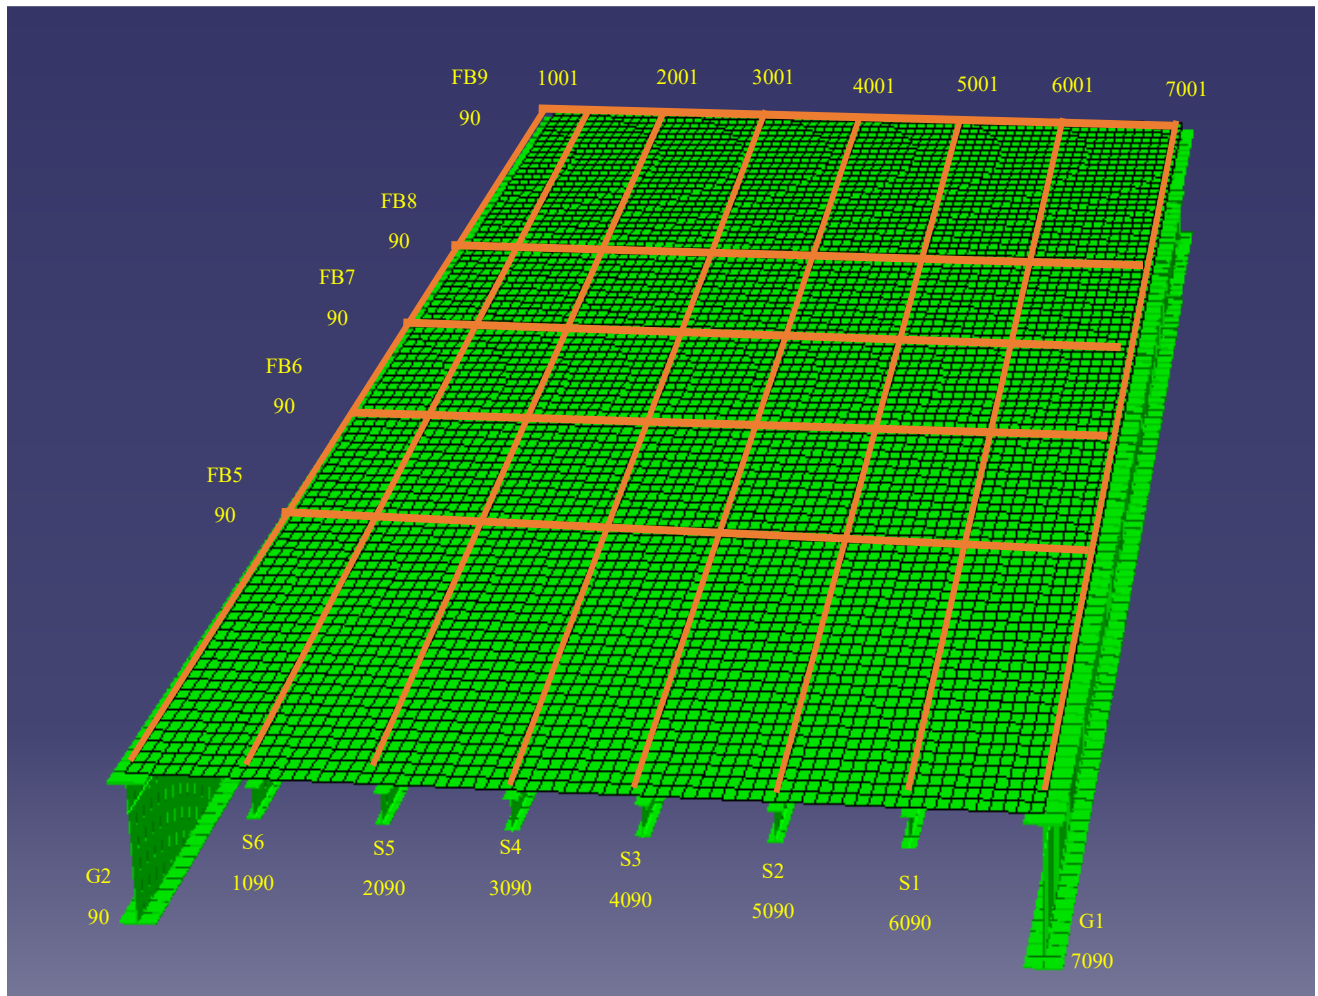
of which increases by 100 in the transverse direction. The length of the span is 89ft and the overhangs, as well as, parapets were not considered in the model.

**Figure 5.9 - Finite Element Method Node and Element Layout**

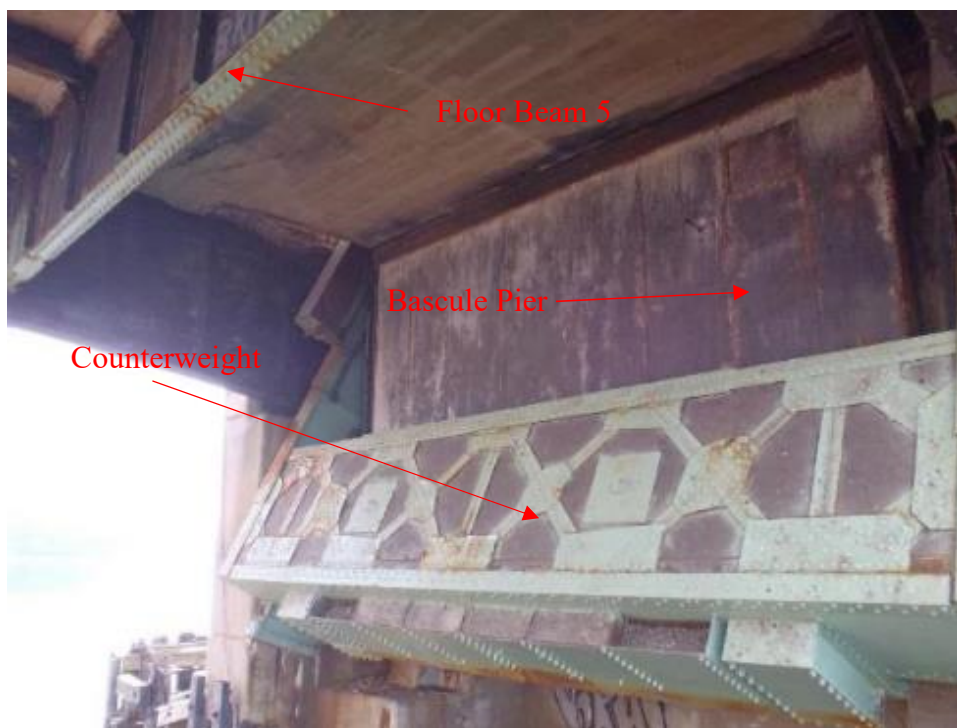
An outlier of the model is the fact that no floor beam exists at the terminus where the main thru girder and stringers meet the main trunnion system. This is because the area between floor beam 5 and the terminus accounts for the main counterweight of the movable span. Additionally, the load of the deck and more importantly the live load is not transferred to the main flanking span, but to the main bascule girder. Figures taken from the field and extracted from the as-built drawings illustrating this can be found below:

Figure 5.10 - Area between Floor Beam 5 and Main Bascule Pier

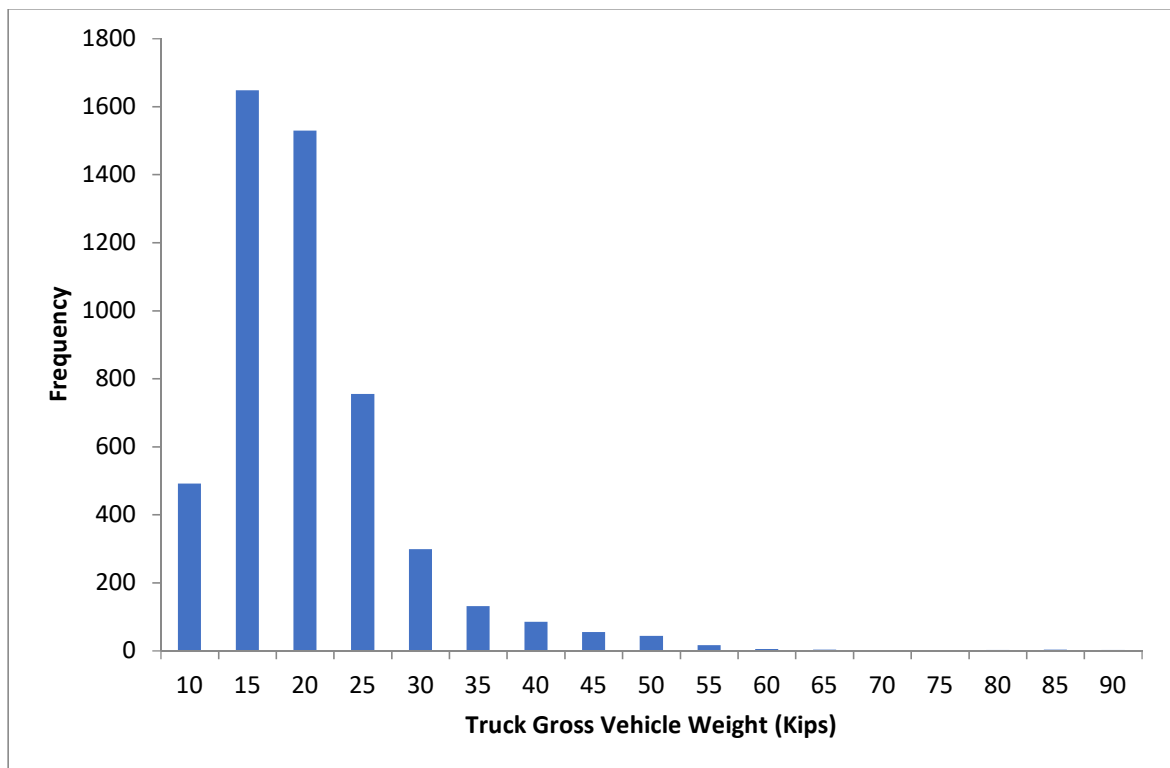
**Figure 6.1 - Bridge S-31 WIM Data Relative Frequency Histogram**

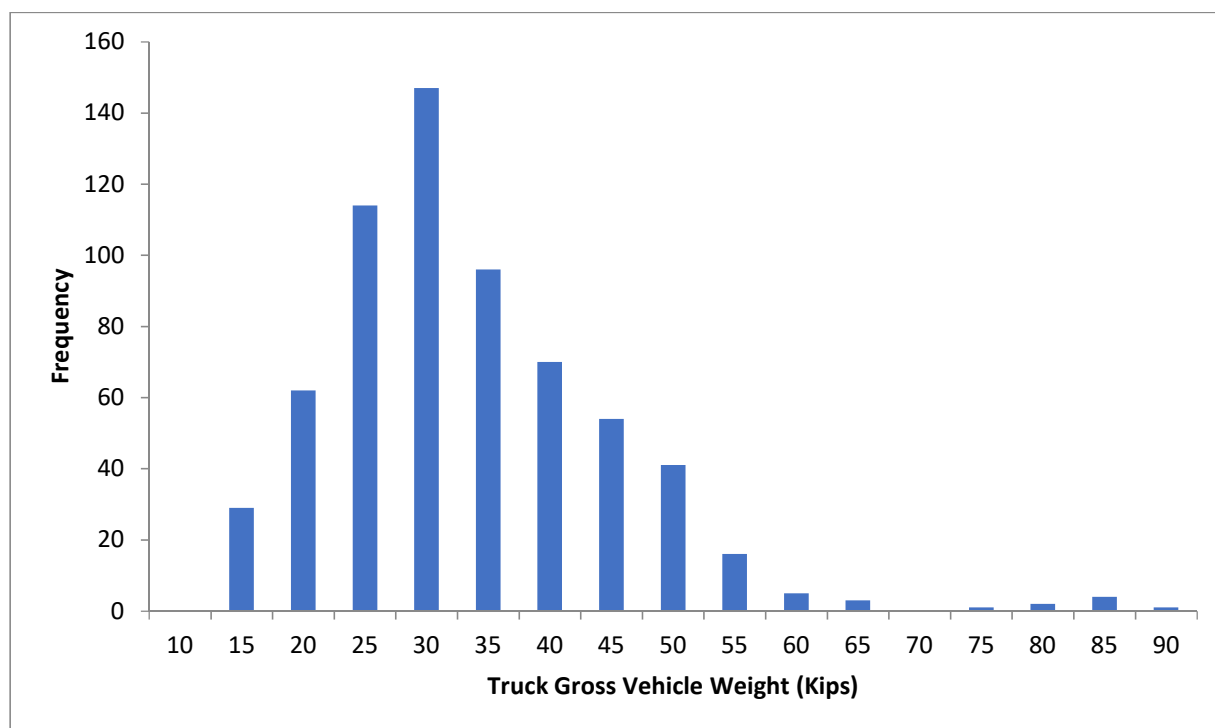
decreased to 645, an 87% reduction. However, most of trucks filtered out fall within the lower Gross Vehicle Weight categories.

**Figure 6.2 - Weigh-in-Motion Relative Frequency Histogram (Without 2-Axle Trucks)**

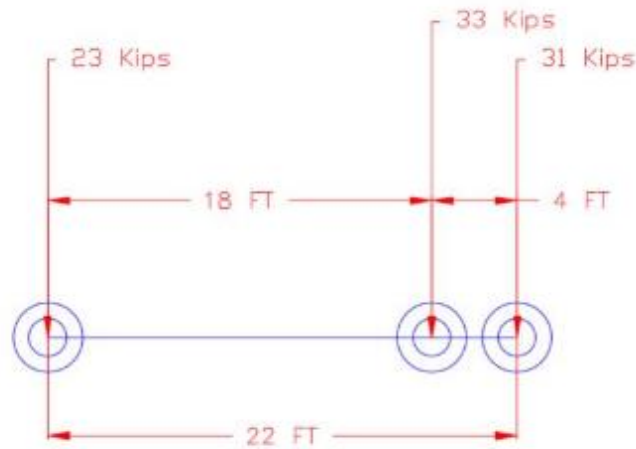
**Figure 6.4 - Maximum Observed Load Case per WIM Sensors**

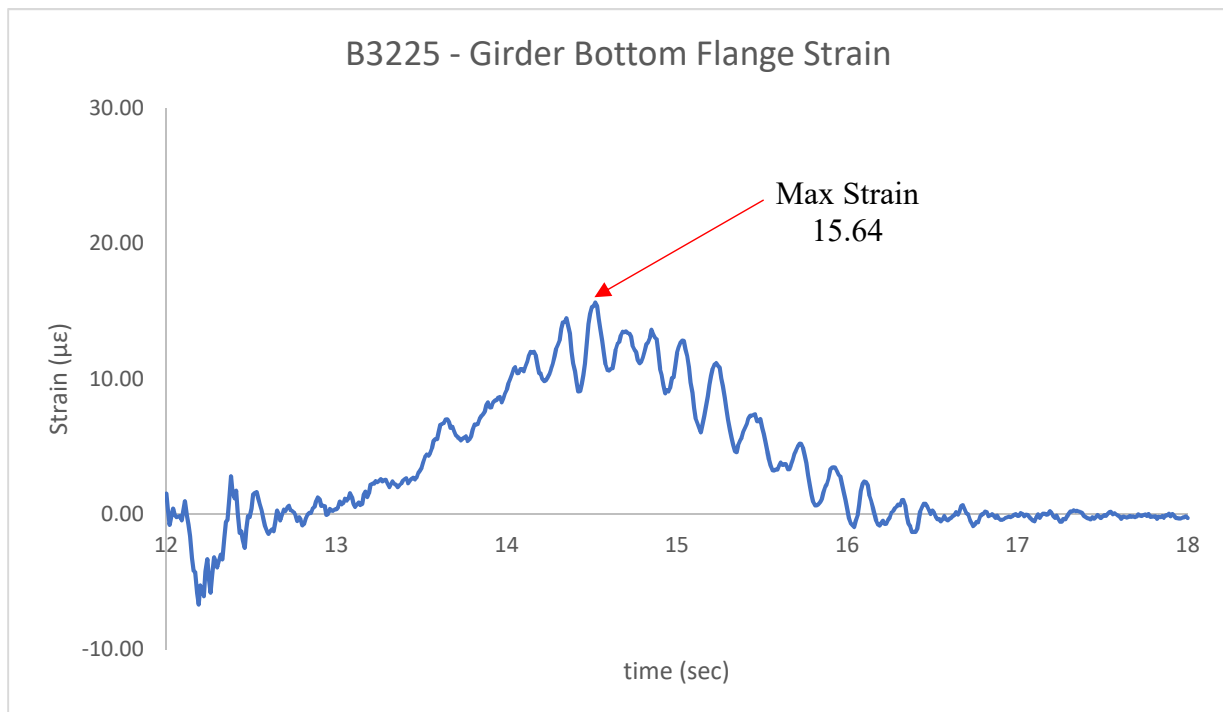
**Figure 6.5 - Strain at B3225, Dynamic**

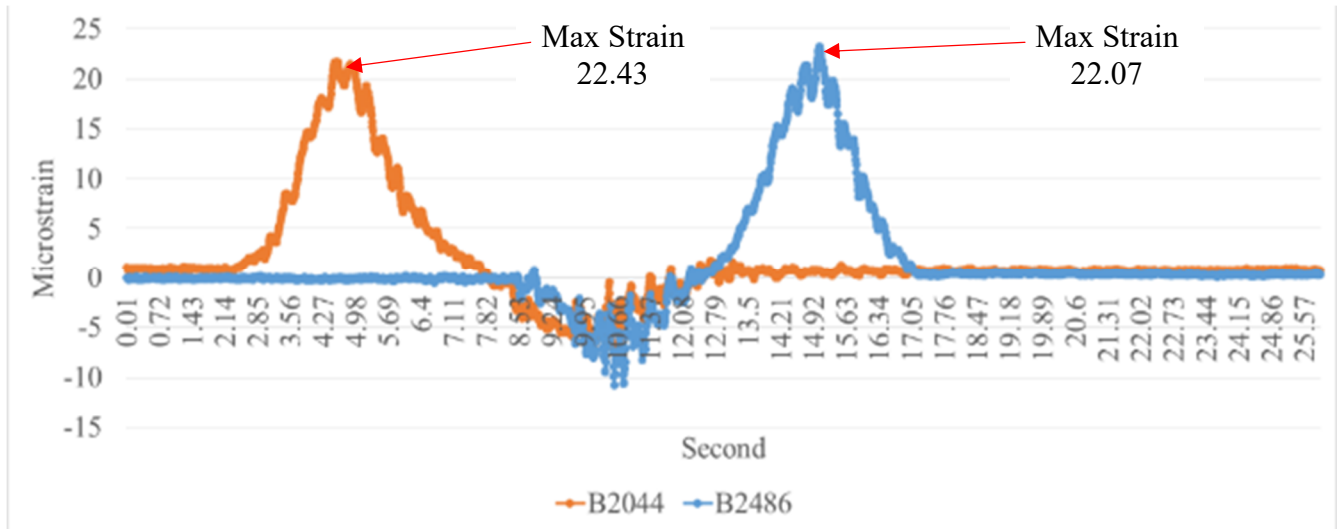
Figure 6.6 - Typical strain data collected from dynamic testing at Fascia Girder

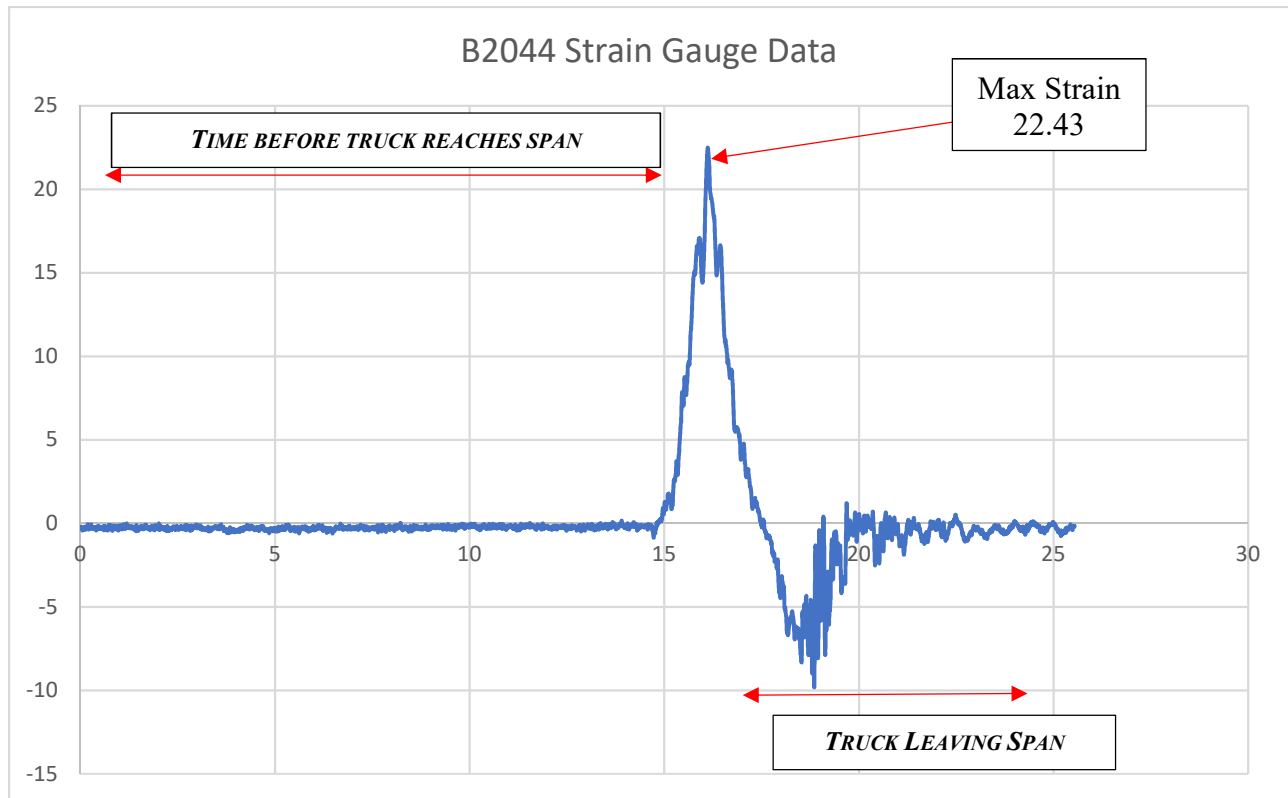
**Figure 6.7 - B2044 Strain Gauge Data**
