# **COMPARISON OF LOAD RATING METHODS FOR COMPLEX BRIDGES**

JOSEPH R. STRAFACI, PE

A dissertation submitted to the

Rutgers, the State University of New Jersey

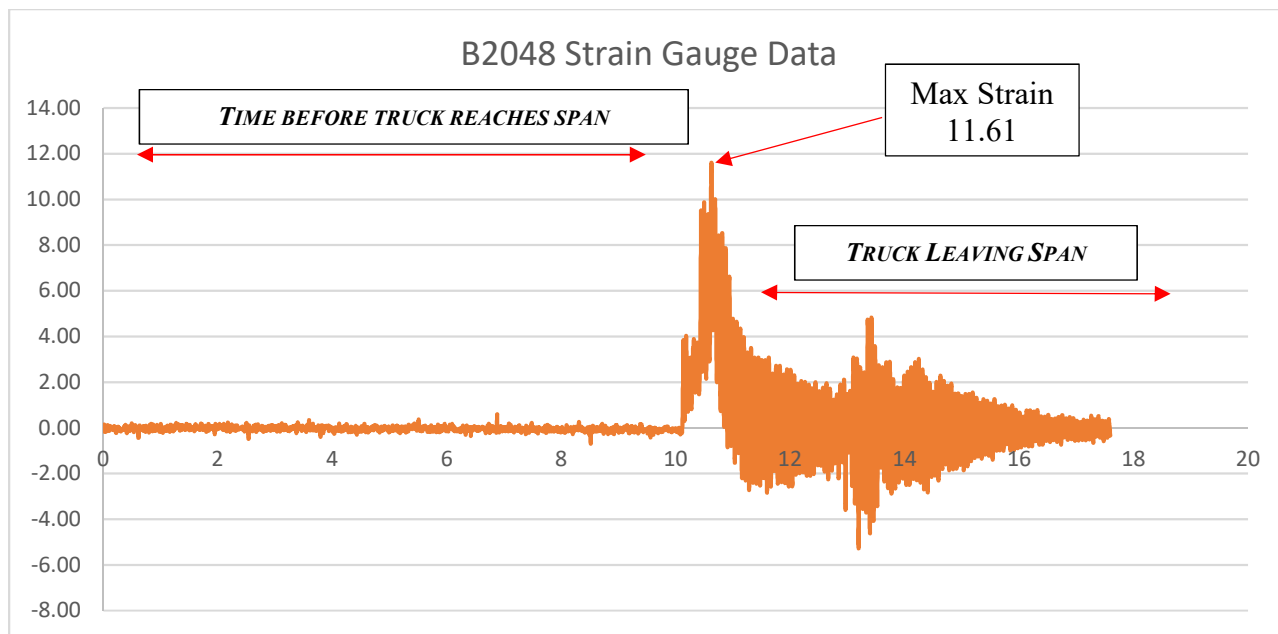
Figure 6.8 - B2048 Strain Gauge Data

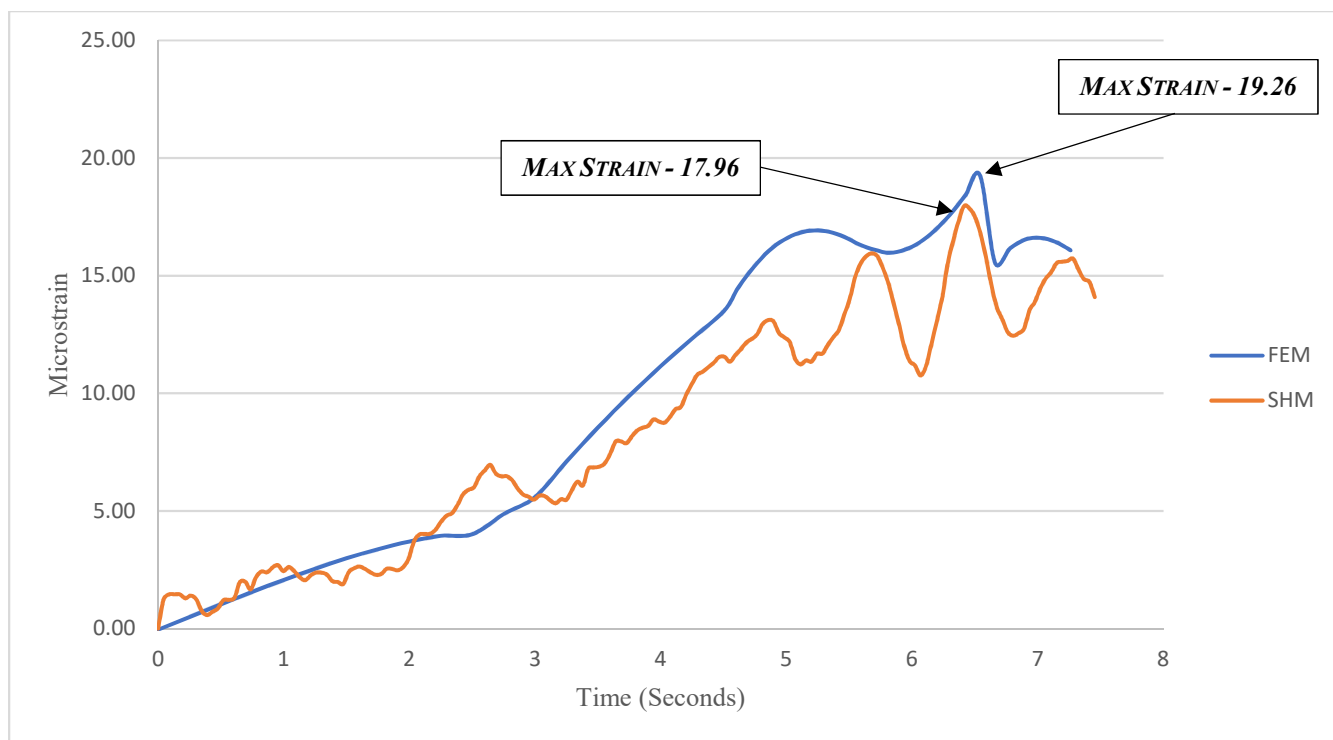
Figure 6.9 - 2016 Calibration Fascia Girder

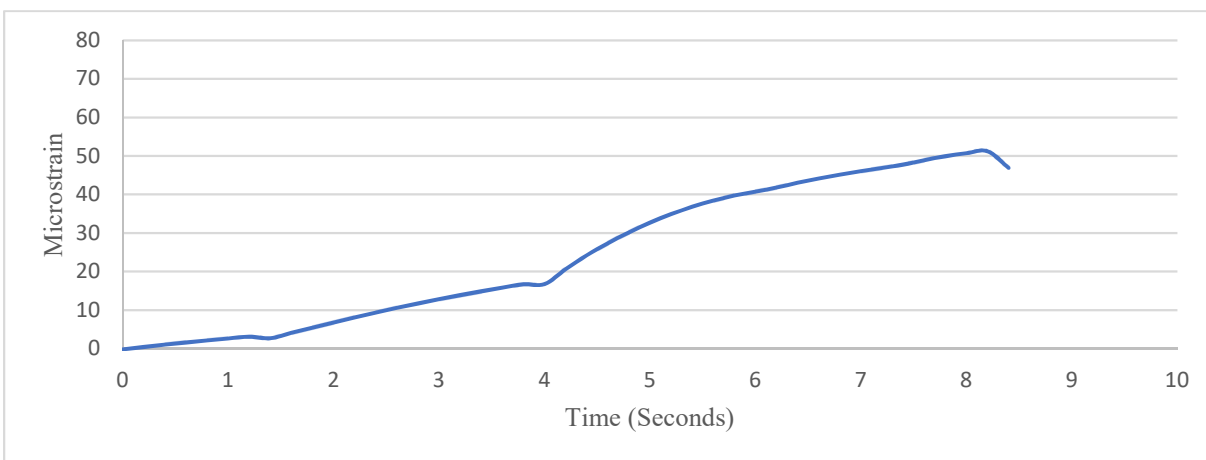
**Figure 6.13 - HS-20 Loading for Model I**

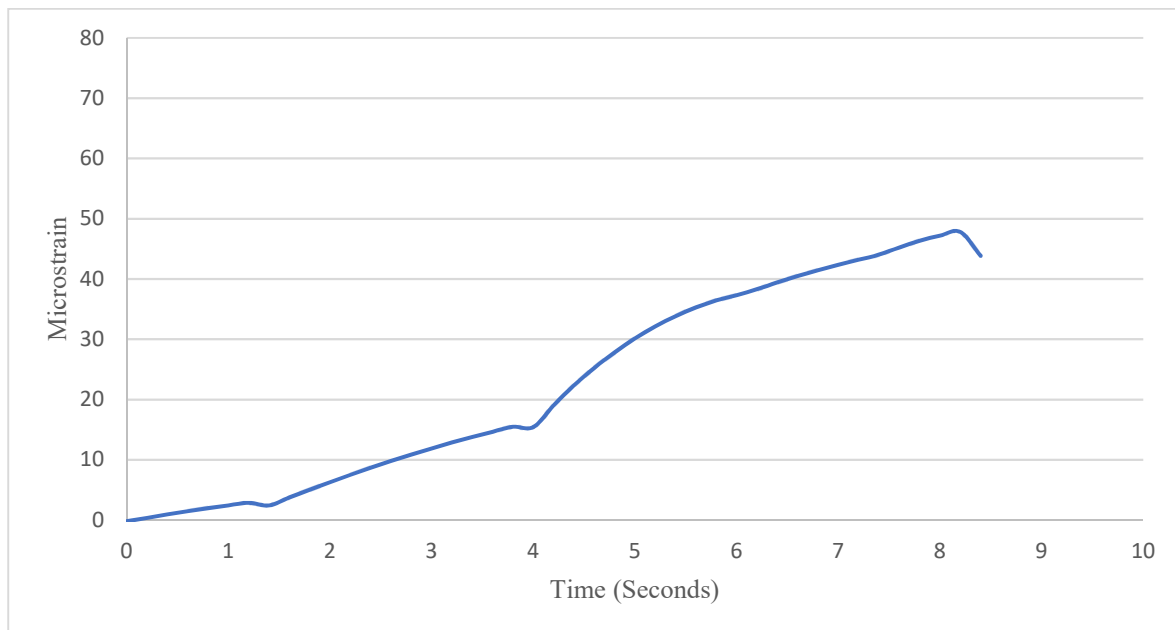
**Figure 6.15 - 1939 Model - HS-20 Load for Model II**

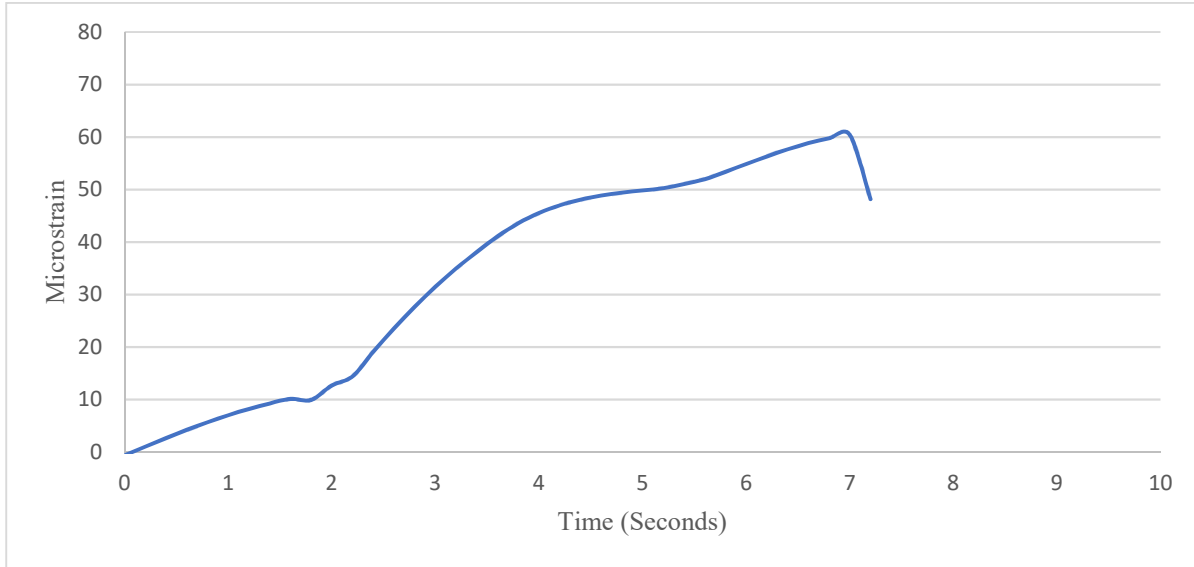
**Figure 6.16 - 1939 Model - Max WIM Load for Model II**

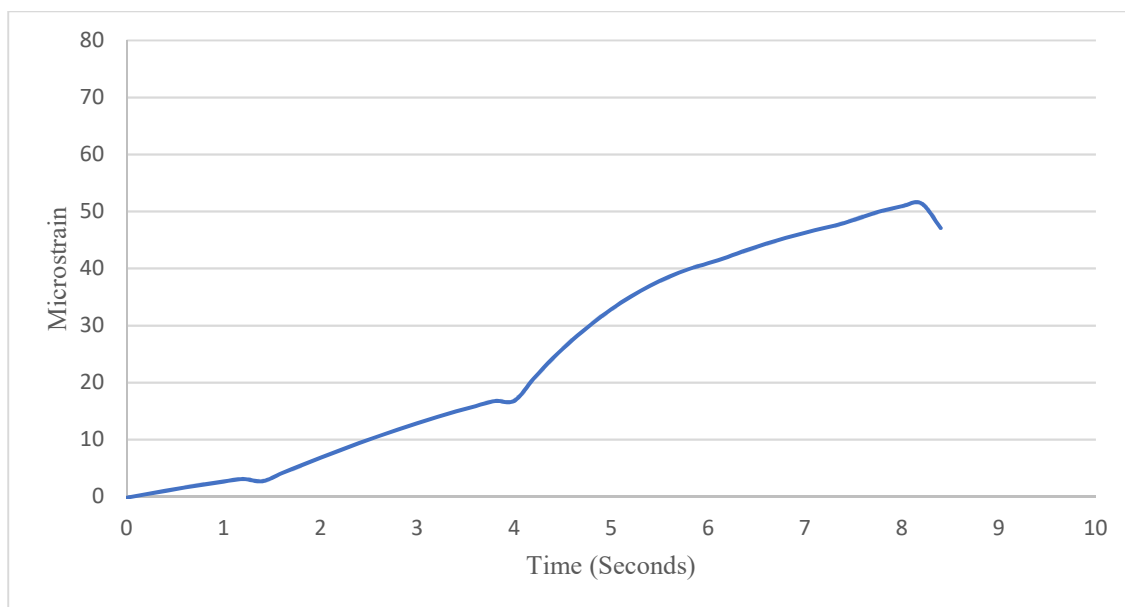
**Figure 6.17 - 2029 Model - HS-20 Load for Model III**

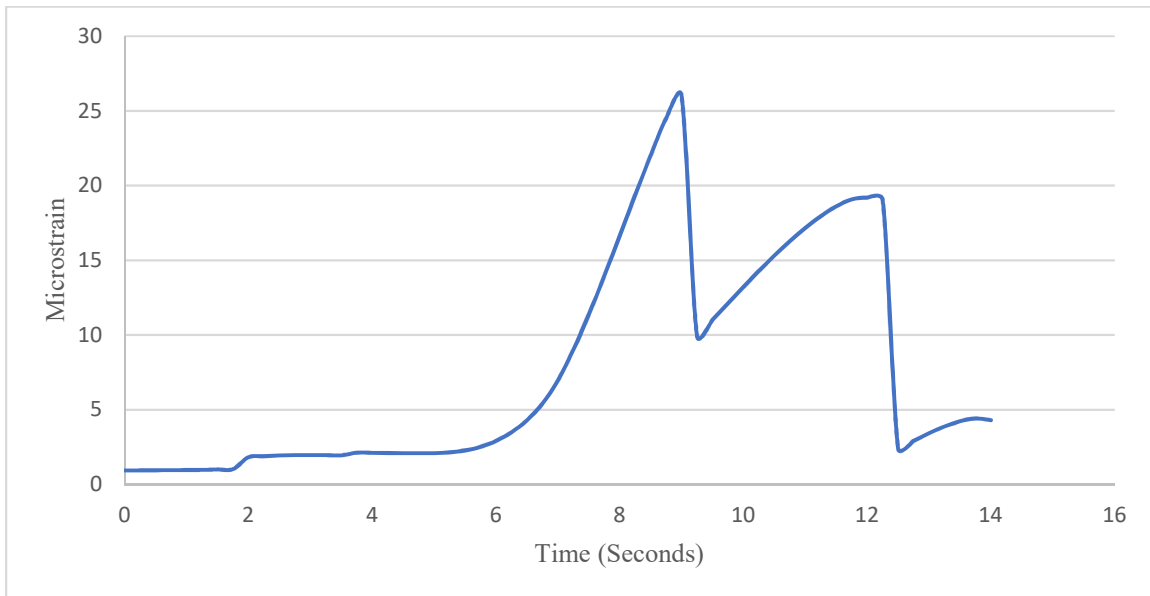
**Figure 6.19 - 2018 Model - HS-20 Load**

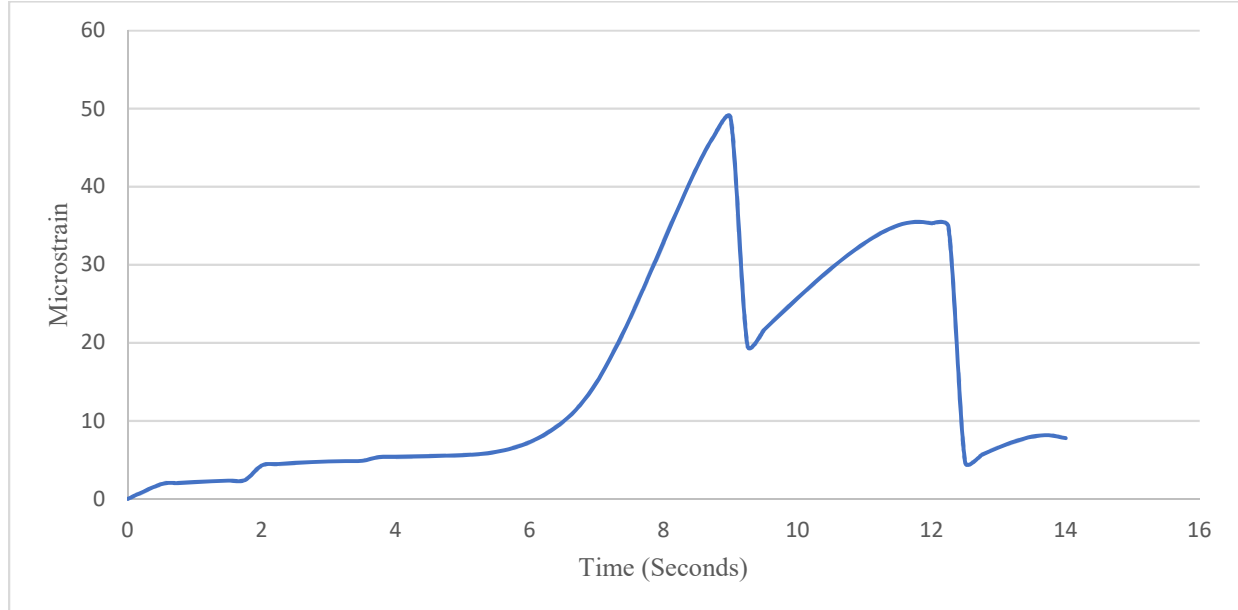
**Figure 6.20- 1939 Floor beam -HS-20 Truck**

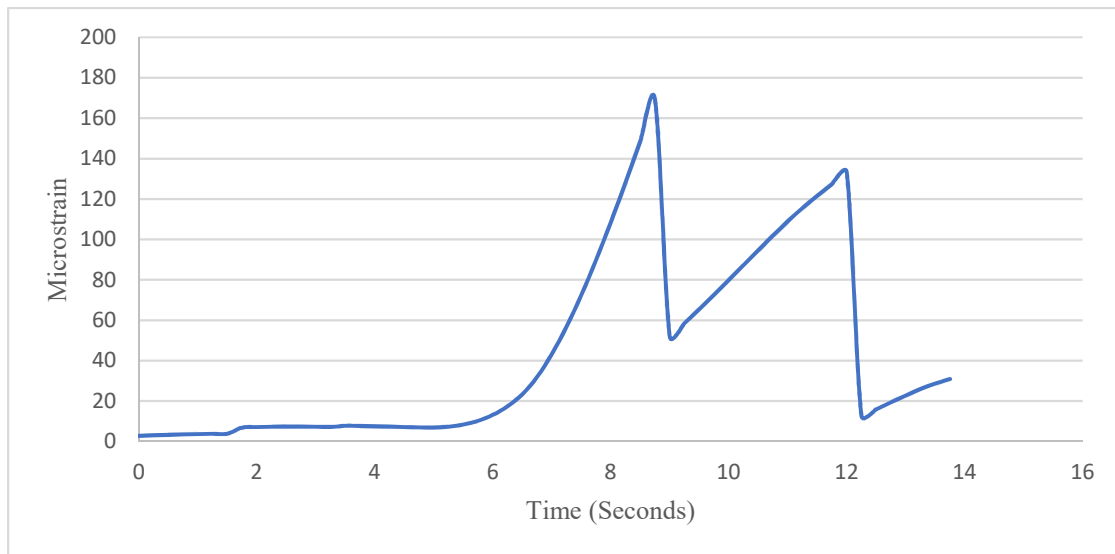
**Figure 6.21 - Finite Element Model III (2013 Model) Floor beam -HS-20 Truck**

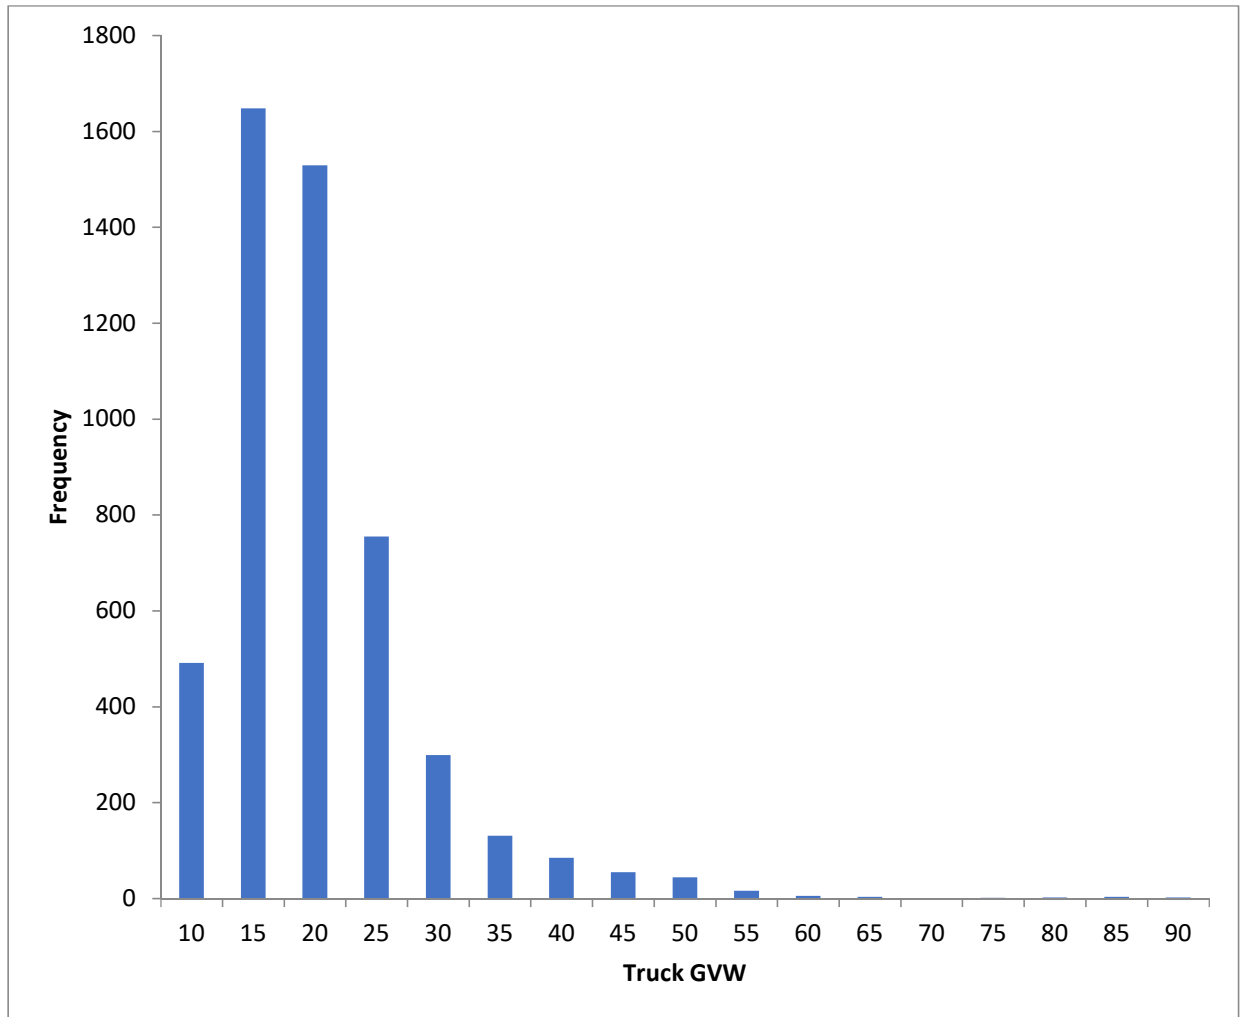
**Figure A.1 - Histogram of Overall Truck Data**

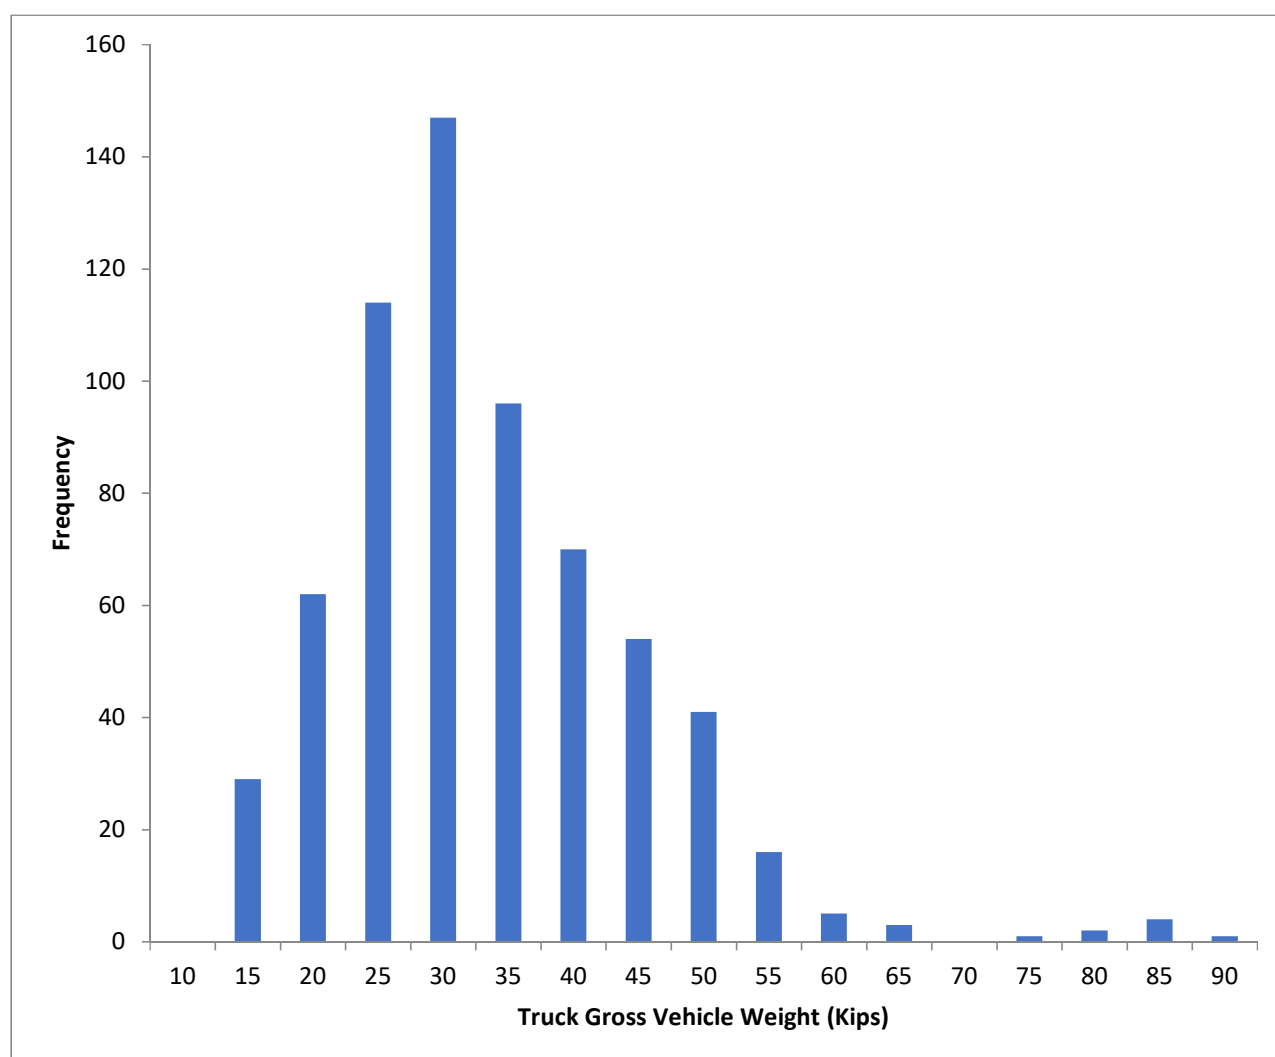
**Figure A.2 - Histogram of Truck Data without 2-Axle Trucks**

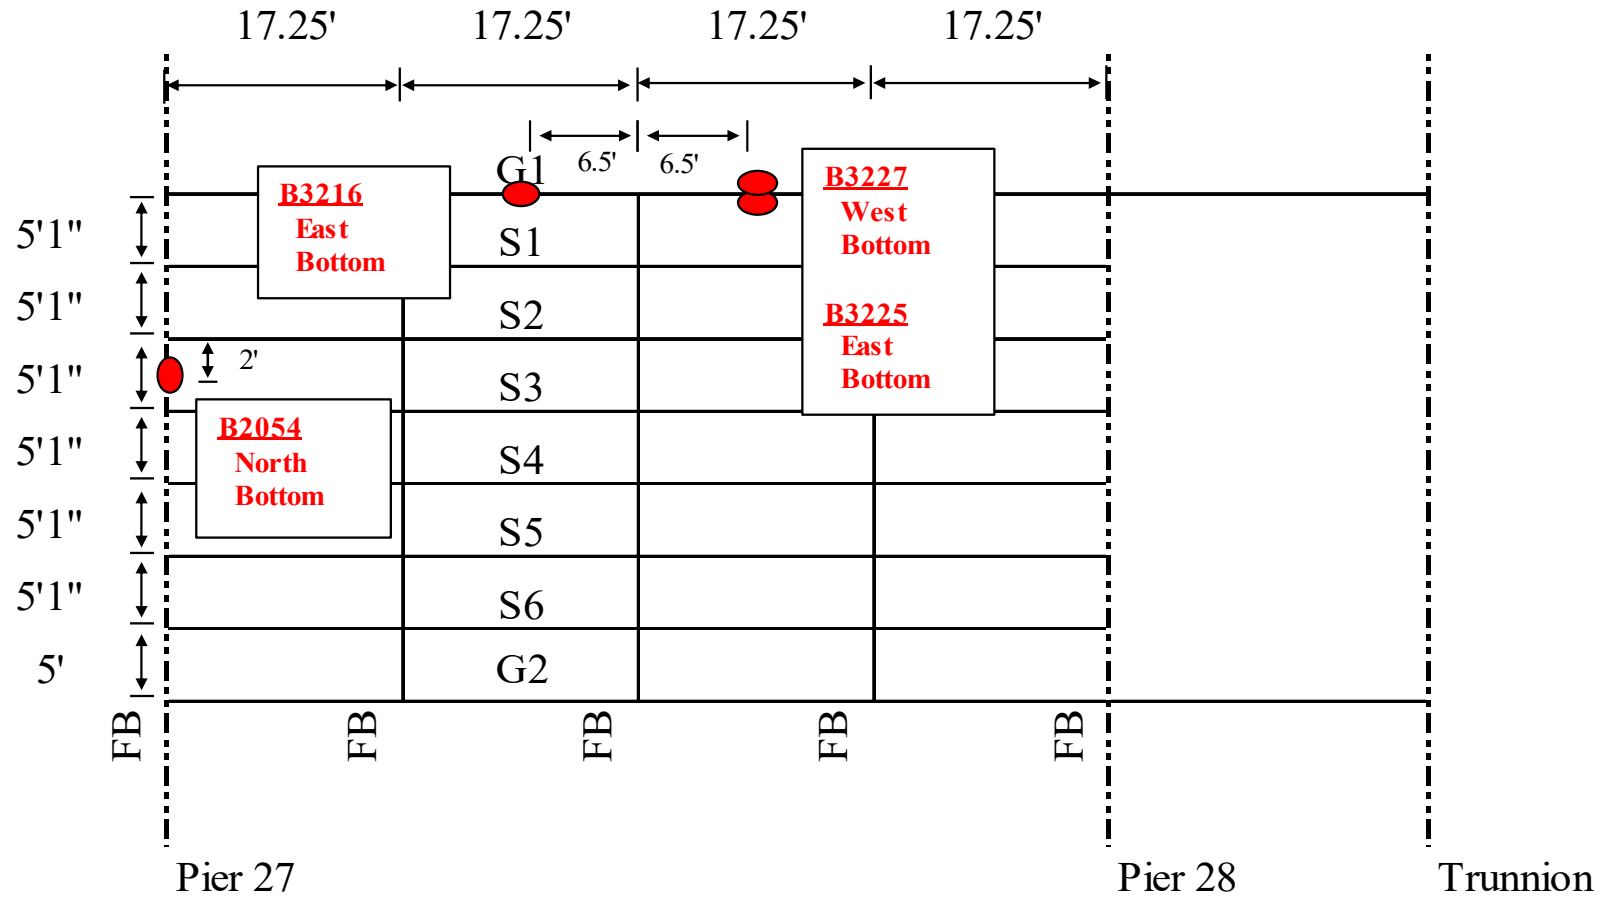
Figure B.1 - 2016 Sensor Plan

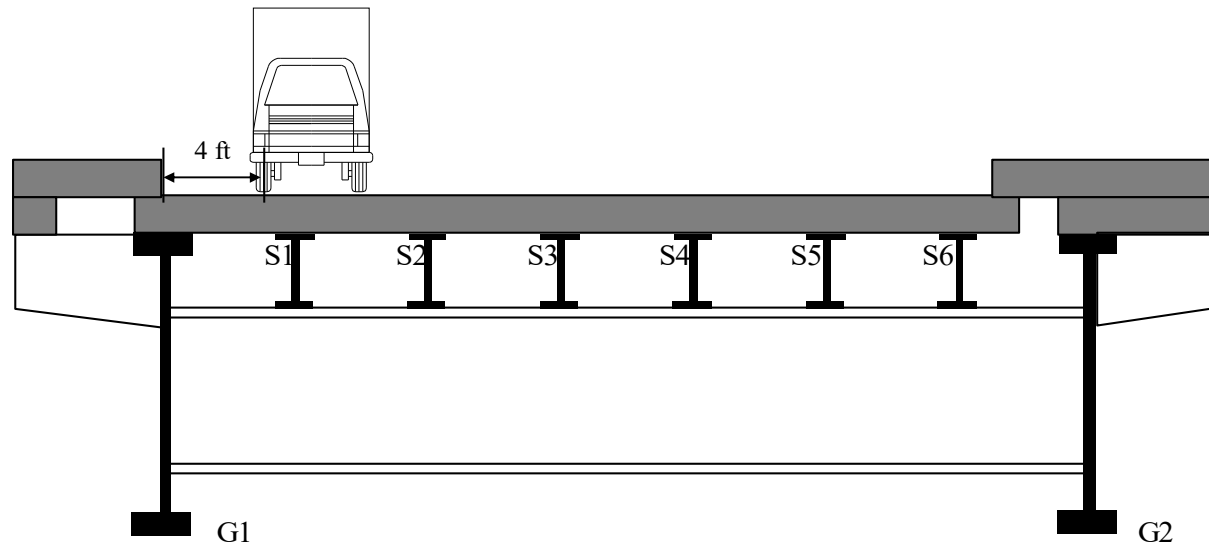
**Figure B.2 - Testing Cross Section**

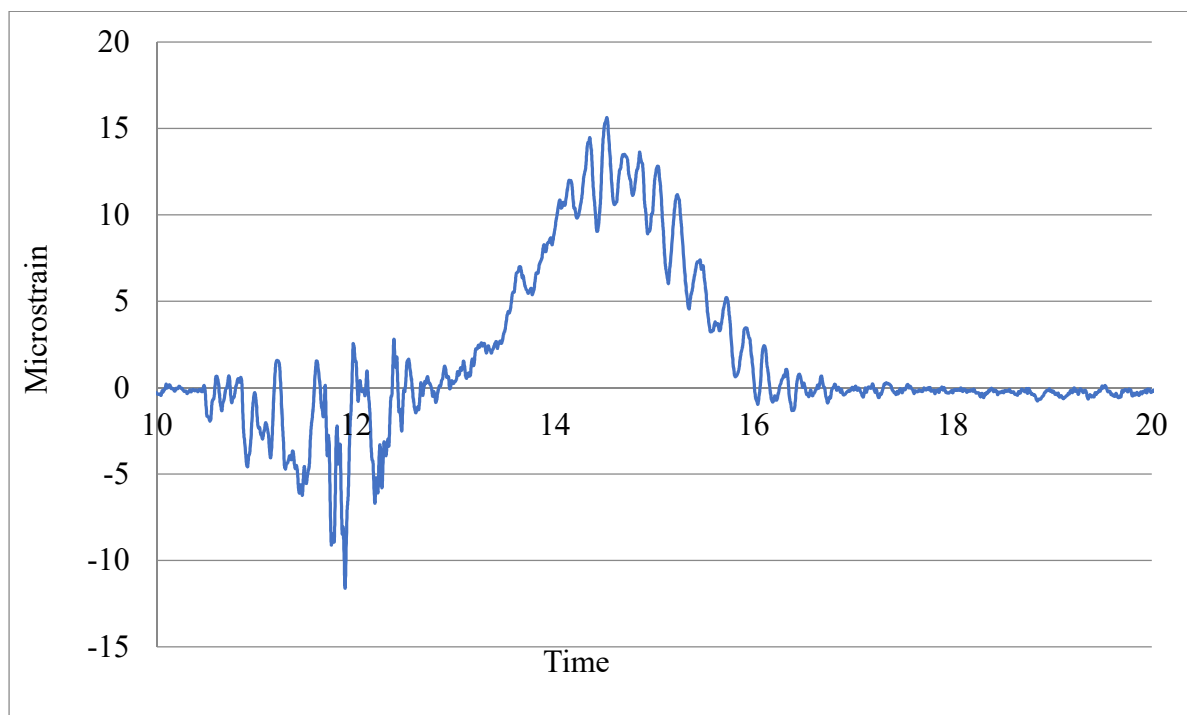
**Figure B.3 - Sensor B3225 Results (30 Mph Test)**

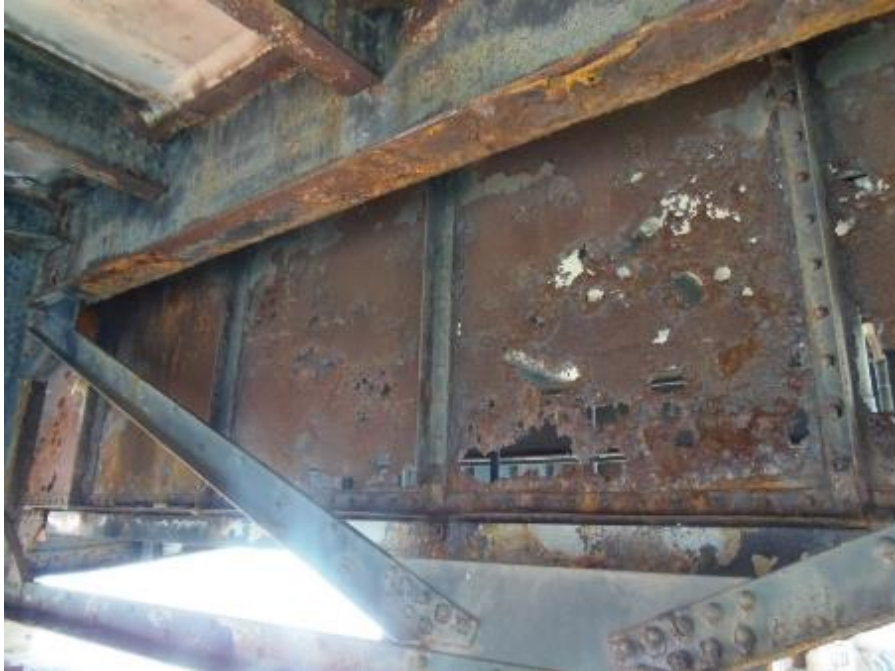
**Figure C.1 - 2013 Deteriorated Floorbeam (Center Panels)**

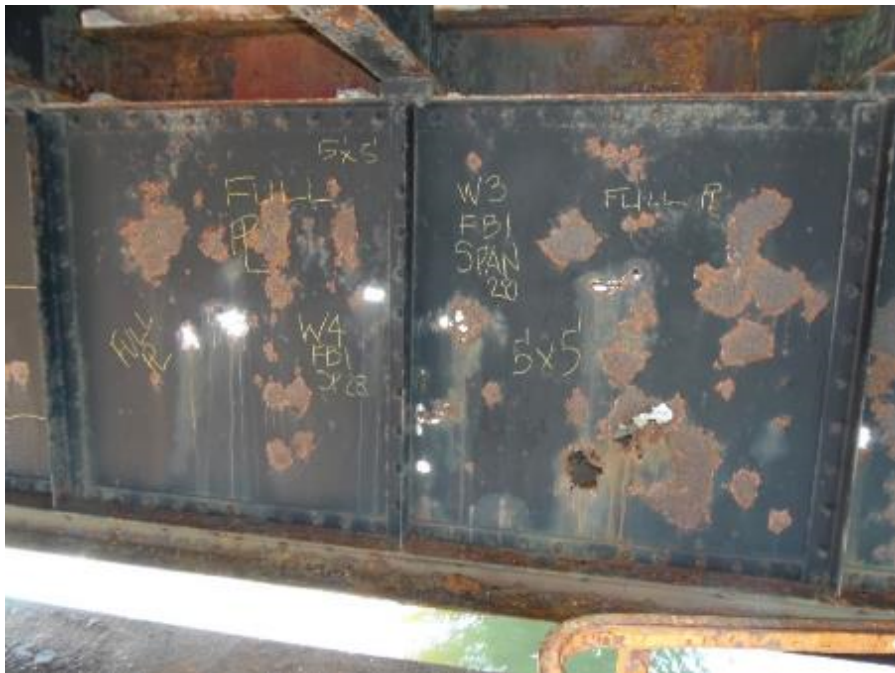
**Figure C.2 - 2013 Deteriorated Floorbeam (Panels 2 and 3)**

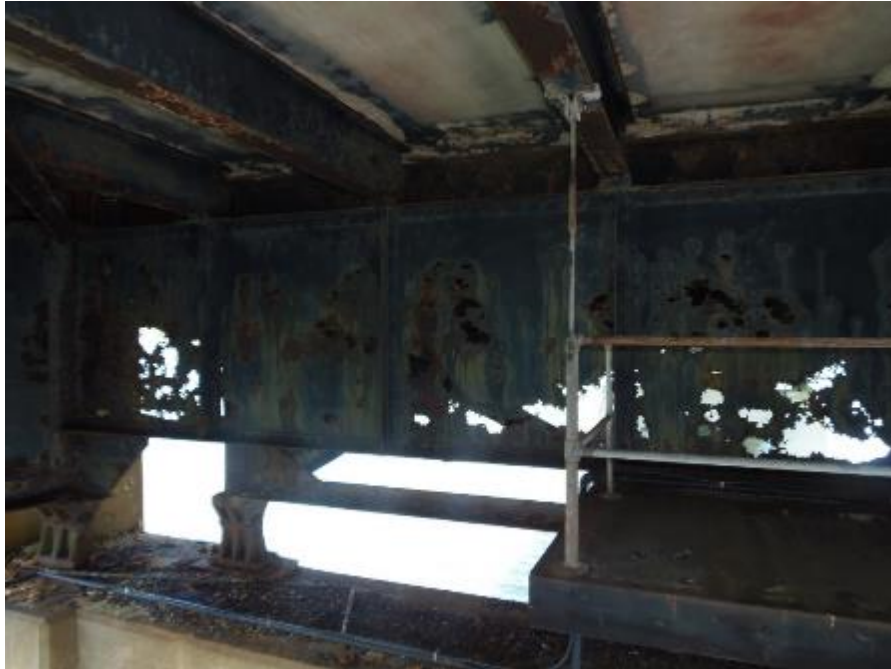
**Figure C.3 - 2013 Deteriorated Floorbeam (Looking North)**

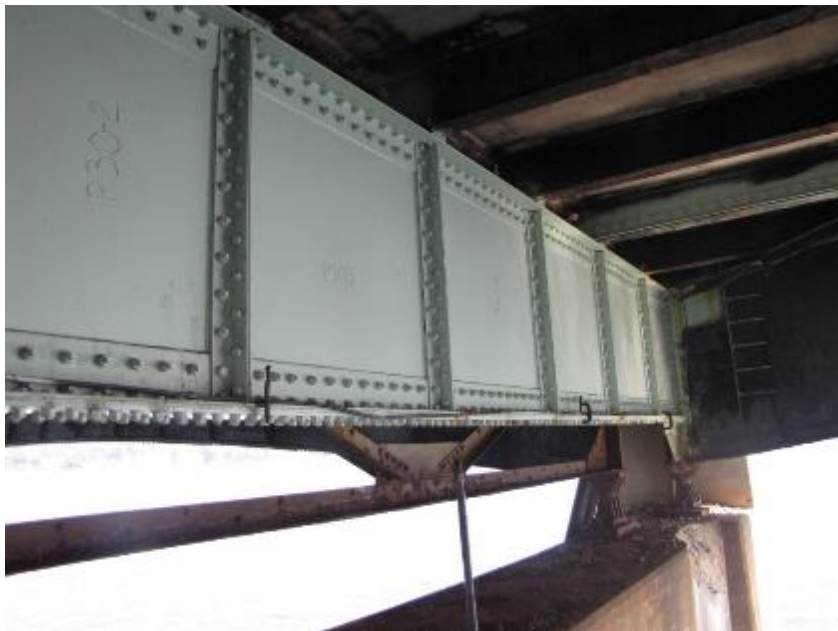
**Figure C.4 - 2015 Repaired Floorbeam (Looking East)**

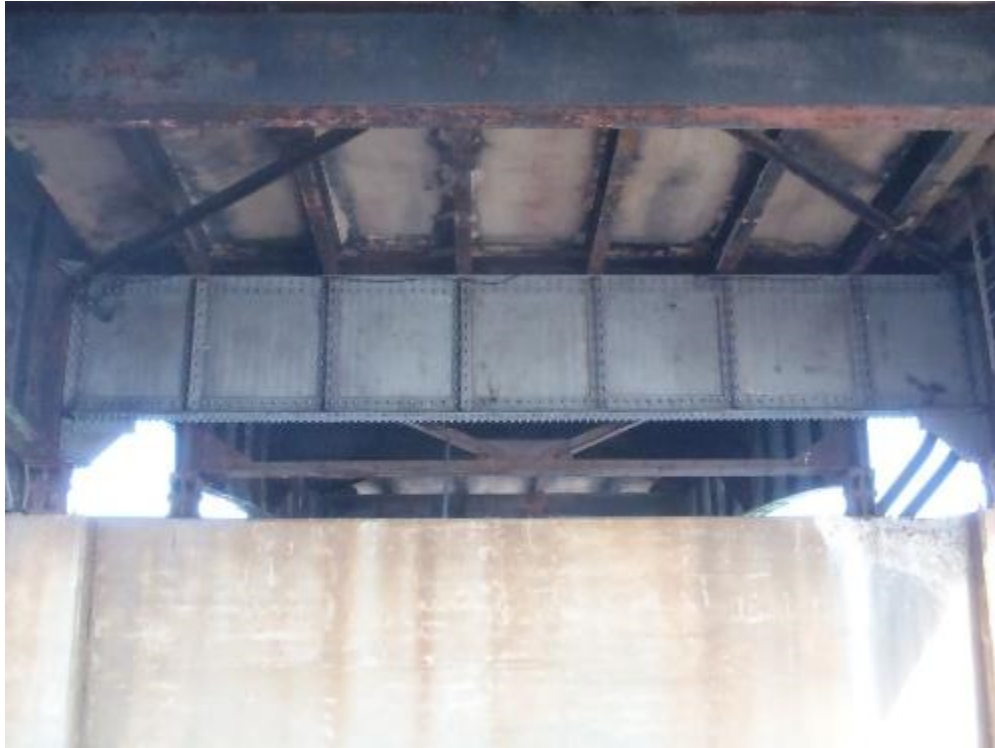
**Figure C.5 - Repaired Floorbeam (Looking North)**

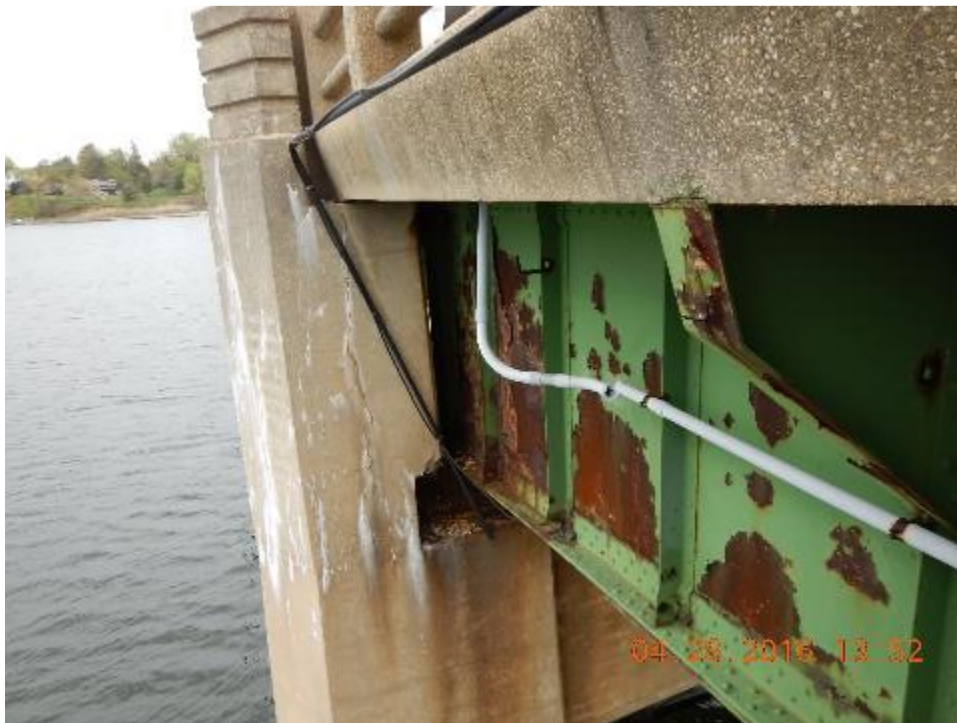
**Figure C.6 - Fascia Girder at Bascule Pier (Looking North)**

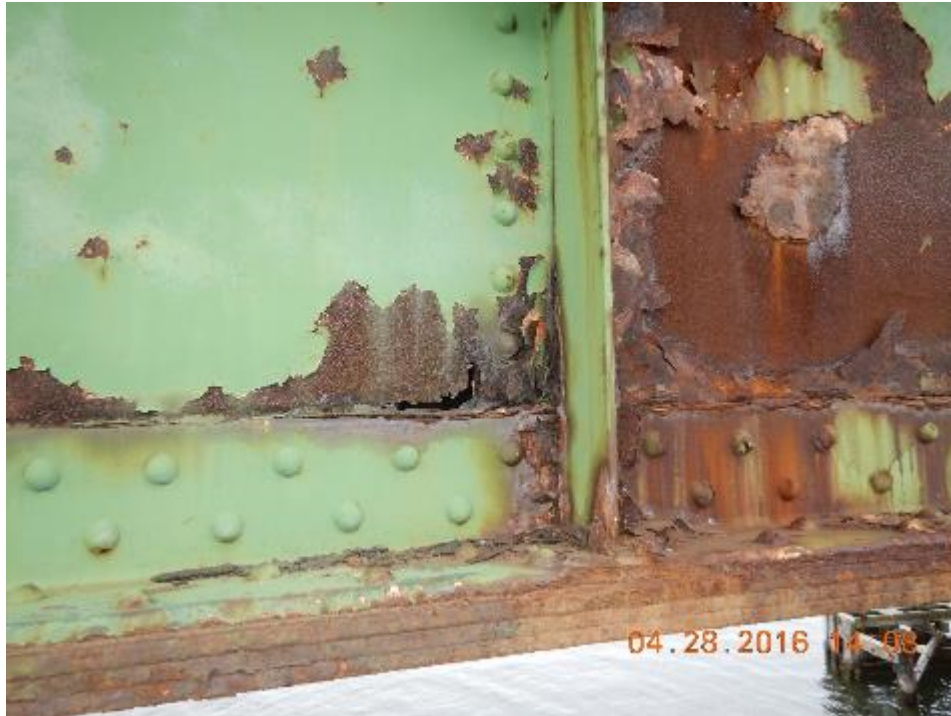
**Figure C.7 - Fascia Girder Midspan Corrosion (Looking East)**

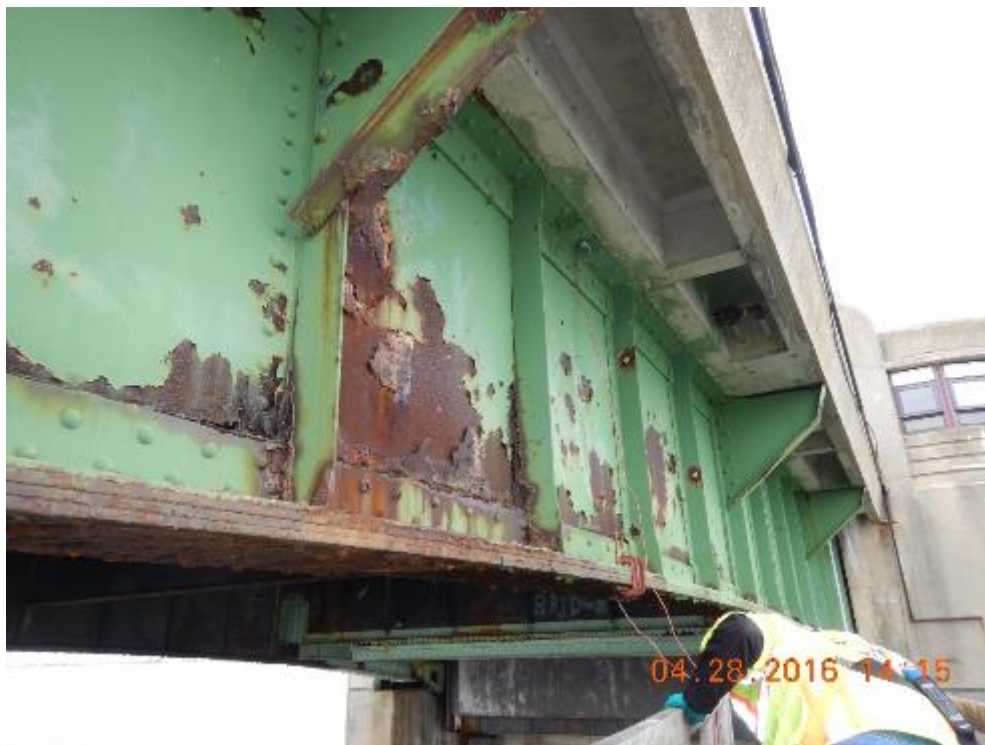
**Figure C.8 - West Fascia Girder (Looking South)**

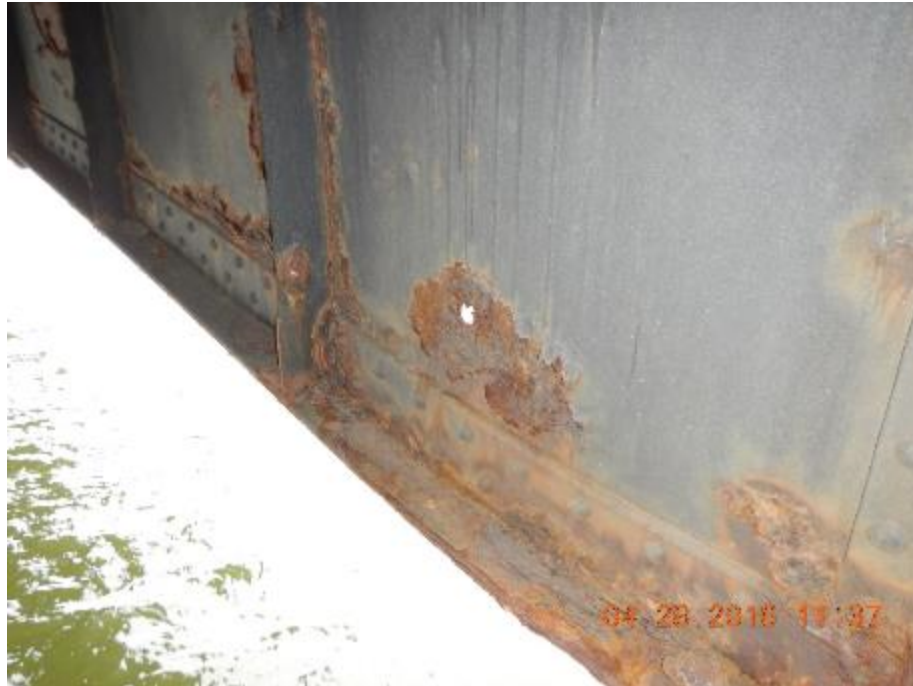
**Figure C.9 - Fascia Girder (Interior View) Corrosion on Bottom Flange**

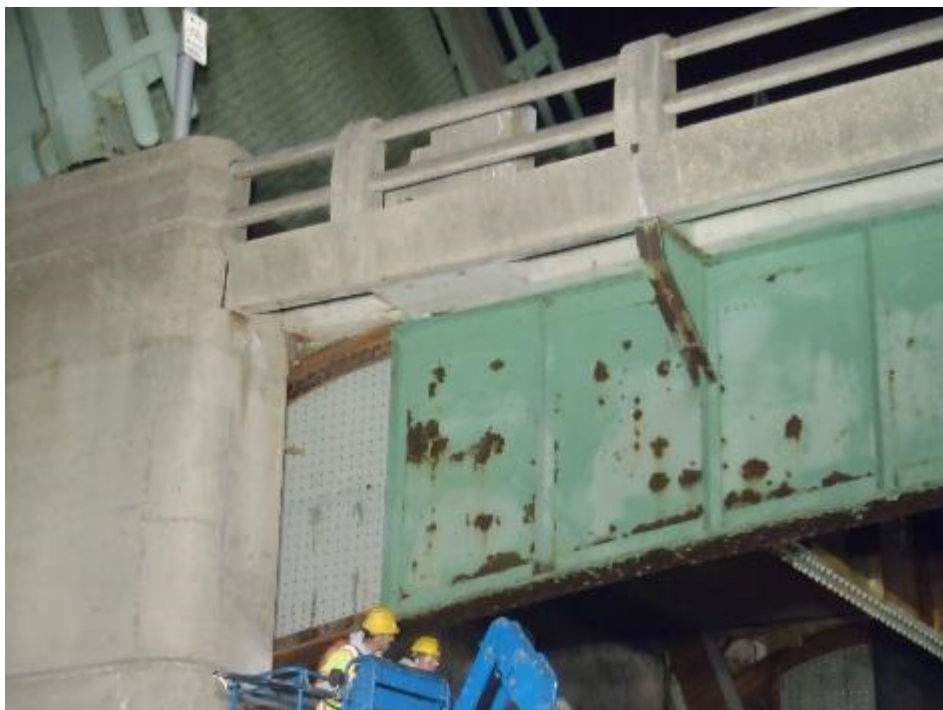
**Figure C.10 - Fascia Girder Repair at Bascule Pier during 2015 Rehabilitation**

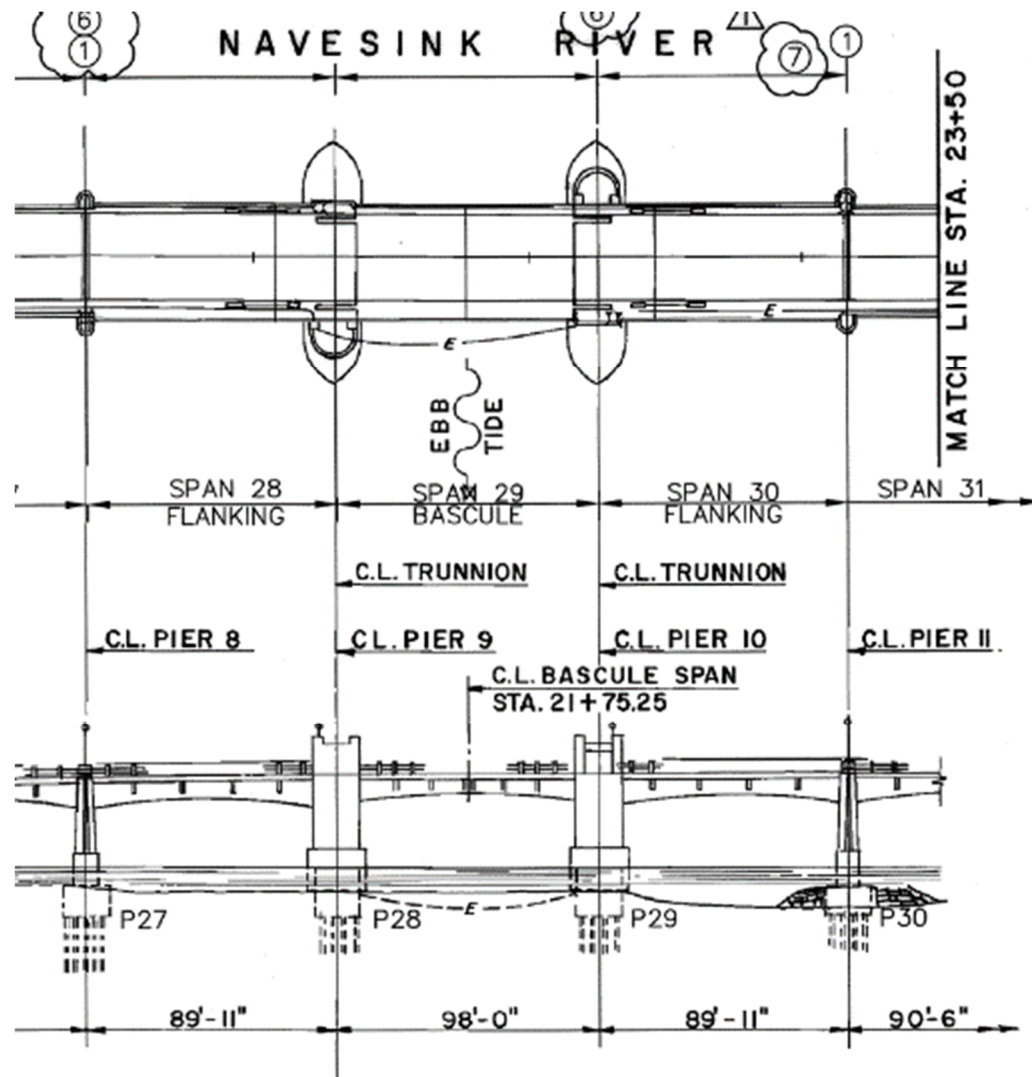
**Figure D.1 - General Plan View and Elevation of S-31 Main Spans (2014 Repair Plans)**

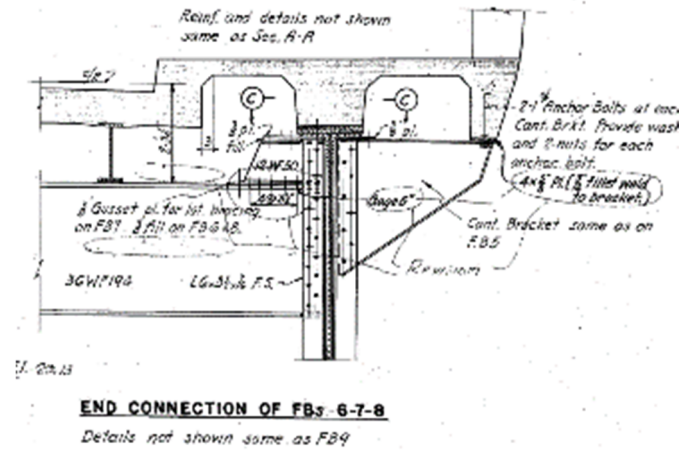
Figure D.4 - Detail of Interior Floor Beam at Flanking Span (1939 As-Built Plans)

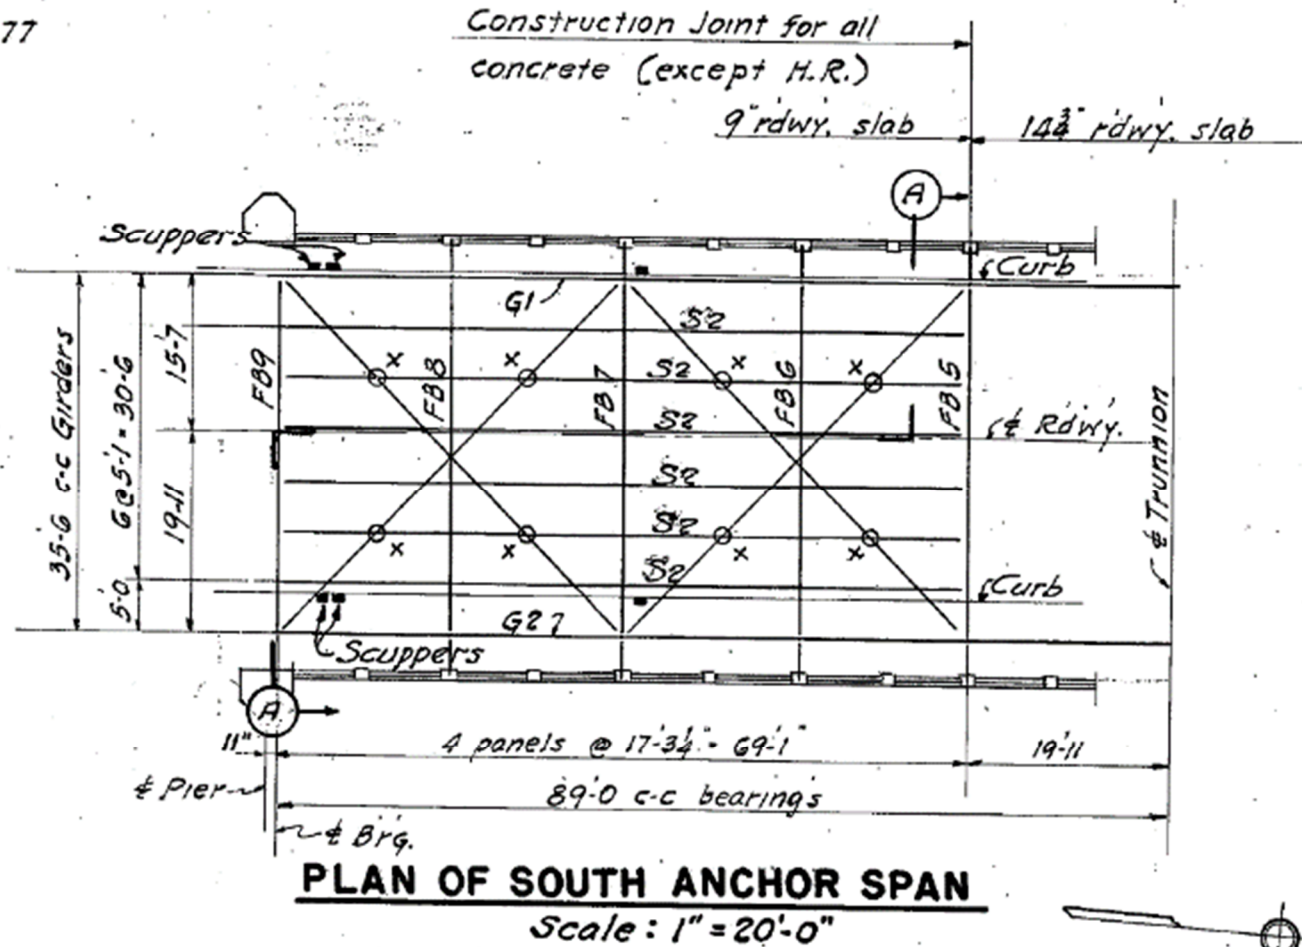
Figure D.7 - Framing Plan of Flanking Span (1939 As-Built Plans)
