# **COMPARISON OF LOAD RATING METHODS FOR COMPLEX BRIDGES**

JOSEPH R. STRAFACI, PE

A dissertation submitted to the

Rutgers, the State University of New Jersey

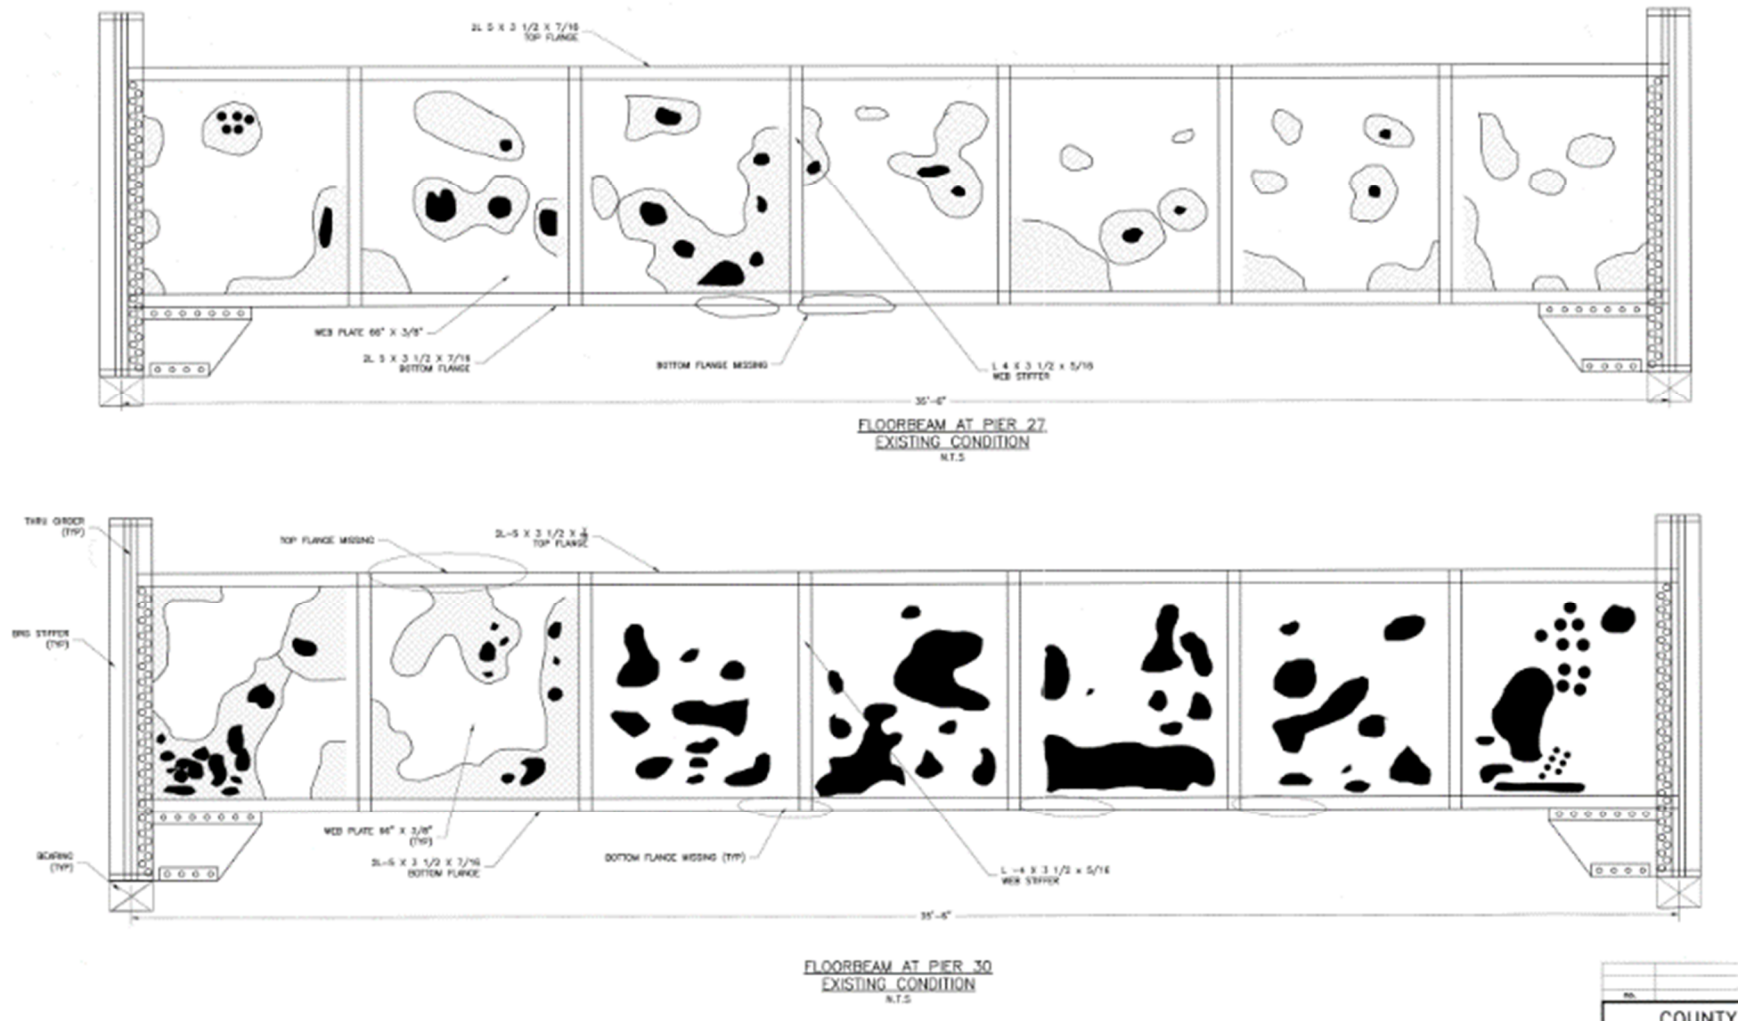
Figure D.8 - Floor Beam Deterioration, Elevation View (2014 Repair Plans)

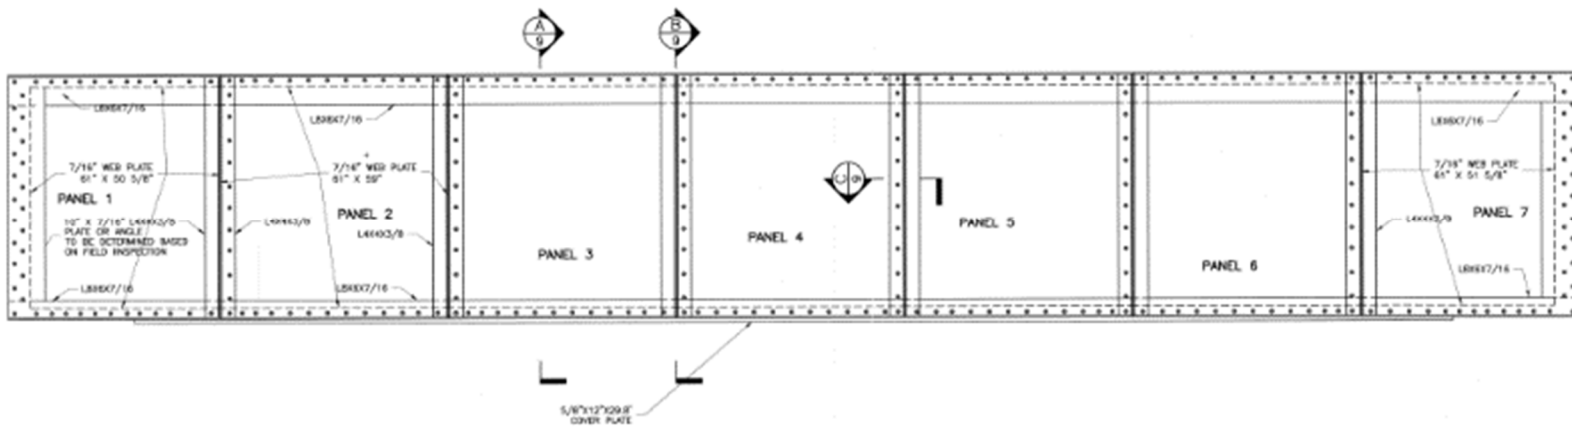
Figure D.9 - Floor Beam Repair, Elevation View (2014 Repair Plans)

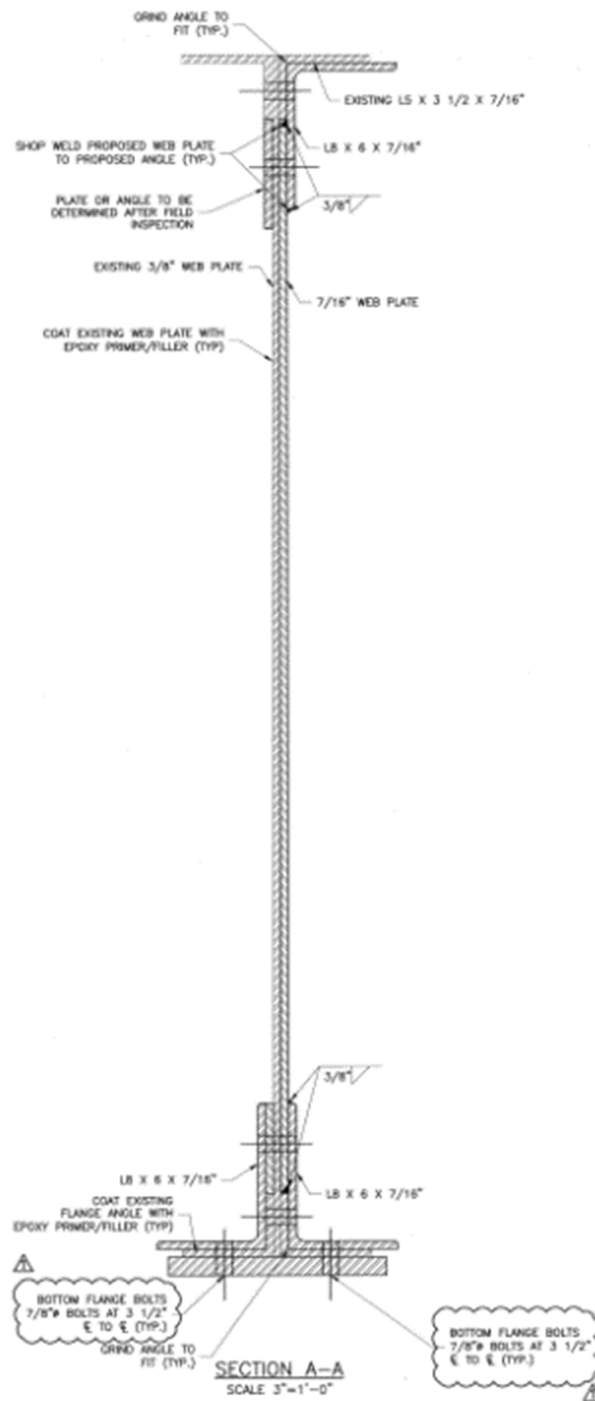
Figure D.10 - Floor Beam Repair, Detail (2014 Repair Plans)
