PAVEMENT CONDITION EVALUATION USING FIELD DATA OF SURFACE  
DEFLECTION AND TIRE-PAVEMENT NOISE

A thesis submitted to the

Rutgers, The State University of New Jersey

January 2021

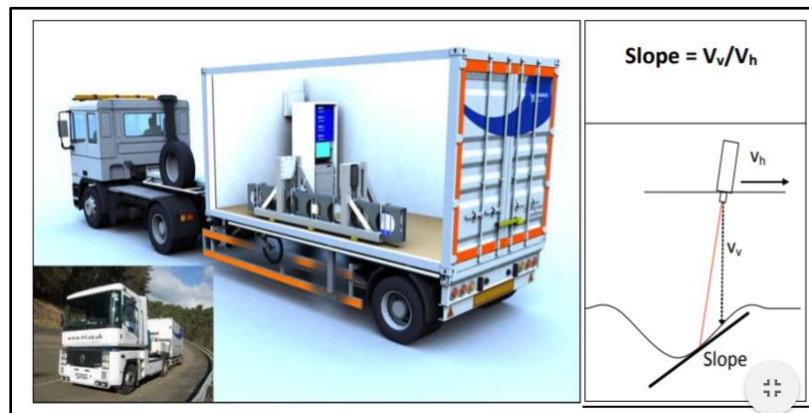
**Figure 1 TSD equipment and operating method (Katicha et al., 2014)**

The deflectometer records the reading while moving at a speed of 50 mph. The deflection velocity is produced (mm/s) while calibrating the measurements. It is then divided by the instantaneous survey speed (m/s) to give deflection slope (mm/m) as output (Ferne et al., 2009).

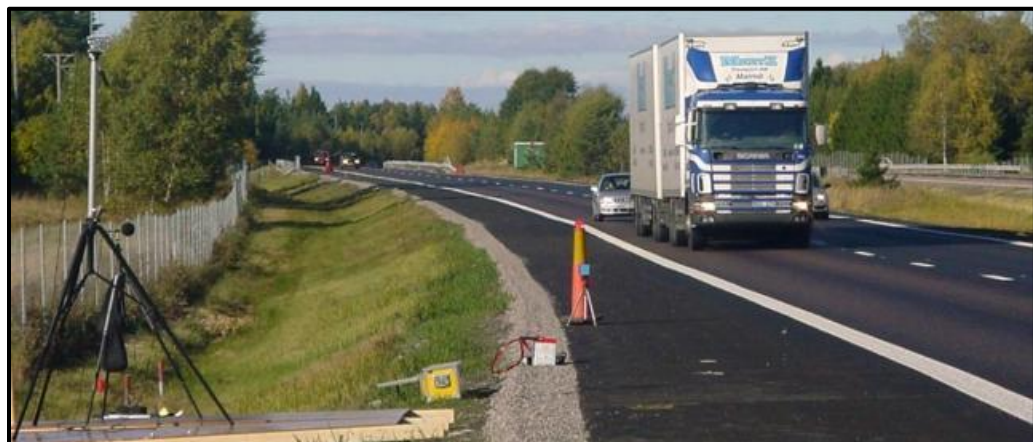
**Figure 3 Statistical Pass-by (SPB) testing method**

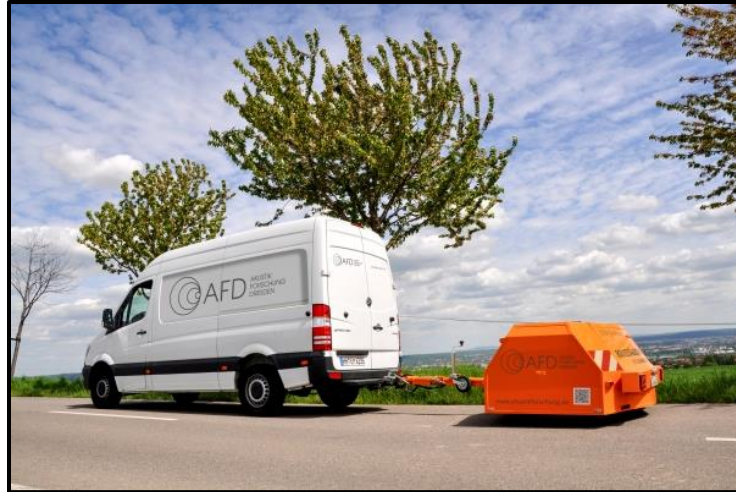
**Figure 4 Close Proximity testing equipment**

CPX method is quick and enough data can be collected as there are few restrictions. This method measures sound pressure by standard sound level meter and can monitor the pavement condition. Since the measurements are recorded on trailer with limited set of tires, the variation occurring due to different types of traffic is not accounted for.

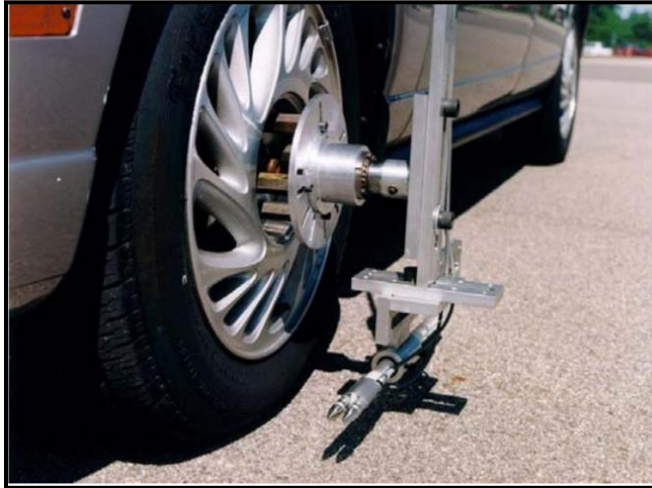
**Figure 5 Close Proximity Sound Intensity testing equipment**

The CPI measures sound intensity instead of sound pressure. Measuring sound intensity is smoother and more sophisticated than sound pressure as it determines basic parameter of sound. It is similar to CPX. The sound intensity is measured by using two microphones located near the rear tire of the trailer. The intensity probe consists of 2.5 mm diameter microphones and preamplifiers spaced 16 mm apart. It is protected with foam windshield. An acoustic chamber is not required due to the nature of the sound intensity. The measurements can be recorded at normal traffic speed. Therefore, sufficient data can be recorded and analyzed for studying the variations of different pavements.

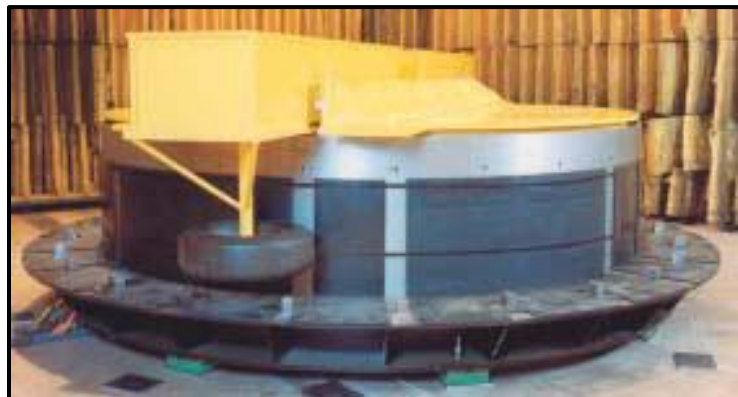
**Figure 8 Tire-Pavement Test Apparatus (TPTA) testing**

The Tire-Pavement Test Apparatus (TPTA) is a laboratory method to test tire-pavement noise on pavement drums. The apparatus contains a stationary pavement drum, and a pair of rolling tires is used on it. It has many advantages over other laboratory techniques. The specimen can produce accurate measurements like the field measurement techniques with a sample size of 4 m in diameter. The rolling tires can speed up to 30 mph and a load of 1000 lbs. can be mounted on.

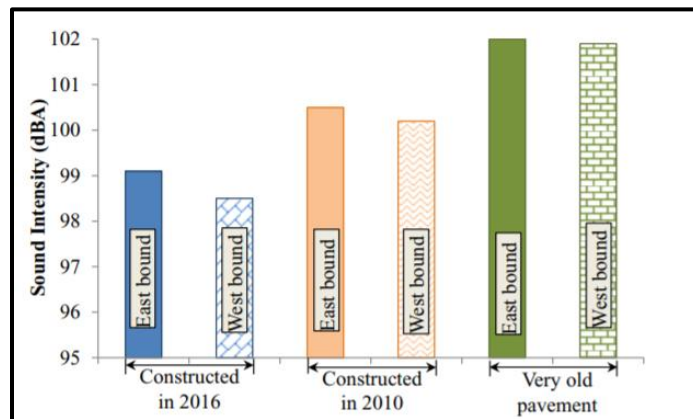
**Figure 9 Effects of aging of OGFC pavement on tire-pavement noise (Sirin et al, 2018)**

A case study in Qatar (Sirin et al., 2018) examined changes in the noise of dense graded asphalt (DGA) pavement over time using OBSI method. From the Figure 9, it can be concluded that the DGA pavement generates louder noise with age with an approximate increase of 3.5dBA. Colorado DOT (Hanson and Waller, 2006) conducted three-year study on tire/pavement noise on 14 Hot Mix Asphalt (HMA) and 15 Portland Cement Concrete (PCC). It was concluded that OGFC is the quietest pavement with an average increase of 1.9 dBA. PCC was observed to be the loudest since the beginning of its service life, at noise level of 97.5 dBA and the level increased by 1 dBA every year. A 10-year performance study of tire-pavement noise on Open-Graded Asphalt Concrete (OGAC) concluded that the noise increased by 0.1 dBA each year and the OGAC pavement got louder by 1.5 dBA over 10 years (Illingworth and Rodkin, 2011).

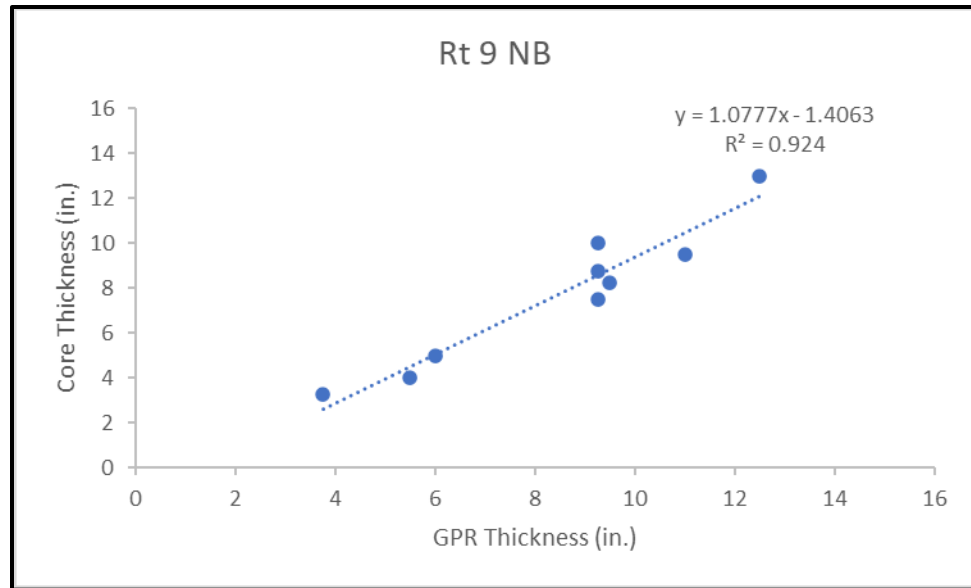
**Figure 11 Scatter plot between Core thickness and GPR thickness for Rt 9 NB**

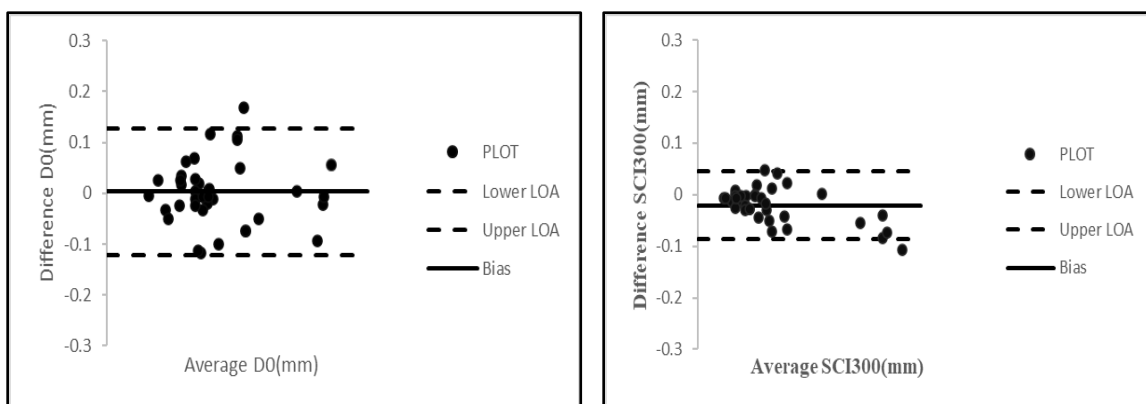
**Figure 16 LOA between FWD and TSD for D0 and SCI300 for Route 40 EB**

The 95% (Confidence Interval (C.I.) Limit of Agreement lies between the upper and the lower lines as shown in Figure 14, Figure 15, and Figure 16. This shows that the data between these two lines agree with each other 95% of the time with measurement error. The distance between the bias and the points show the measurement error. The farther the point from the bias line, the greater will be the measurement error. The points that lie outside of the 95% LOA can be interpreted as true change since it is greater than the measurement error.

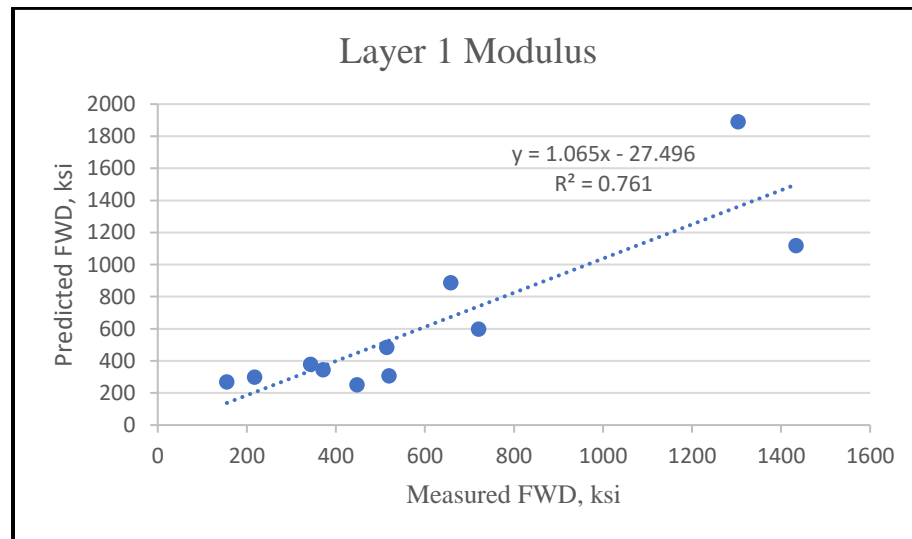
**Figure 18 Layer 1 plot between Measured and Predicted FWD modulus**

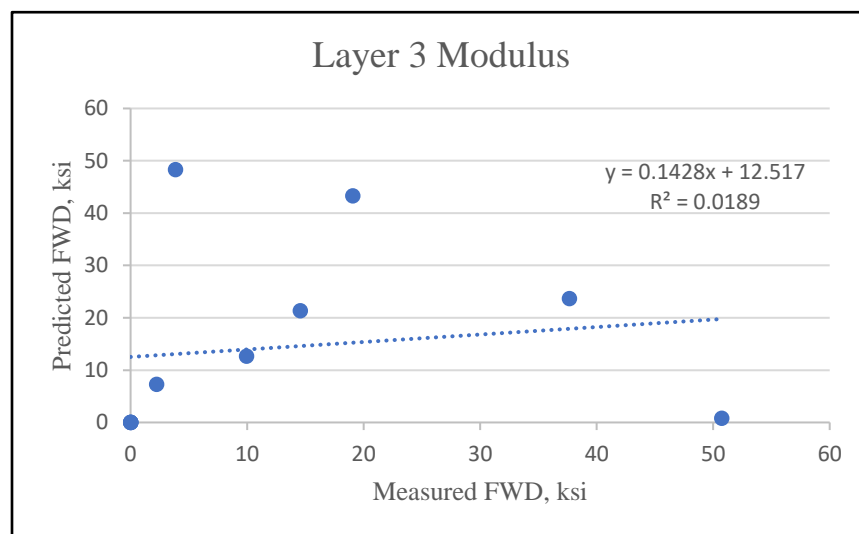
**Figure 20 Layer 3 plot between Measured and Predicted FWD modulus**

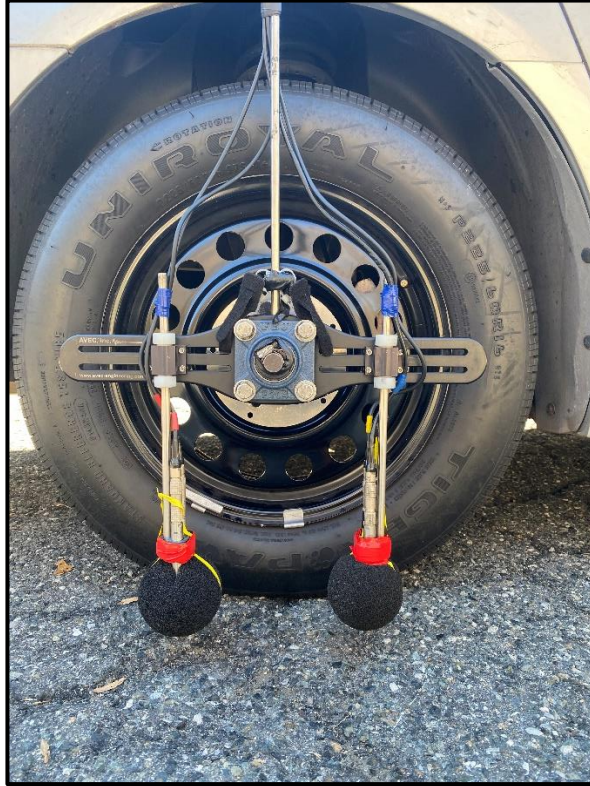
**Figure 22 On-Board Sound Intensity (OBSI) Equipment**

The On-Board Sound Intensity (OBSI) method was adopted to measure the tire – pavement noise for the study of effects of aging on tire – pavement noise. As discussed earlier, OBSI measures the sound intensity at the source (tire-pavement interface) with the help of microphones. The sound intensity measurement is made over 440 ft (134.1 m) test section as per AASHTO TP 360-16 (6) which is approximately equivalent to 5 seconds measurement at speed of 60 mph (96 km/h). The equipment is mounted on Standard Reference Test Tire (SRTT) as shown in Figure 22. The right lane of each section was considered for testing to provide consistency when comparing with other sections. The Brüel & Kjaer Pulse system was utilized to record and process the data during testing. As per AASHTO TP 76-12 (8), minimum of three test runs are required for each point (location) and the difference between the measurements should not differ by more than 0.5 dBA.

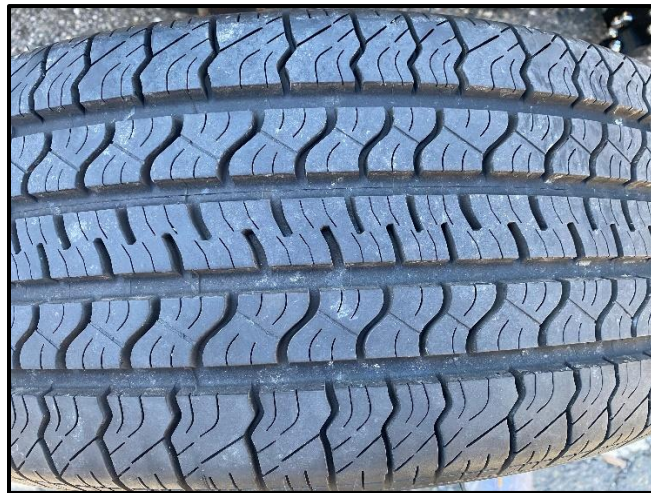
**Figure 23 Standard Reference Test Tire (SRTT) Tread**

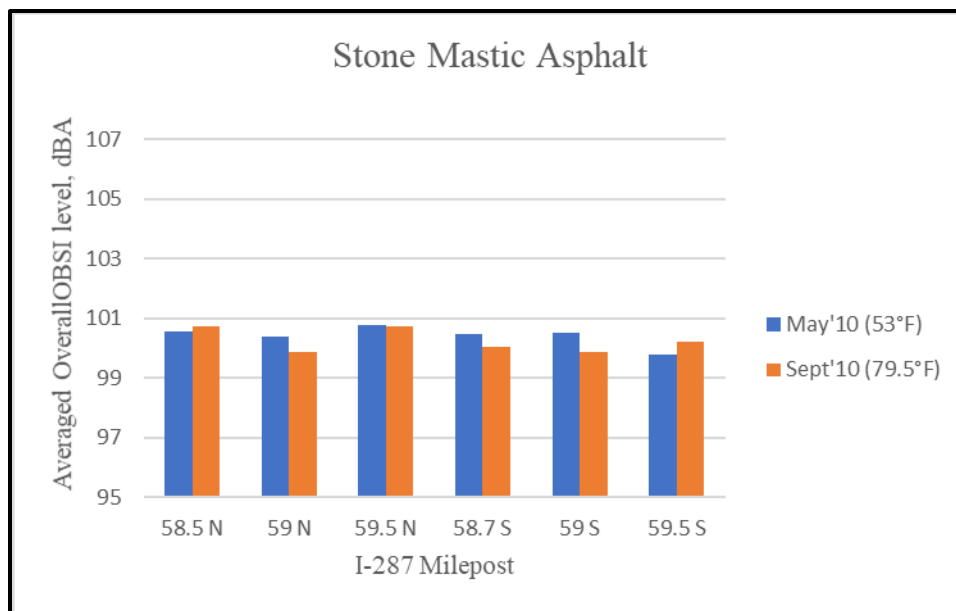
**Figure 30 Temperature effect for I-287 in 2010**

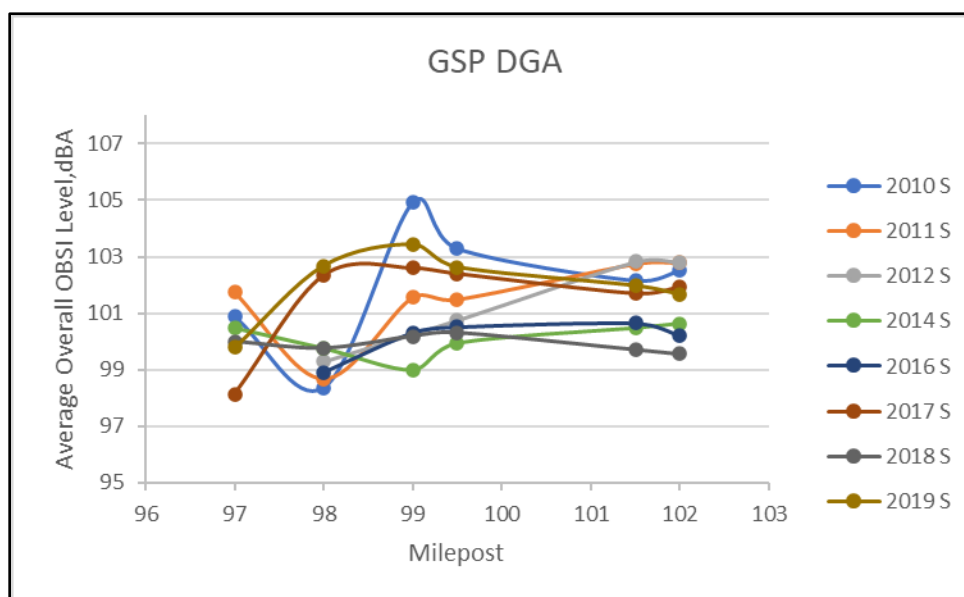
**Figure 38 GSP (South) MM 97-102 noise levels from 2010-2019**

This GSP south section as shown in Figure 38 does not show a similar trend like the north section. In the year 2010, the noise levels recorded were highest for some mileposts. However, there was significant drop of noise from 2017 to 2018 (of about 2 dBA) which is similar to the north section. This confirms the construction of new pavement layer between the testing period. The overall increase of noise levels was observed for both the sections of GSP DGA pavement.

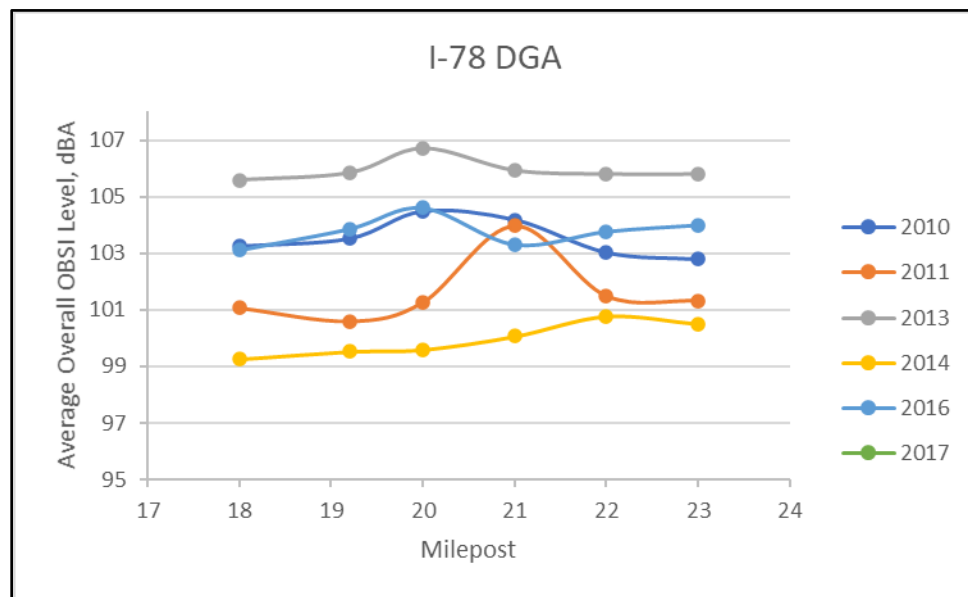
**Figure 39 I-78 (East) MM 18-23 noise levels from 2010-2017**

The Figure 39 shows the noise levels for I-78 East section from milepost 18 to 23. The noise levels for this DGA section is observed to decrease and increase over the years. It is similar to the GSP sections presented above. For the year 2016 and 2017, the noise levels decrease with a drop of approx. 2 dBA. The pavement could have undergone treatments for maintenance. The overall pavement noise from 2010 to 2017 decreased from an average of 104 dBA to an average of 100 dBA respectively.
