EVOLUTION OF THE MORPHOLOGY SURROUNDING DETERIORATING SHORE-PARALLEL PROTECTION STRUCTURES ON SANDY ESTUARINE BEACHES

KATHERINE HELEN KOROTKY

Rutgers, The State University of New Jersey

JANUARY, 2019

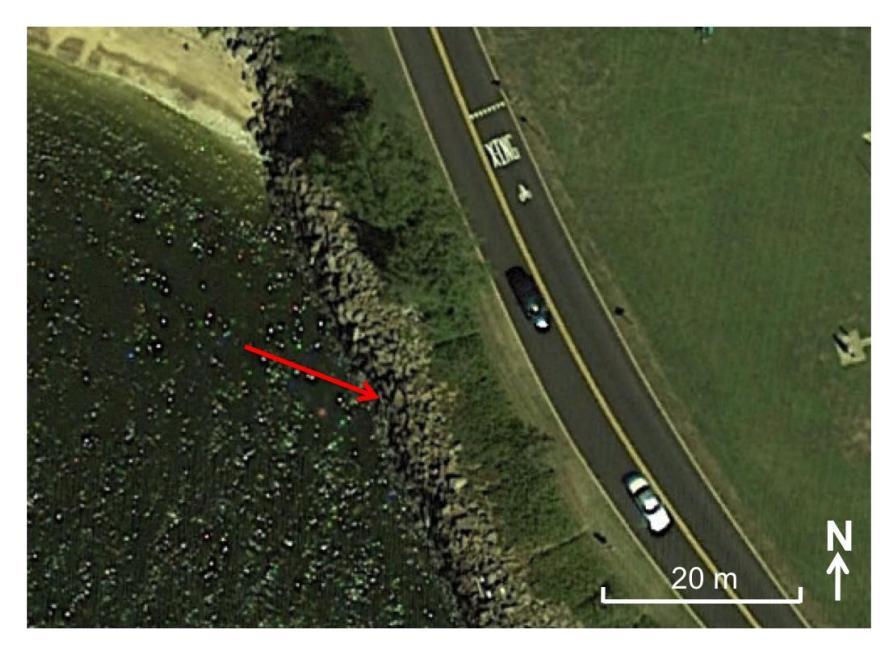
Figure 1. Satellite imagery from Google Earth depicting an example of Stage 1 of the initially proposed shore protection structure life stage model (Sandy Hook, NJ). The structure is intact and there is no evidence of erosion or the regular presence of water landward of the structure.

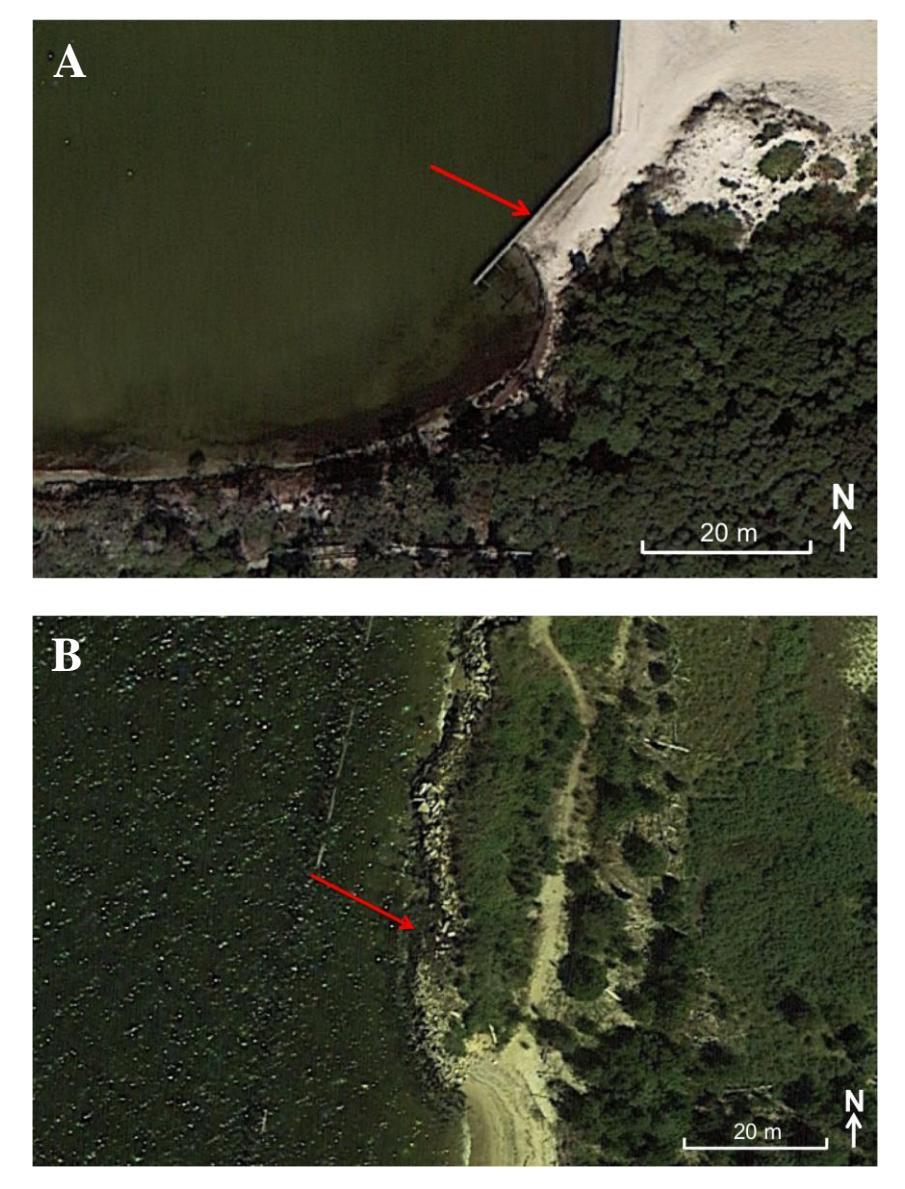
Figure 2. Satellite imagery from Google Earth depicting two examples of Stage 2 of the initially proposed shore protection structure life stage model (A: Fire Island, NY; B: Sandy Hook, NJ). Overtopping or breaching of the structures is occurring.

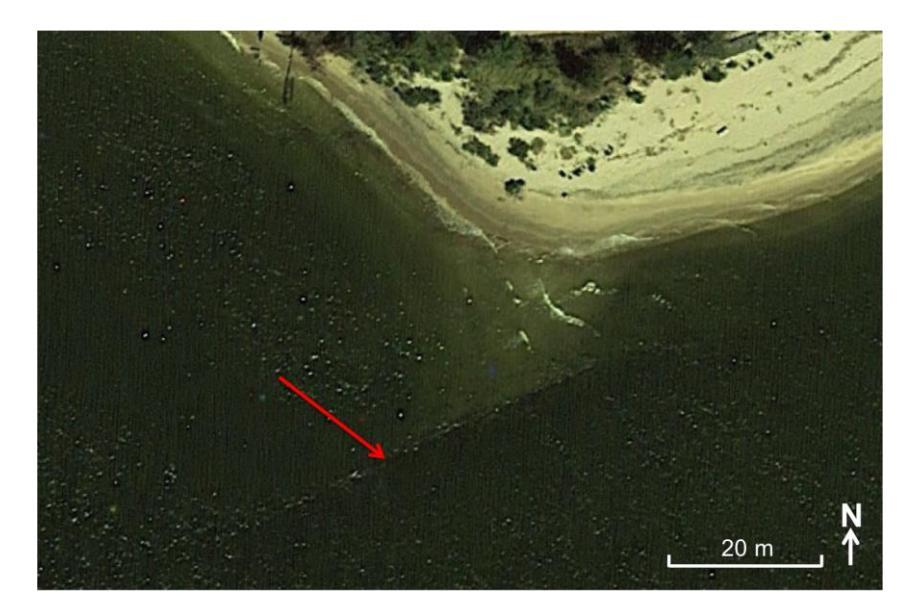
Figure 4. Satellite imagery from Google Earth depicting an example of Stage 4 of the initially proposed shore protection structure life stage model (Sandy Hook, NJ). The structure is in poor condition and the low water line is landward of the structure.

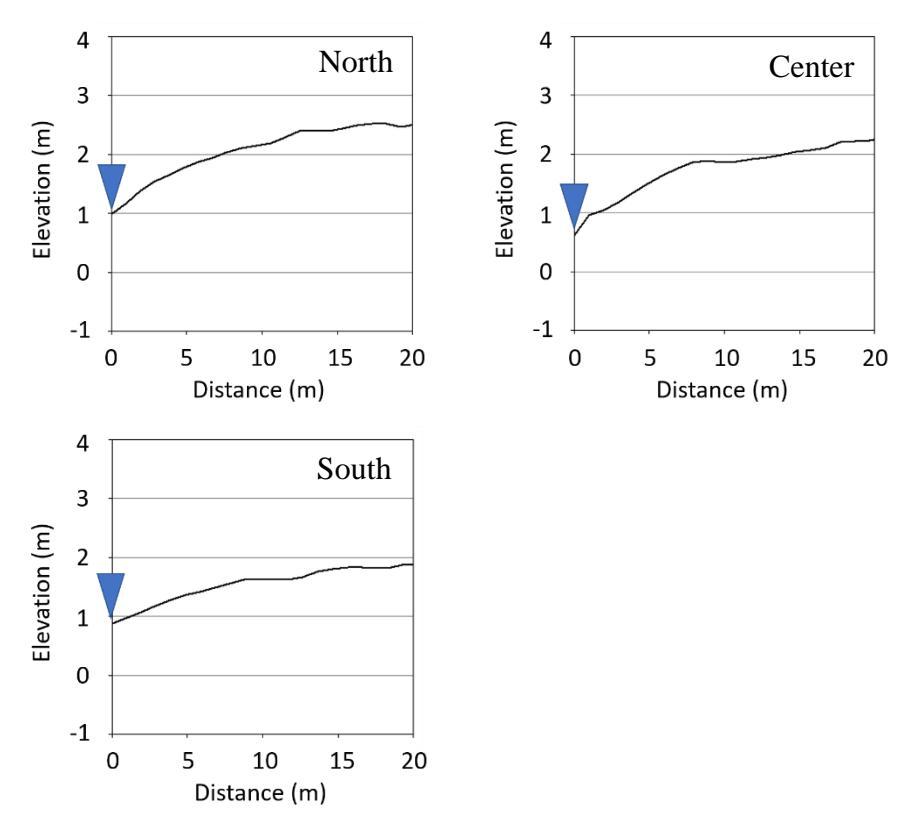
The elevation of the bulkhead is approximately 1.9 m; the elevation of the ground surface directly landward, between the bulkhead and dirt road, is approximately 2.0 - 3.0 m. Elevation increases gradually with distance landward from the bulkhead, across the dirt road, indicating a lack of erosion of the emplaced backfill and continued structural integrity of the bulkhead (Figure 19).

Figure 19. North, center, and south shore-normal beach profiles at the Great Kills site. Black lines represent the National Elevation Dataset surface. Blue arrows point to the location and elevation of the bulkhead.

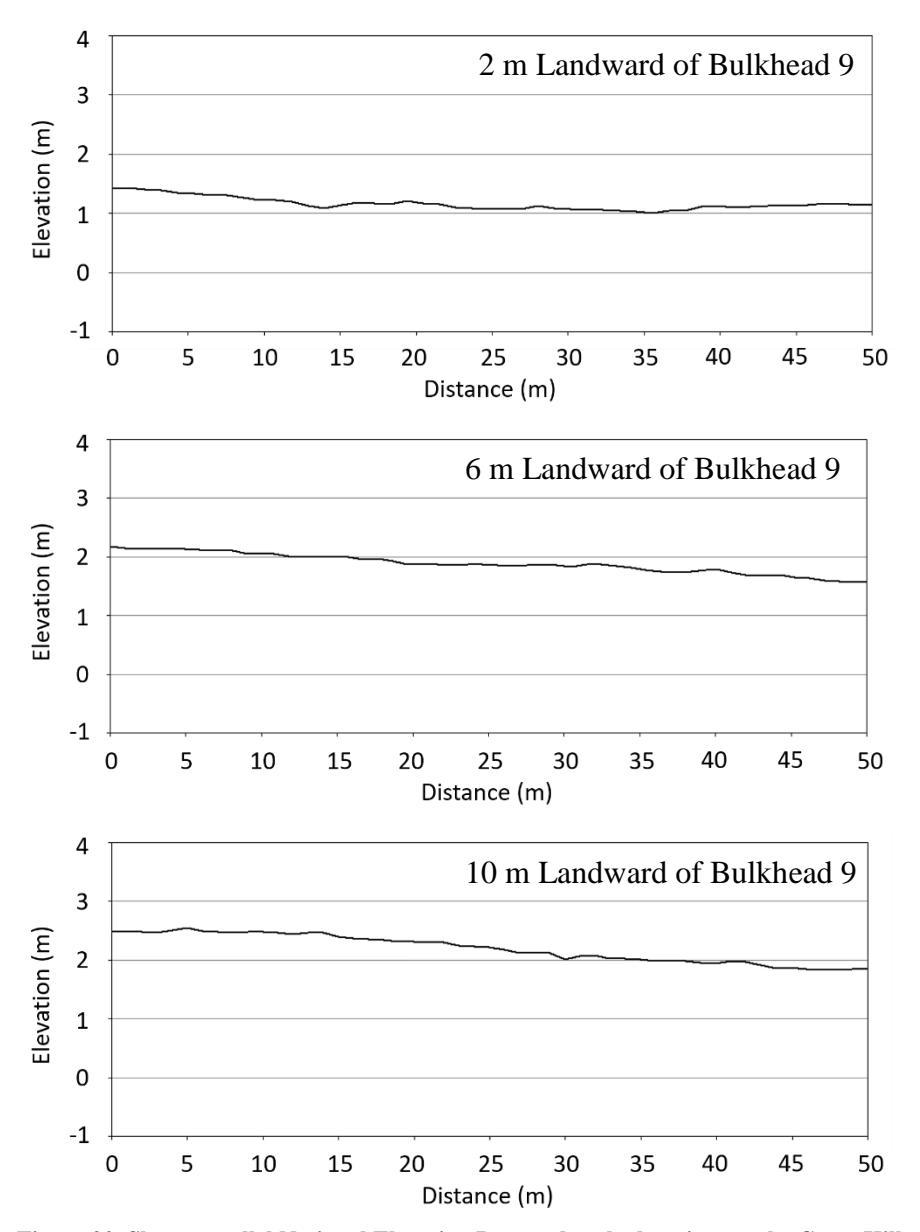
Shore-parallel profiles were taken at distances of approximately 2 m, 6 m, and 10 m landward from the bulkhead. Elevation decreases slightly (~0.5 m over 50 m) from the western to eastern end of the site (Figure 20). There are no sudden changes in slope along the profiles that would indicate areas of erosion.

Figure 20. Shore-parallel National Elevation Dataset beach elevations at the Great Kills site. Elevations were taken 2 m landward of the structure, 6 m landward of the structure, and 10 m landward of the structure.

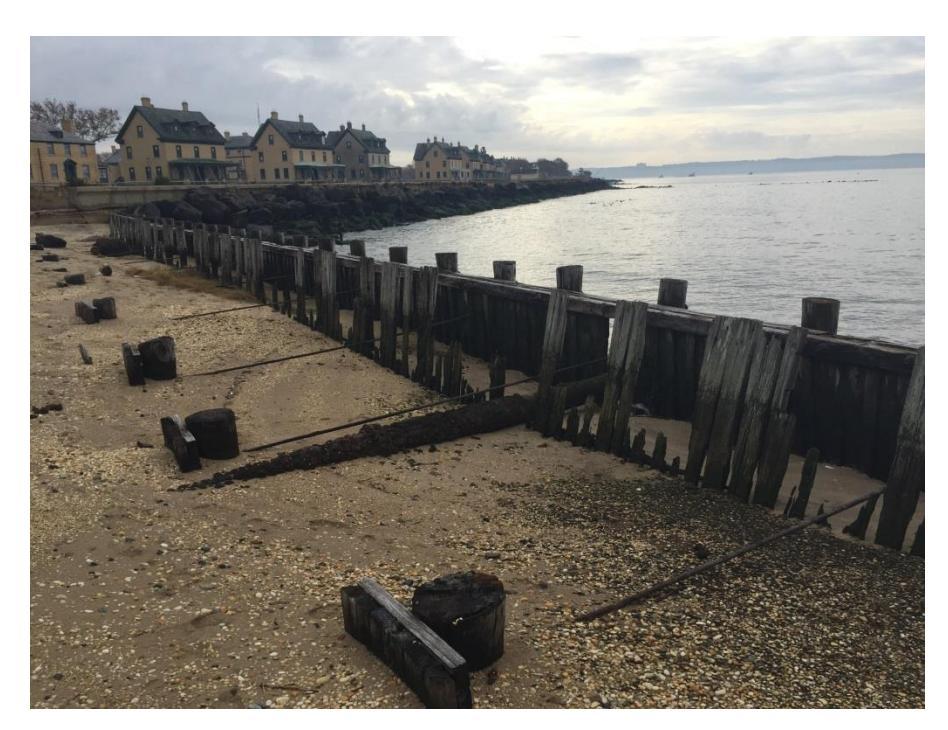
The southernmost 120 m of the bulkheads are more intact than portions to the north. Most sheet piles along Bulkhead 1 are present, with some extending to their original height while others do not extend far above the ground surface. All sheet piles show visible damage or deterioration. Upper wales and tie rods are not present. Deadmen are not visible but may remain buried below the beach surface (Figure 22).

Figure 22. Structures at Chapel South site, including Bulkhead 1 (landward) and Bulkhead 2 (seaward). Photo was taken looking to the southeast. Officer's Row is in the distance.

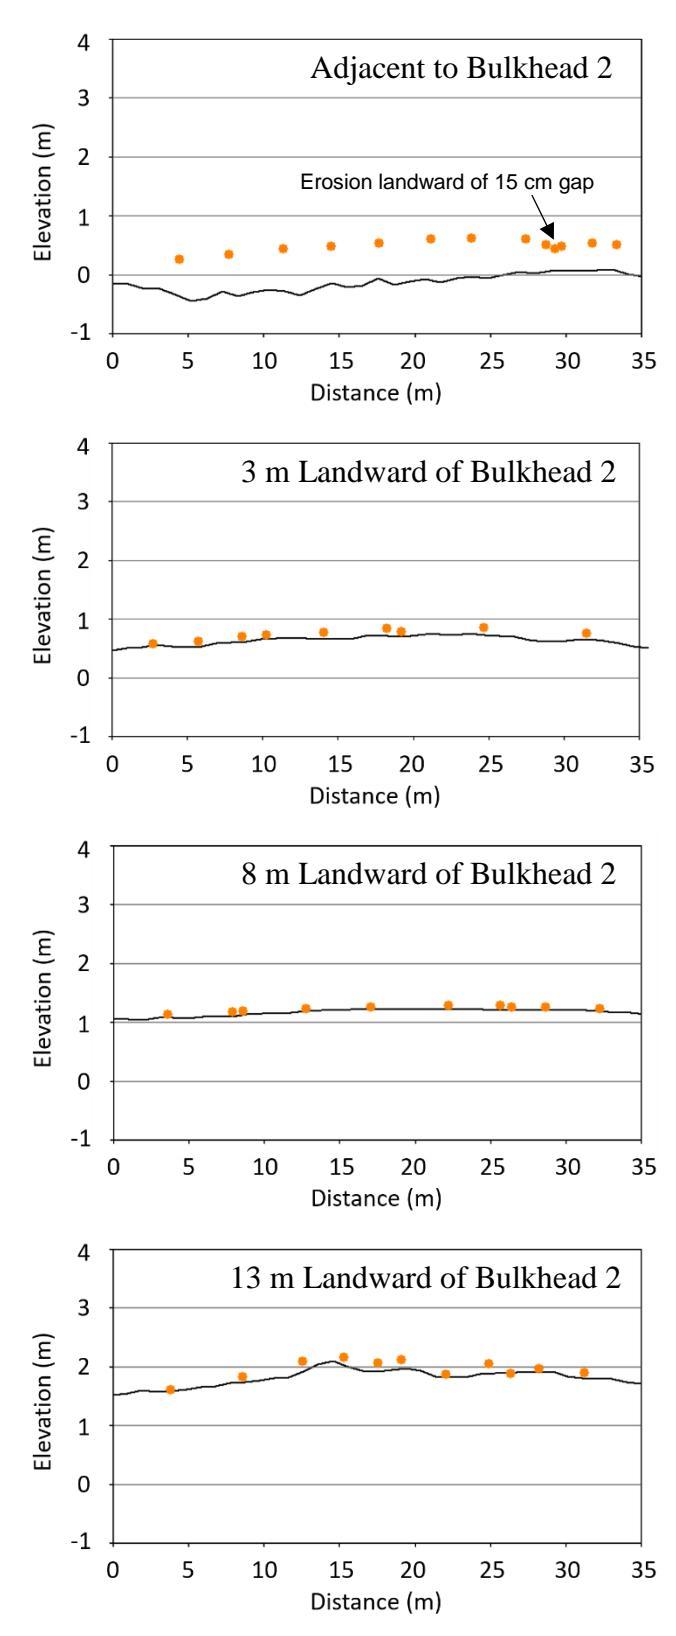
The elevations on the beach landward of Bulkhead 2 were generally lower at the northern and southern ends and highest towards the center. This is also true for the profile along the dune ridge (Figure 26). This topography implies that flanking of Bulkhead 2 may be taking place, which is supported by aerial imagery (Figure 29).

Figure 26. Shore-parallel beach elevations at the Chapel South site. Elevations were taken on the ground surface on the landward side of Bulkhead 2, 3 m landward of the structure, 8 m landward of the structure, and 13 m landward of the structure. GPS data points are depicted as orange dots. National Elevation Dataset surface is depicted as a black line.

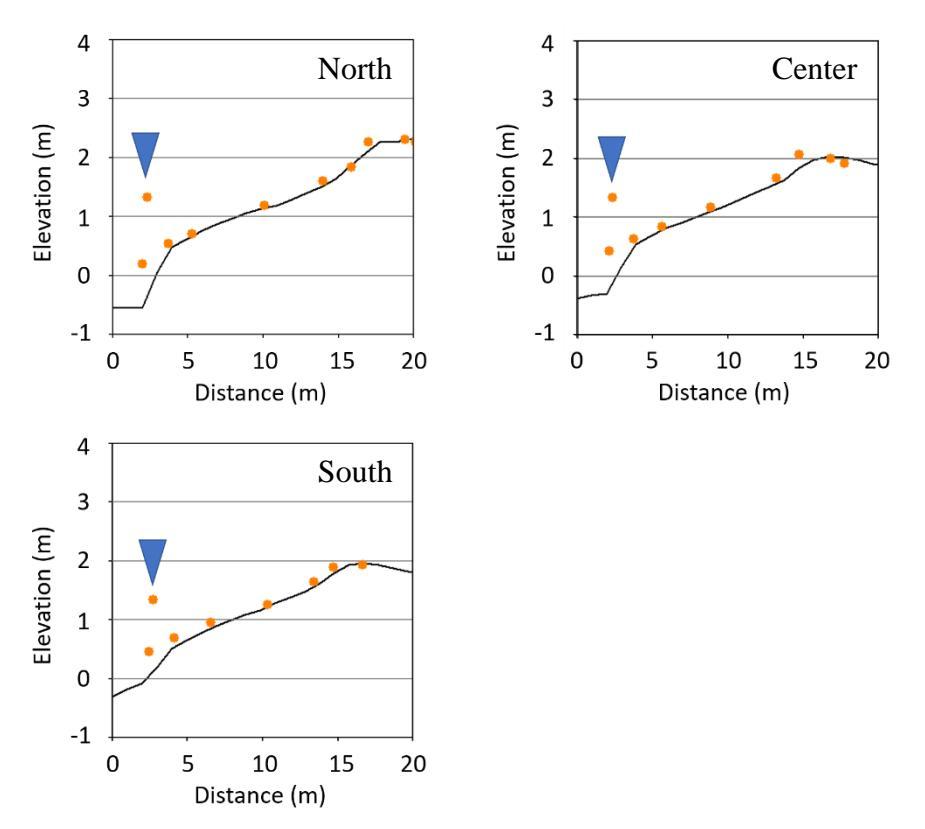
The horizontal distance between the bulkhead and the dune ridge varies between 12 m and 15 m (Figure 27). The greatest distance occurs at the northern end of the site where vegetation coverage of the upland area is less dense, implying that the upland has experienced more erosion there. Smaller patches of grassy vegetation are present on the beach face adjacent to the bulkhead landward of sections without gaps in the structure where there is more protection from water movement. The beach has a slight concave shape, with an average slope between the structure and the dune toe of approximately 0.1.

Figure 27. North, center, and south shore-normal beach profiles at the Chapel South site. GPS data points are depicted as orange dots. National Elevation Dataset surface is depicted as a black line. Blue arrows indicate the position and elevation of the top of Bulkhead 2.

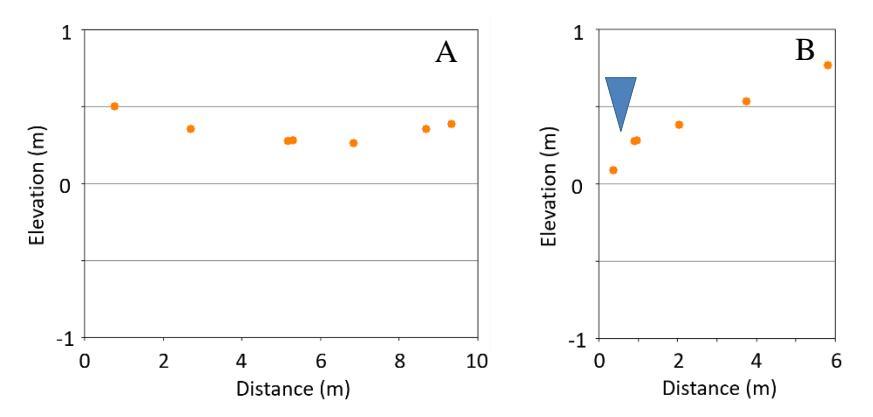
Topographic data were collected surrounding the reentrant landward of the 15 cm gap using the RTK GPS unit. NED data were not used because of the small size of the feature. Elevations were measured down the center of the reentrant normal to the bulkhead and alongshore directly landward of the bulkhead. The dimensions of the reentrant were approximately 8.5 m (alongshore) by 6 m (cross-shore) by 0.2 m deep (Figure 28). The ground surface seaward of the bulkhead in the vicinity of the gap (Figure 28) was also approximately 0.2 m lower in elevation than similar points in the Central and South shore-normal profiles (Figure 27), indicating erosion both seaward and landward of the gap.

Figure 28. Shore-parallel (A) and shore-normal (B) beach profiles at a 15 cm wide gap in Bulkhead 2 at the Chapel South site, Sandy Hook Unit, Gateway National Recreation Area. The blue arrow indicates the position of Bulkhead 2.

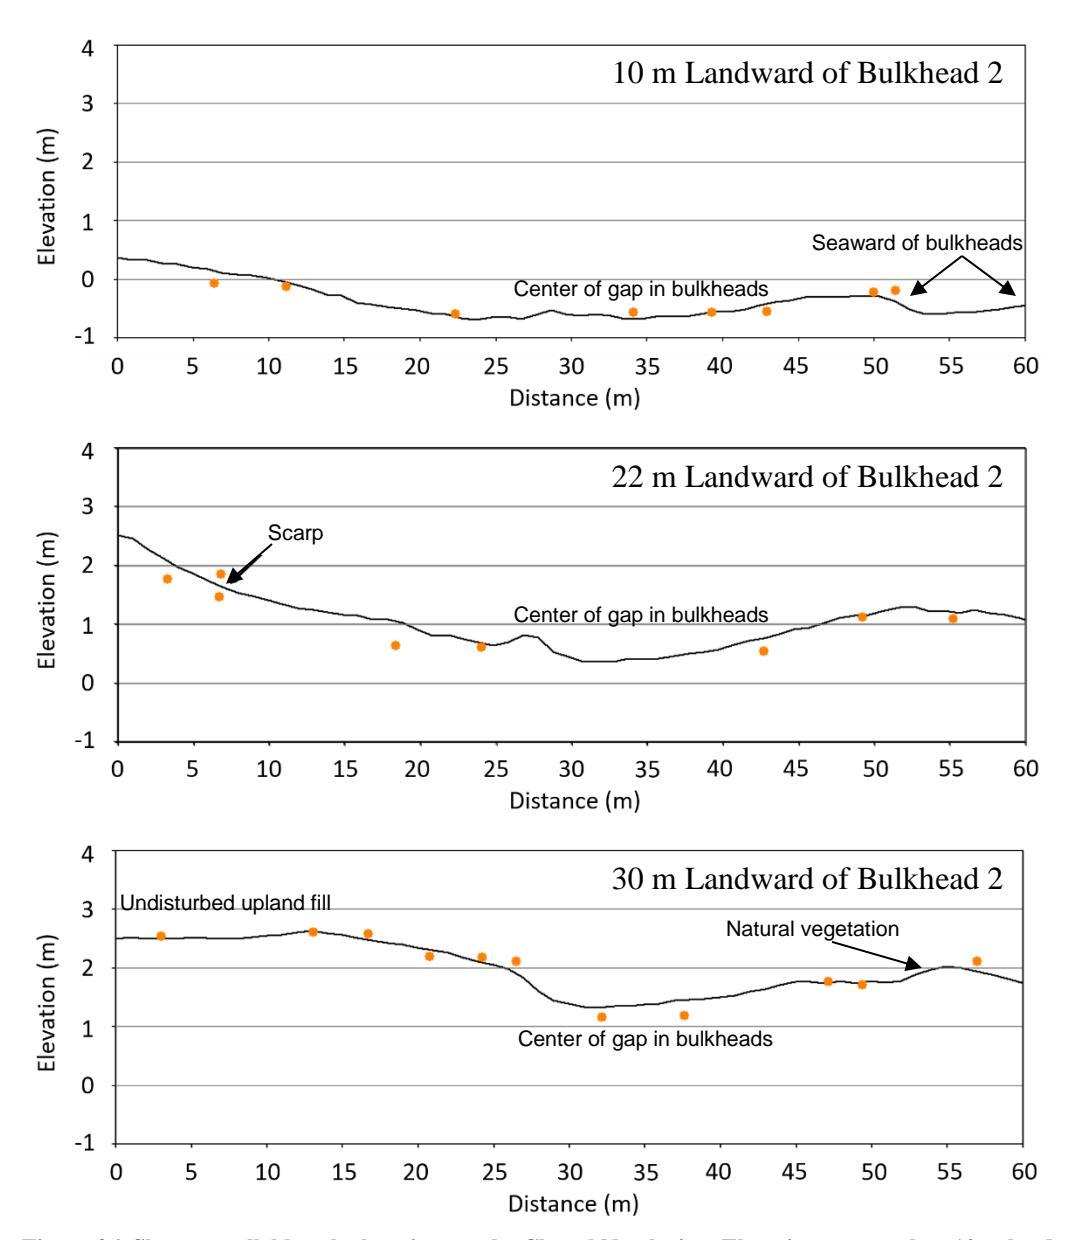
The greatest erosion is found at the center of the gap in the bulkhead, in both the alongshore and shore-normal directions, as indicated by the lower elevations in Figure 36 and Figure 37. The greatest elevations at this site (approximately 2.1 - 2.8 m) represent undisturbed upland fill (Figure 36) and were higher than the dune ridge at the nearby Chapel South site (approximately 2.0 - 2.3 m). This implies that the ground area surrounding the chapel was filled to an elevation higher than the area of natural vegetation at the Chapel South site. Backfilled sediment is now being eroded, confirming this portion of the structure is at a more advanced stage of deterioration. The widest portion of the reentrant from the bulkhead to the eroding upland is approximately 35 m (Figure 37).

Figure 36. Shore-parallel beach elevations at the Chapel North site. Elevations were taken 10 m landward of the structure, 22 m landward of the structure, and 30 m landward of the structure. GPS data points are depicted as orange dots. National Elevation Dataset surface is depicted as a black line. The first profile intersects the northwest-southeast segment of the bulkheads.

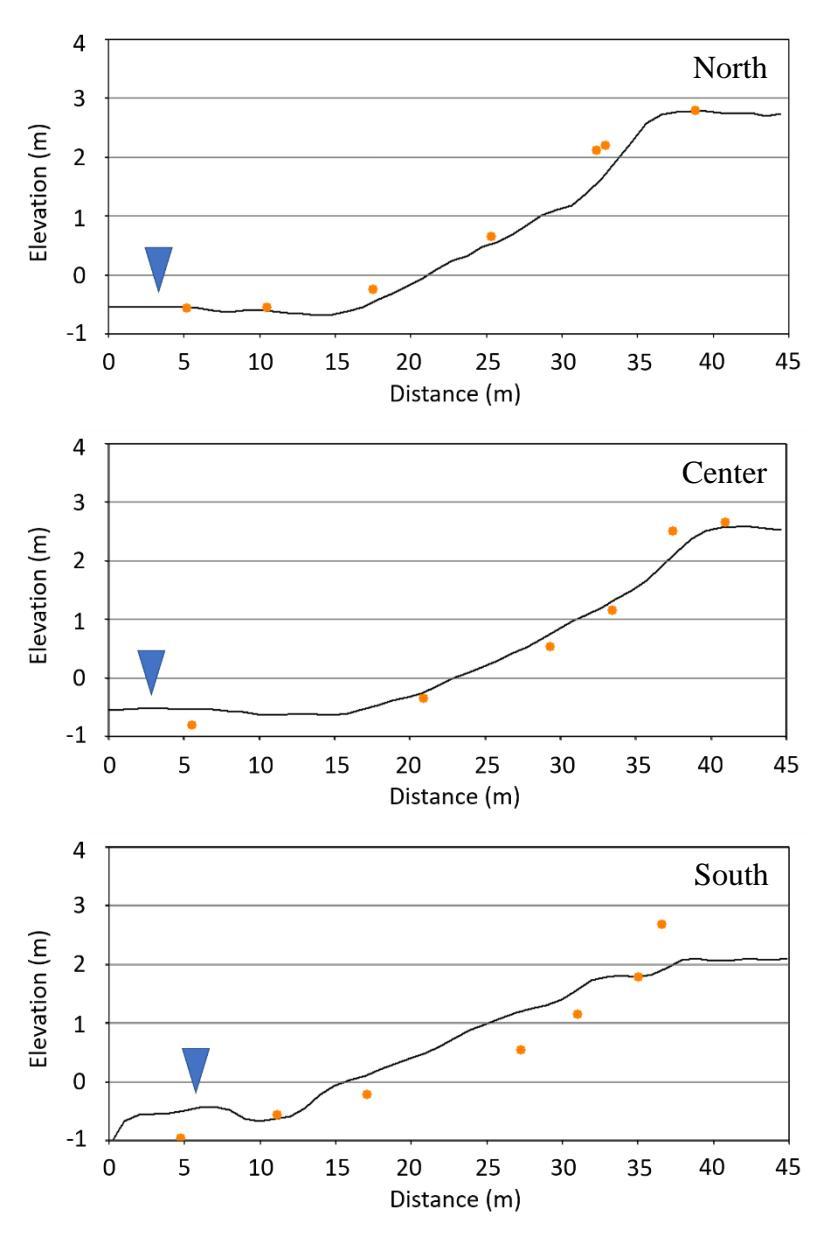
Figure 37. North, center, and south shore-normal beach profiles at the Chapel North site. GPS data points are depicted as orange dots. National Elevation Dataset surface is depicted as a black line. Blue arrows represent the location that is in line with the intact portions of the bulkhead.

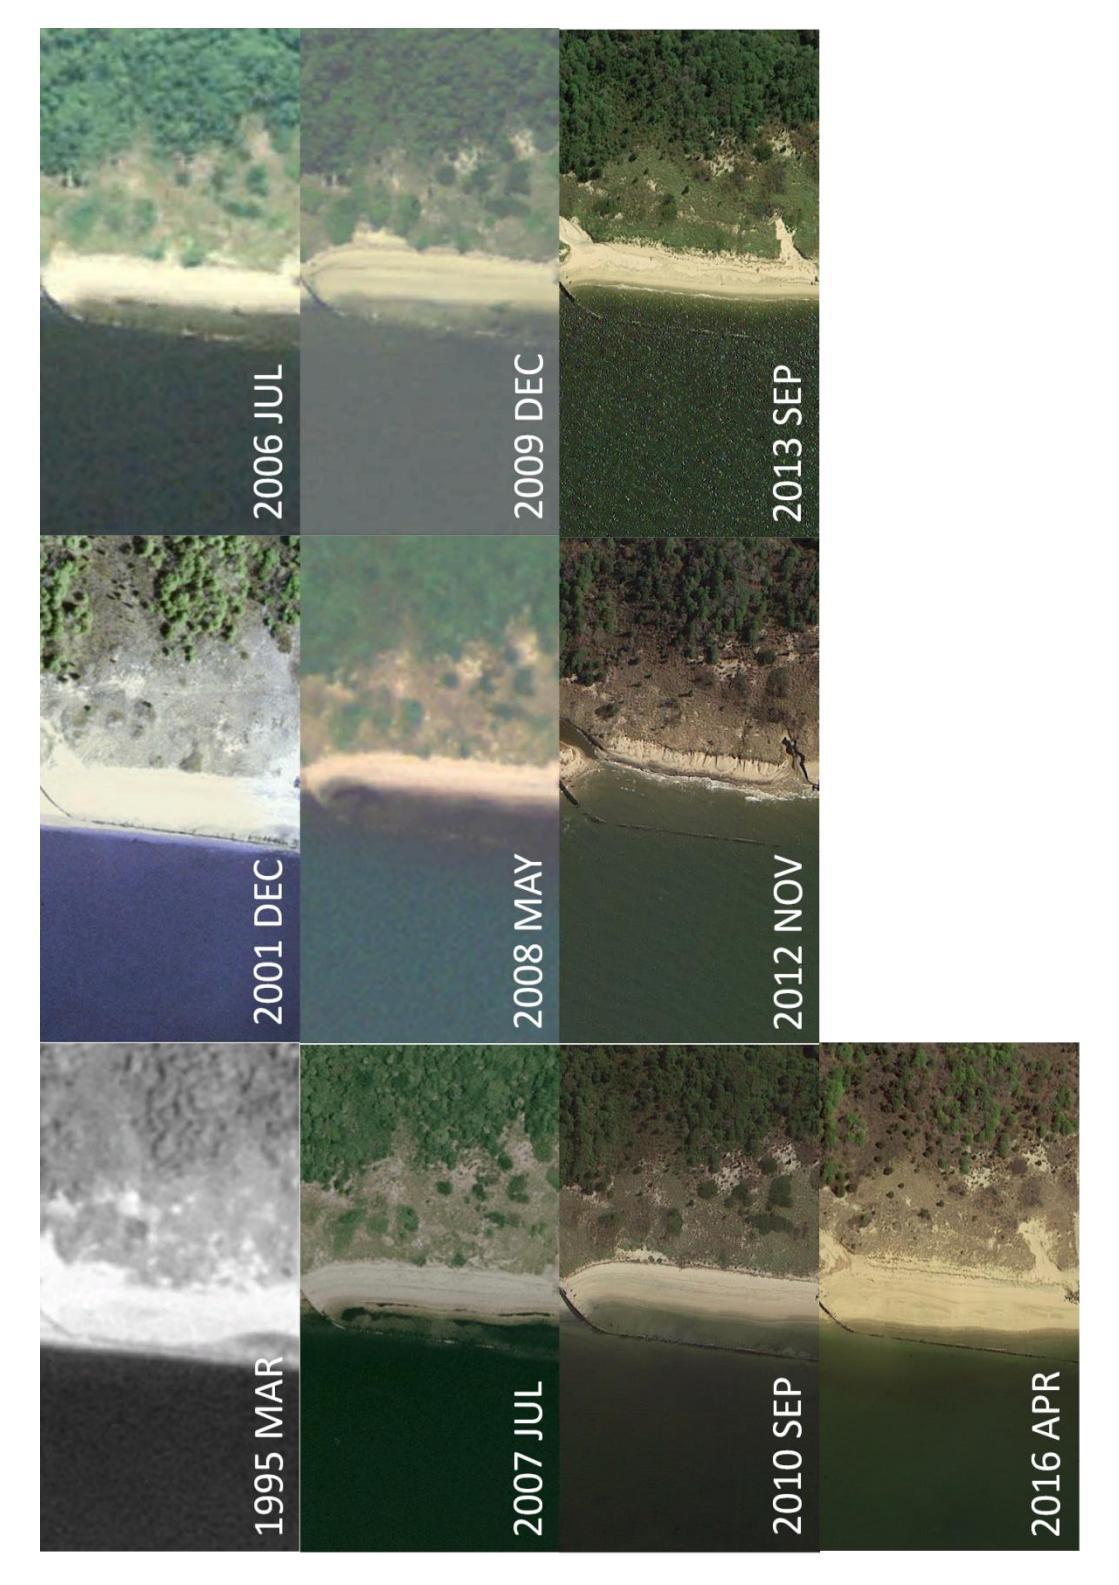
This site (Figure 8) was chosen because it contains a wood bulkhead, Bulkhead 5, which is easily identifiable via site visits and satellite imagery but retains little structural integrity (Figure 38 and Figure 39). Bulkhead 5 is 1400 m long and was constructed in 1961 (Dallas et al. 2013). A winter storm in 1974 breached the bulkhead and removed several pilings from the structure. Further storm damage took place in the 1970s, damaging the bulkhead and eroding the shoreline (Layton and Foulds 2010). There has been open water landward of Bulkhead 5 for at least part of tidal cycle since at least 1995, with noticeable erosion following Hurricane Sandy in 2012 (Figure 40).

Figure 40. A linear active beach has been present landward of the Battery Kingman North site for at least the last 21 years. Imagery obtained from Google Earth.

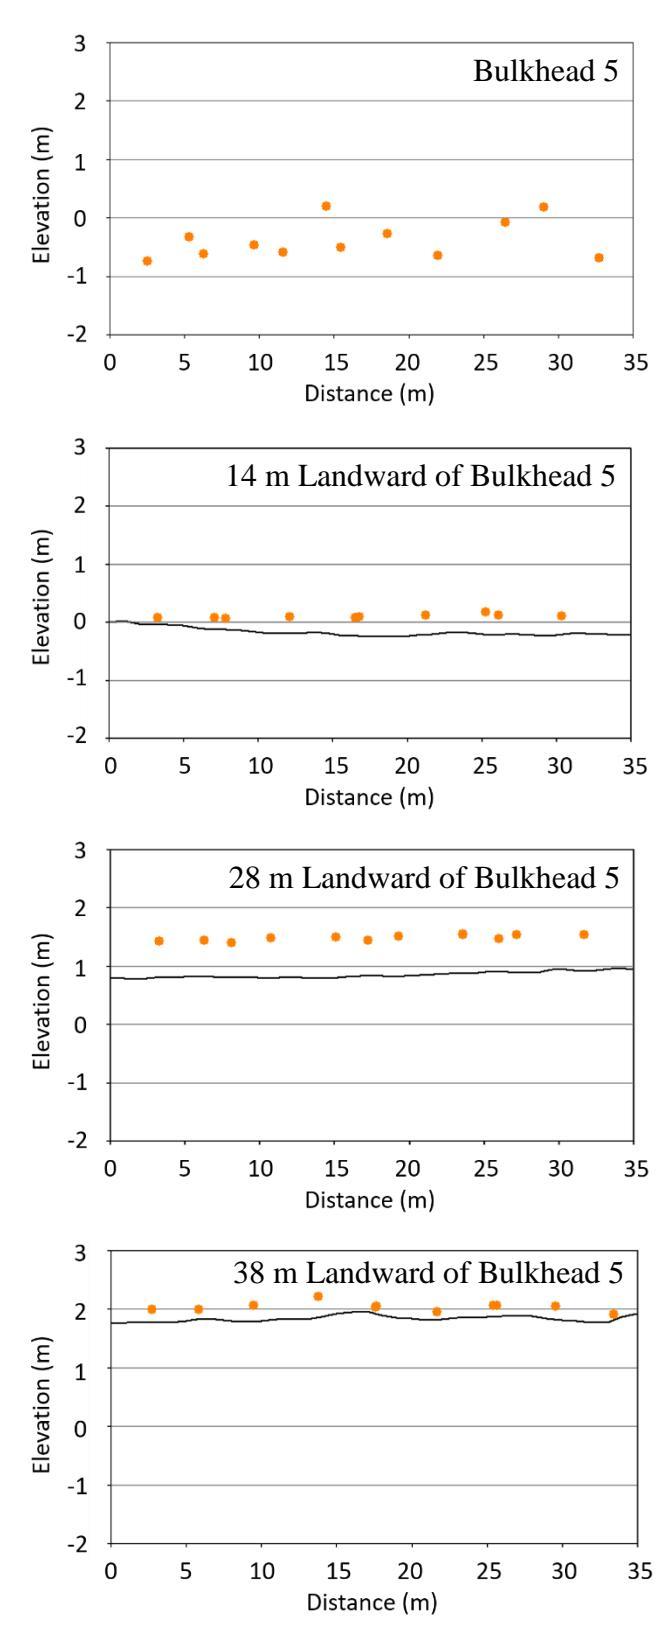
Figure 41. Shore-parallel beach elevations at the Battery Kingman North site. Elevations were taken on top of the bulkhead, 14 m landward of the bulkhead, 28 m landward of the bulkhead at the berm crest, and 38 m landward of the structure at the dune crest. GPS data points are depicted as orange dots. National Elevation Dataset surface is depicted as a black line.

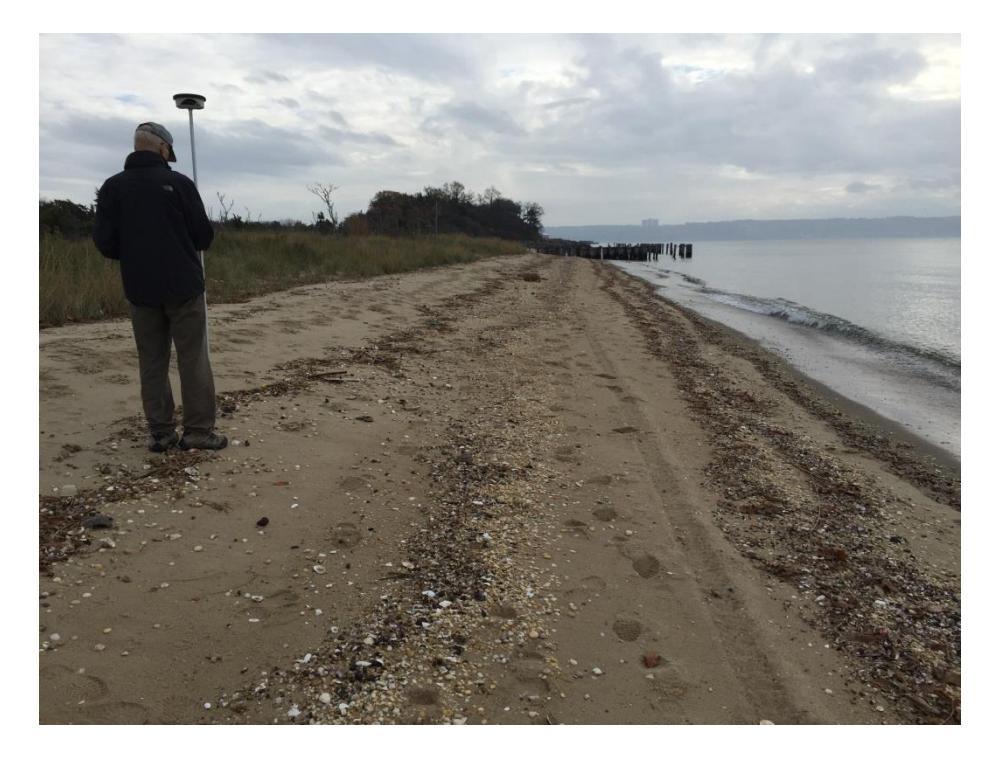
Figure 43. The beach at the Natural Control site is linear. Densely vegetated grasses and shrubs occur landward of the backshore.

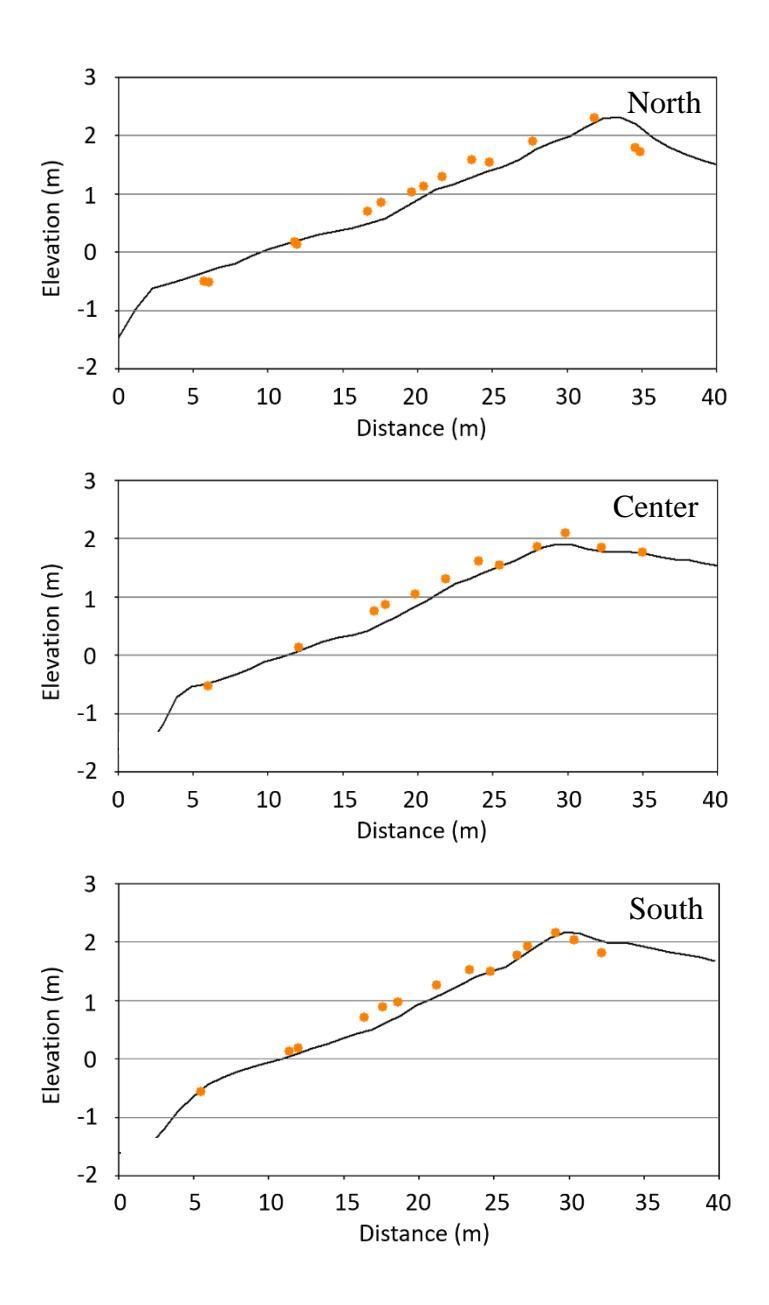
The shore-normal profile of this site is typical for a low energy beach, with a steep and narrow foreshore and no backshore (Figure 43) (Jackson and Nordstrom 1992, Jackson et al. 2002). The beach is linear and alongshore with little to no variation in elevation; the three shore-normal profiles show similar beach widths and elevations, and dune crest heights. The slope of the foreshore is constant (Figure 44).

Figure 44. North, center, and south shore-normal beach profiles at the Natural Control site. GPS data points are depicted as orange dots. The National Elevation Dataset surface is depicted as a black line.

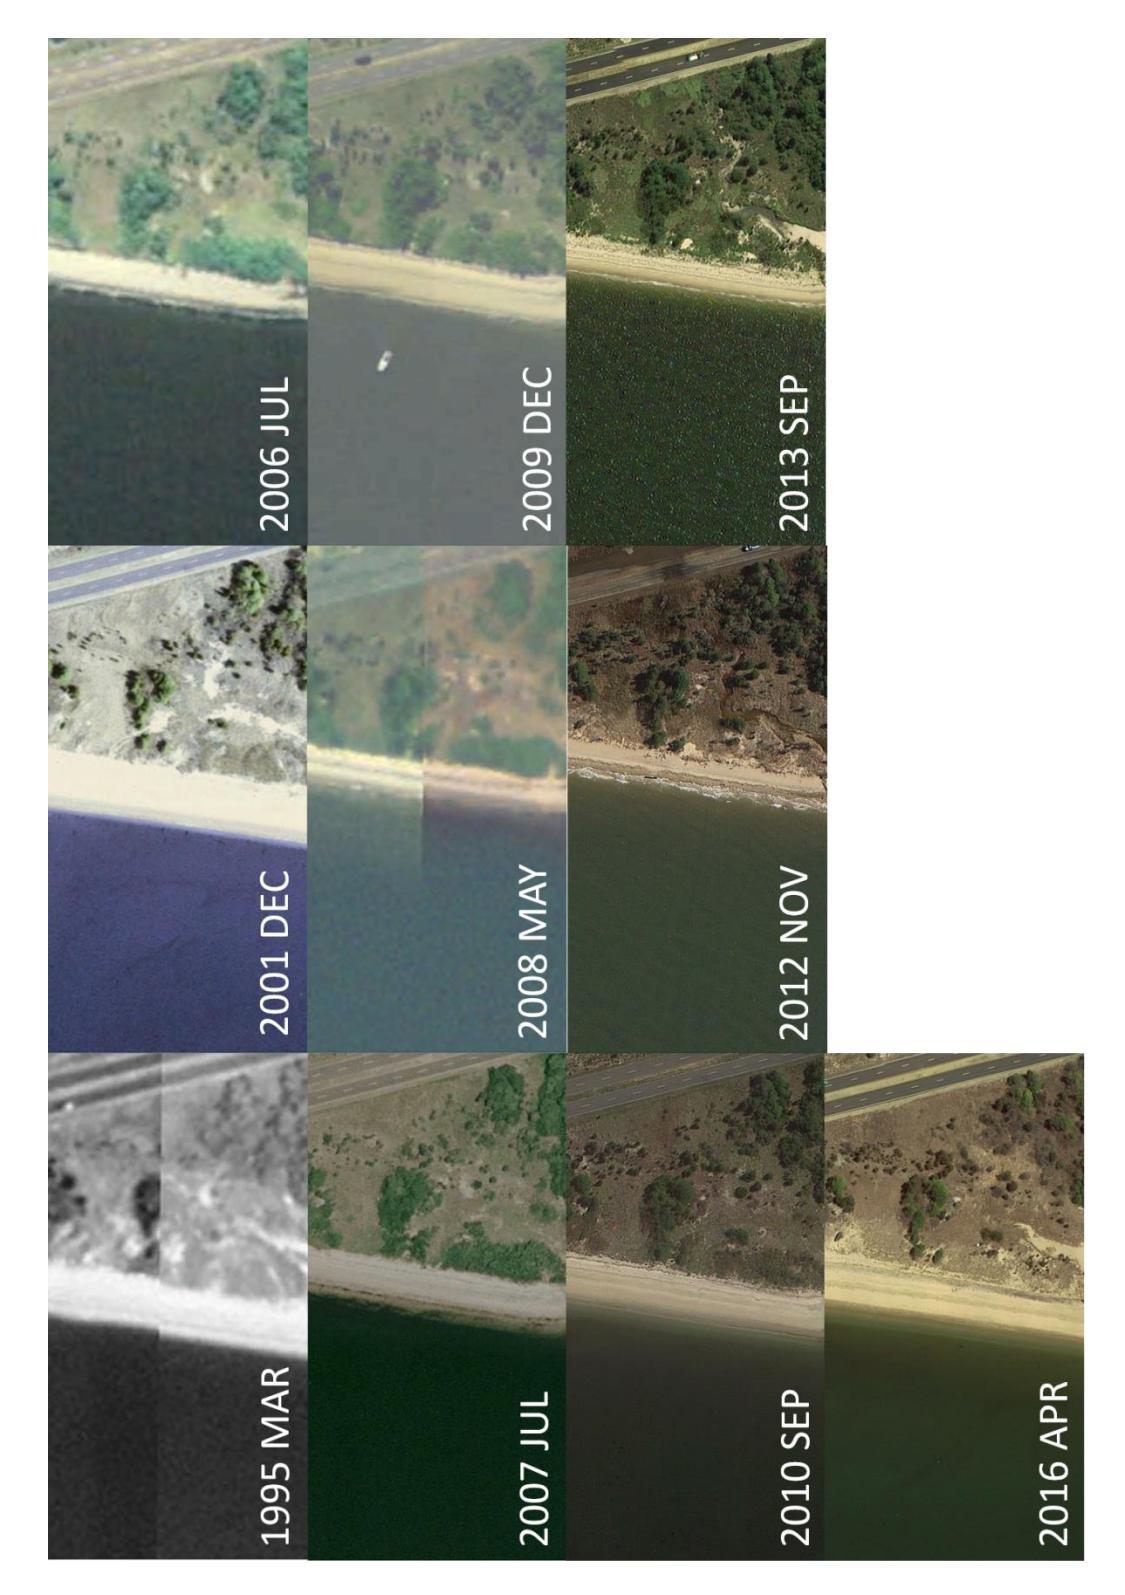
consistently linear alongshore, with a lack of evidence of reentrants (Figure 45). Some visible differences in vegetation and beach width occur, but changes of these characteristics are not similar to sites with a bulkhead that have a more homogenous upland instead of an established dune with crest and leeward slope.

Figure 45. The Natural Control site has been consistently linear over the last 21 years. Historical aerial imagery obtained from Google Earth.

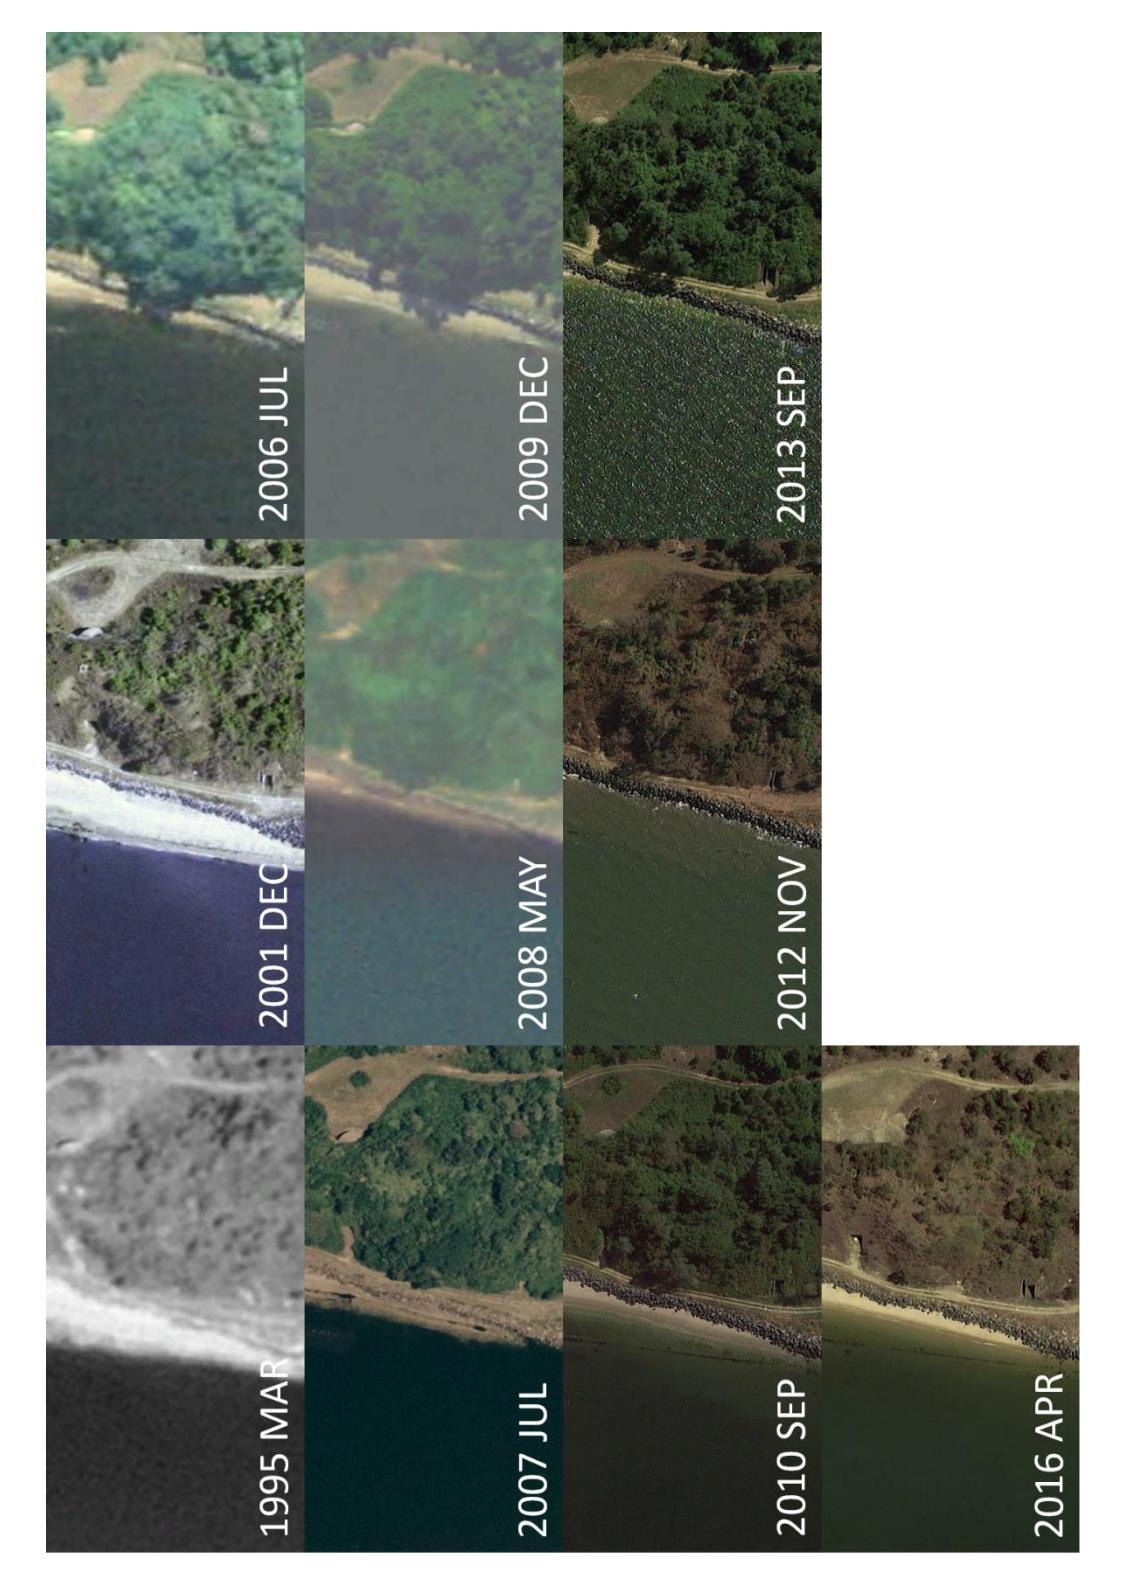
Beach width has been consistently greater along the northern portion of the revetment and narrower in the southern portion (Figure 47). The ground surface between the revetment and the dirt road has remained covered in herbaceous grassy vegetation, with tree coverage on Battery Kingman landward of the dirt road. No evidence of erosion or water overtopping the structure is present in the aerial images, including immediately following Hurricane Sandy in 2012 (Figure 47).

Figure 47. Beach width has been consistently greater along the northern portions of Revetment 8 at the Battery Kingman South site. No evidence of erosion landward of the revetment is present in the last 21 years of imagery. Historical imagery obtained from Google Earth.

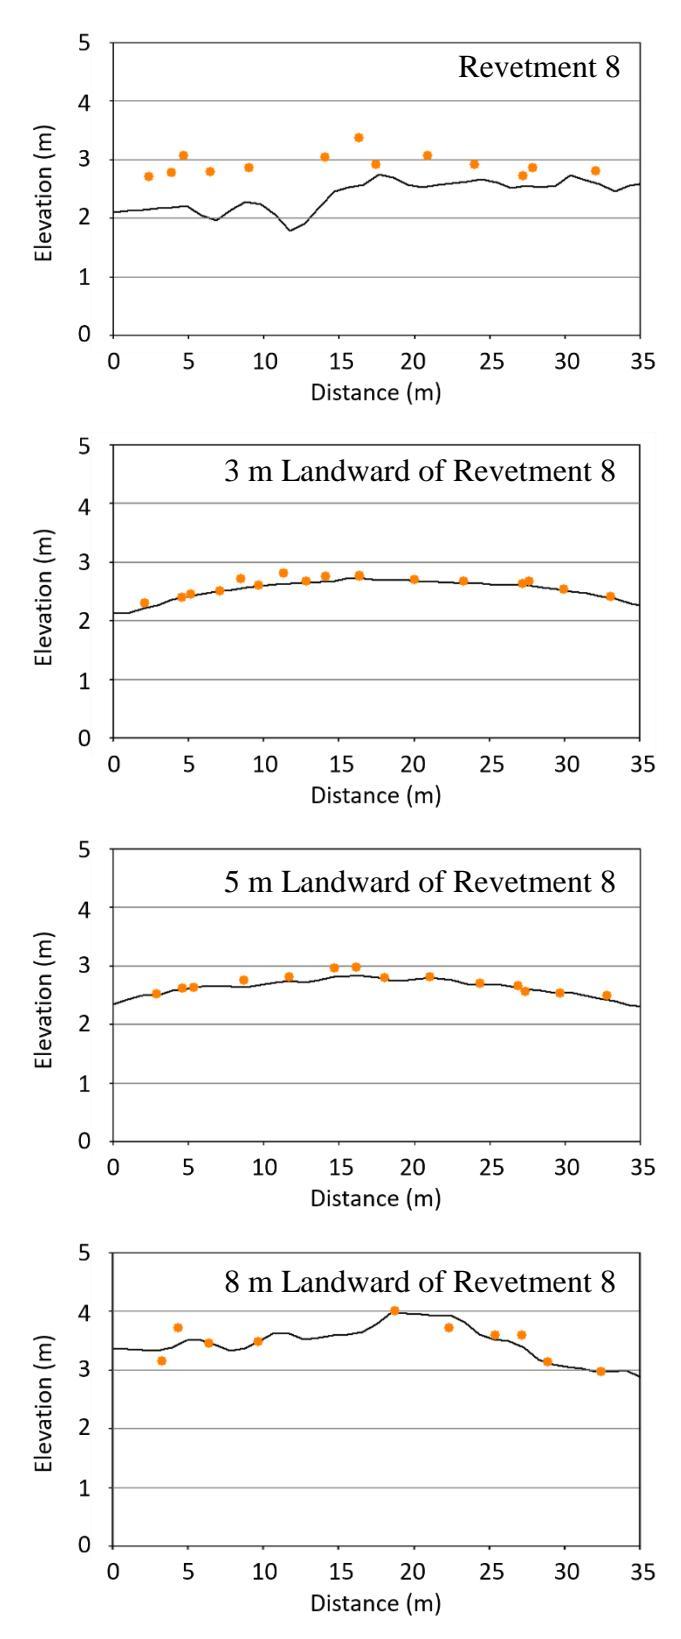
The elevation of the top of Revetment 8 ranges between 2.7 and 3.4 m, with most measurements lower than 3.0 m (Figure 49). The revetment is higher than the ground surface landward of it where the elevation decreases with distance landward, with the exception of the earth mound built over Battery Kingman (Figure 50). The elevation of the structure and ground surface landward is highest towards the center of the structure and decreases to both the north and south (Figure 49).

Figure 49. Shore-parallel beach elevations at the Battery Kingman South site. Elevations were taken at the revetment crest, 3 m landward of the structure, 5 m landward of the structure, and 8 m landward of the structure. GPS data points are depicted as orange dots. National Elevation Dataset surface is depicted as a black line.
