EVOLUTION OF THE MORPHOLOGY SURROUNDING DETERIORATING SHORE-PARALLEL PROTECTION STRUCTURES ON SANDY ESTUARINE BEACHES

KATHERINE HELEN KOROTKY

Rutgers, The State University of New Jersey

JANUARY, 2019

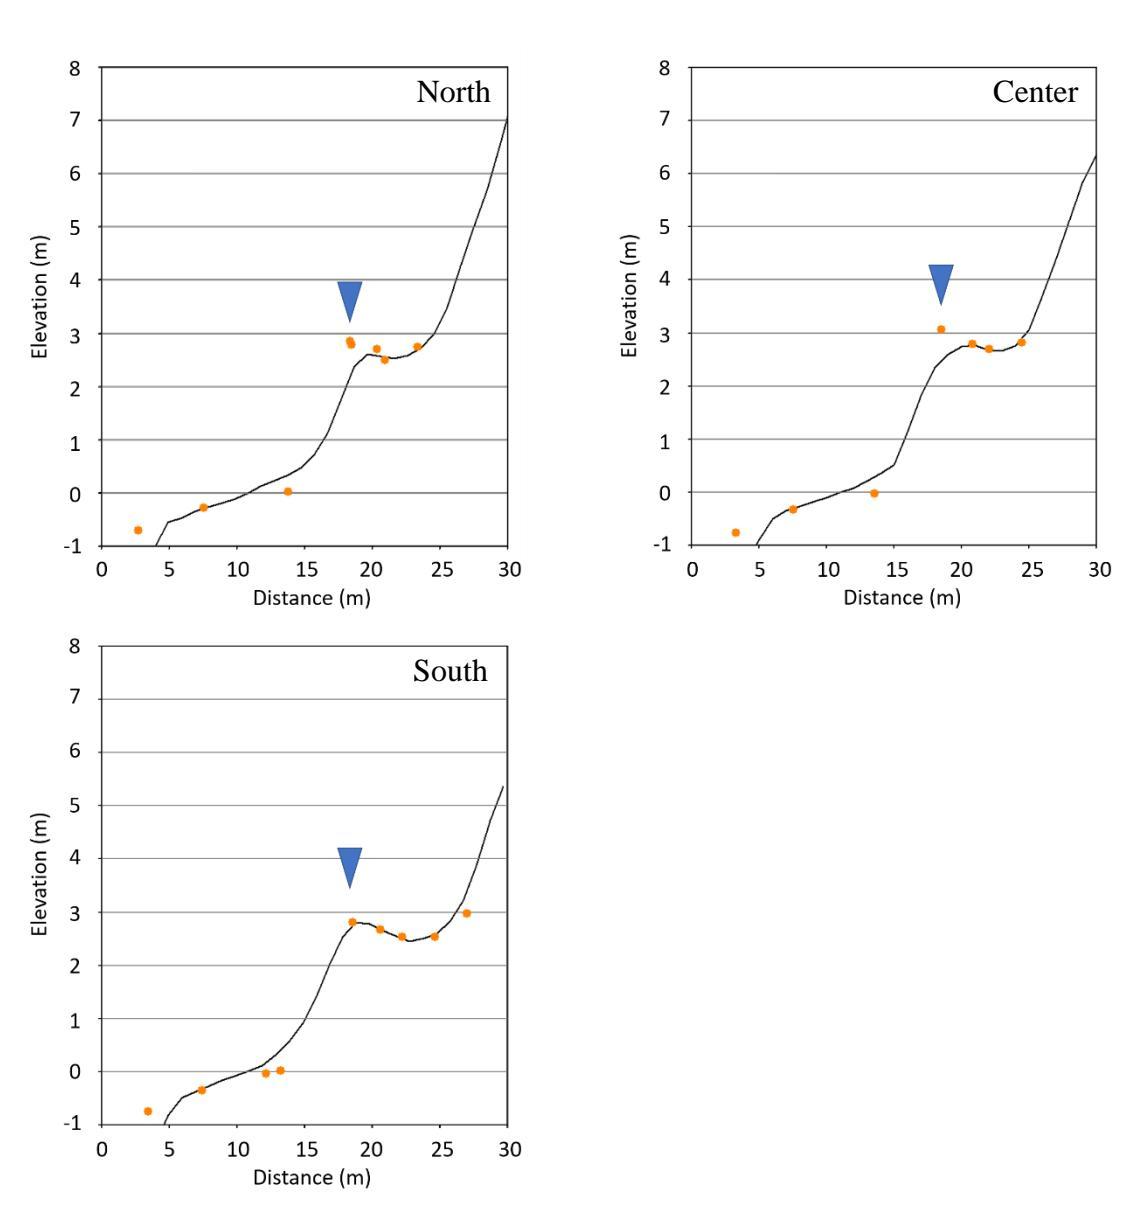
Figure 50. North, center, and south shore-normal beach profiles at the Battery Kingman South site, Sandy Hook Unit, Gateway National Recreation Area. GPS data points are depicted as orange dots. National Elevation Dataset surface is depicted as a black line. Blue arrows represent the location and elevation of the revetment.

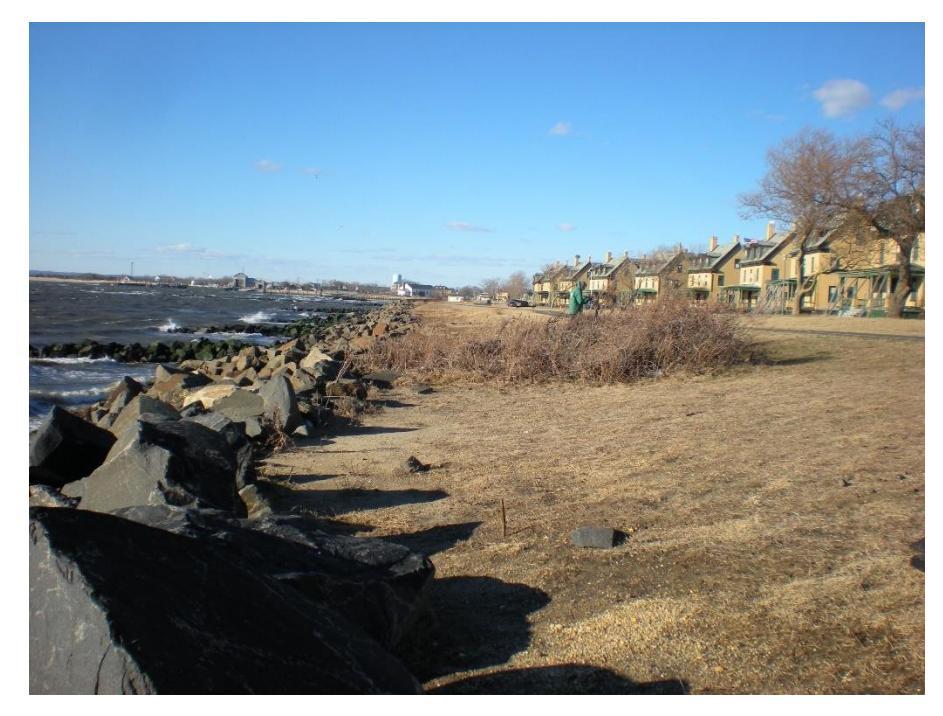
This site is located in the Fort Hancock area of Sandy Hook, seaward of the southernmost building in Officer's Row (Figure 8). This site was chosen because there is no visible evidence of erosion or reworking of sediment landward of the structure (Revetment 2), and there is a wider undeveloped area landward than at the Battery Kingman site. A series of approximately 30 m-long groins exists along the length of the revetment, spaced approximately 50 m apart. The ground surface landward of the structure is primarily lawn grass with very small areas of bare sand close to the structure, and one patch of shrubs (Figure 51).

Figure 51. The ground surface landward of Revetment 2 at Officer's Row South site is primarily covered with lawn grass. Photograph was taken looking north.

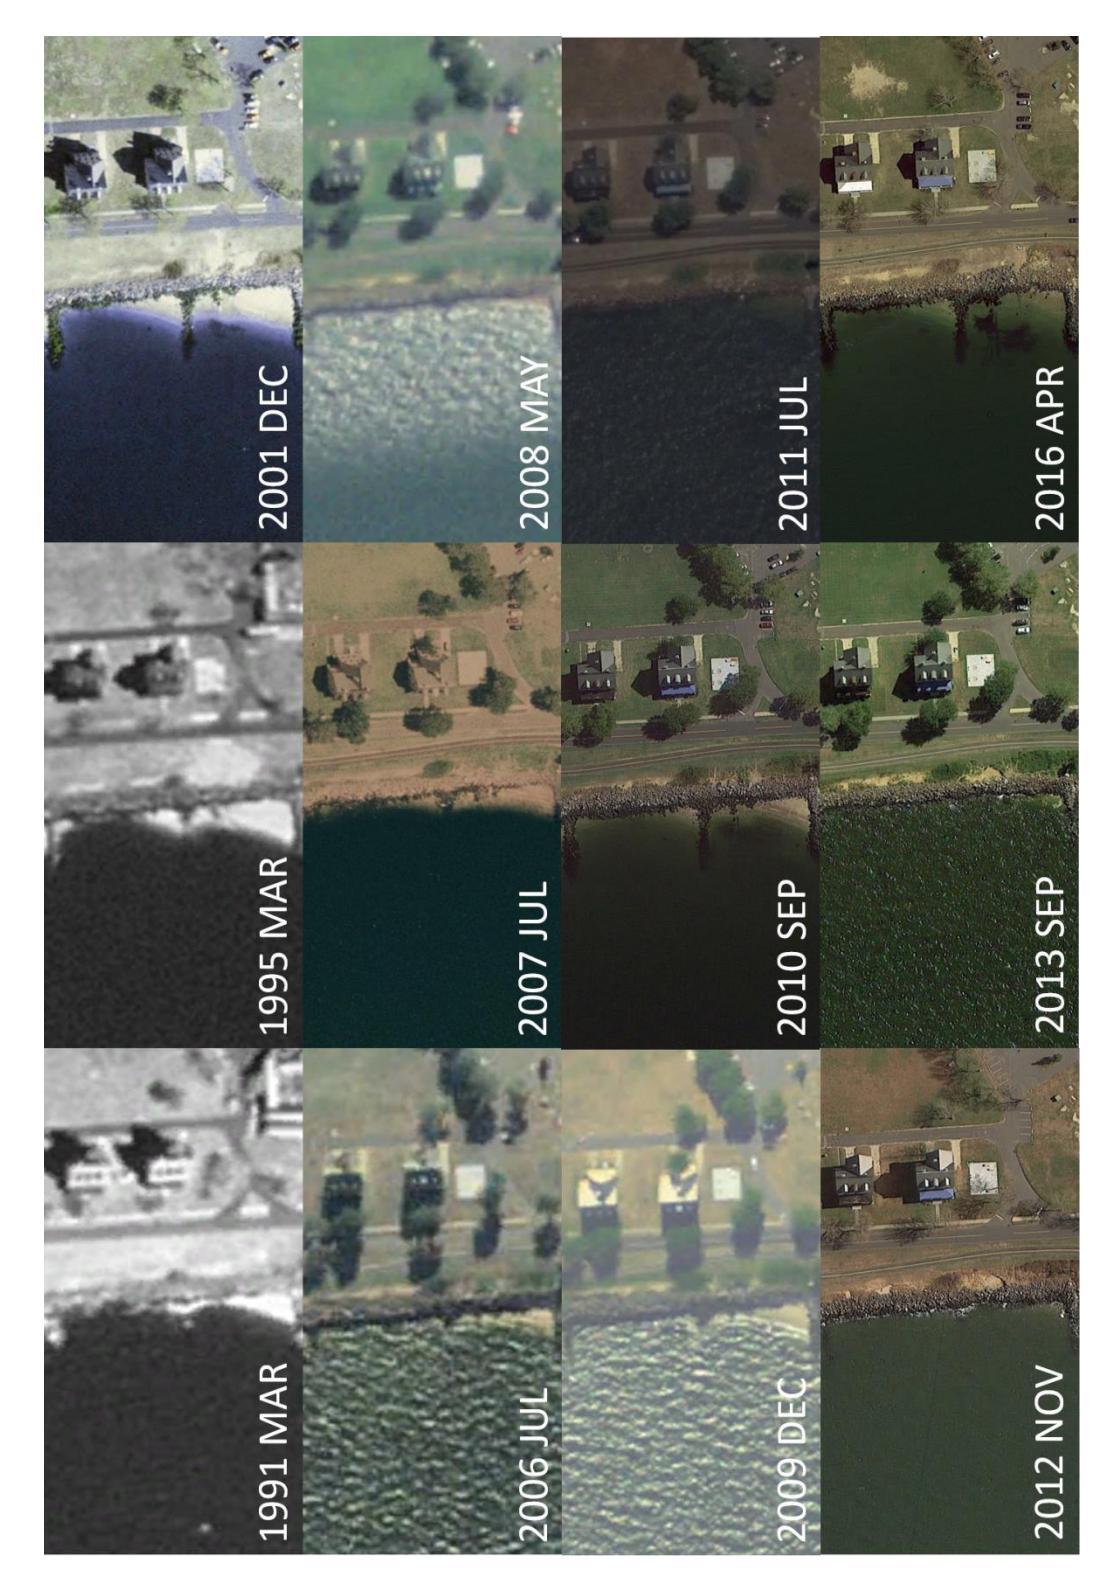
Figure 52. Small areas of bare sand landward of the revetment are present over the last 25 years of imagery at the Officer's Row South site. Historical imagery obtained from Google Earth.

Historical aerial images reveal small areas of bare sand landward of the structure during the entire period of coverage (Figure 52), but they have not experienced a noticeable increase in size, indicating a lack of erosion. The beach fronting the revetment is subaerial in the earlier images and submerged in the more recent images, but this may be due to differences in the tidal cycle at the time the image was captured rather than erosion of the beach.

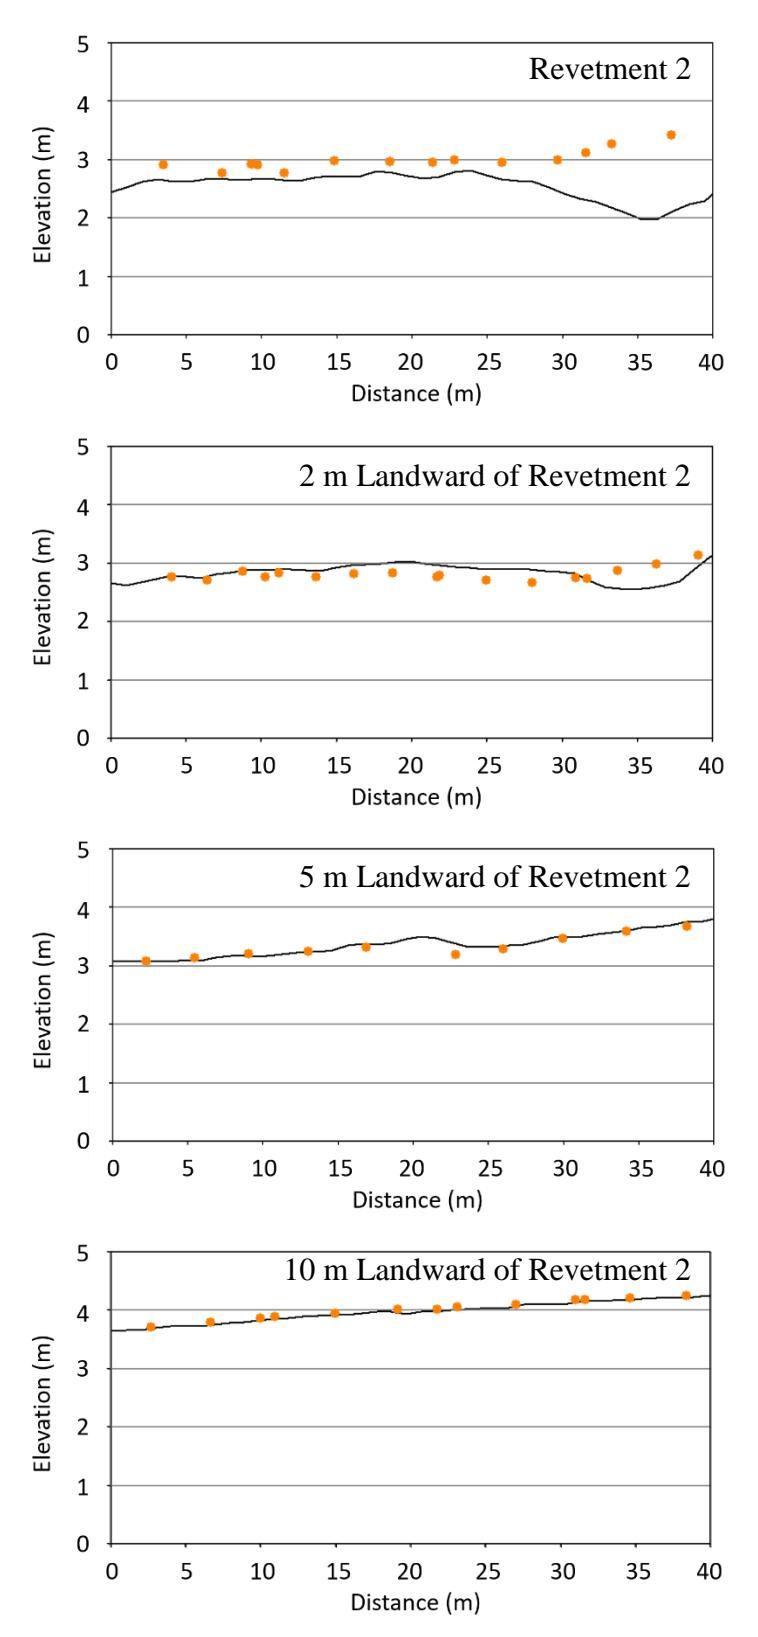
The elevation of the top of the revetment ranges between 2.8 and 3.4 m. The elevation is lowest at the northern end of the site and increases to the south. The top of the revetment extends about 1 m above the landward ground surface (Figure 53). No evidence of sediment movement or removal, or erosional features such as scarps are present landward of the structure. The cross-shore slope of the ground surface is relatively constant between the structure and the paved recreational path approximately 10 m landward of the structure (Figure 54).

The NED is a bare-earth surface and does not represent the structure elevation. It also diverges from the GPS data along the shore-parallel profile 2 m landward of the revetment, especially at the southern end of the site where the NED elevation is approximately 0.3 m lower than the GPS data. It is possible that this area was filled after the NED data were gathered, but there was no evidence of recent fill during site visits or in aerial imagery (Figure 52).

Figure 53. Shore-parallel beach elevations at the Officer's Row South site. Elevations were taken at the revetment crest, 2 m landward of the structure, 5 m landward of the structure, and 10 m landward of the structure. GPS data points are depicted as orange dots. National Elevation Dataset surface is depicted as a black line.

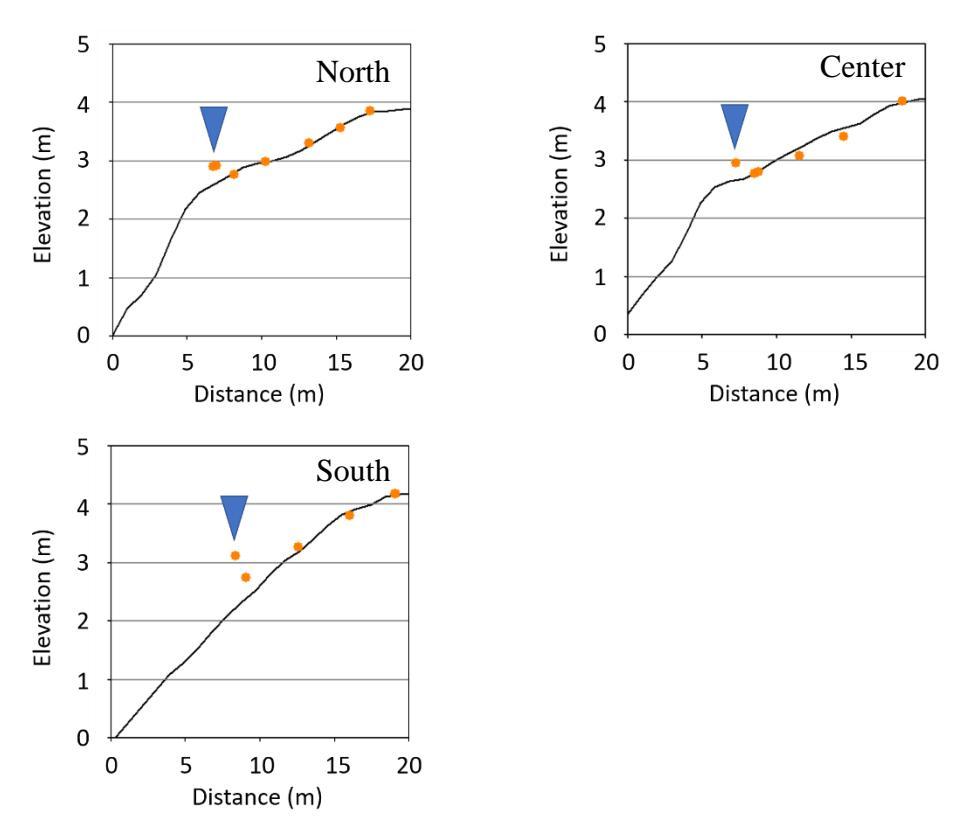
Figure 54. North, center, and south shore-normal beach profiles at the Officer's Row South site. GPS data points are depicted as orange dots; no GPS data were gathered along the seaward face of the revetment due to safety concerns. National Elevation Dataset surface is depicted as a black line. Blue arrows represent the location and elevation of the crest of the revetment.

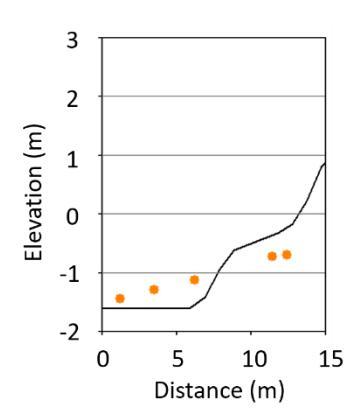
Revetment 2 was constructed in 1901 to protect the upland and a pre-existing bulkhead from further deterioration (Bearss 1981). According to Bearss (1981), the sand surface was approximately 8 ft (2.4 m) below the top of that bulkhead in 1901. The revetment that now covers the original bulkhead is currently approximately 3.5 m above the beach surface. The elevation of the beach obtained by RTK GPS just seaward of the revetment is approximately -0.6 to -1.5 m (Figure 56).

Figure 56. Shore-normal beach profile seaward of Revetment 2. GPS data points are depicted as orange dots. National Elevation Dataset surface is depicted as a black line.

The NED does not provide accurate elevations for submerged ground surfaces seaward of Revetment 2 (Figure 56), or for the structure itself (Figure 59). GPS and NED elevations landward of the structures are comparable (Figure 59). The one critical feature that is not captured in the NED is the scarp at the landward edge of the bare sand (Figure 60).

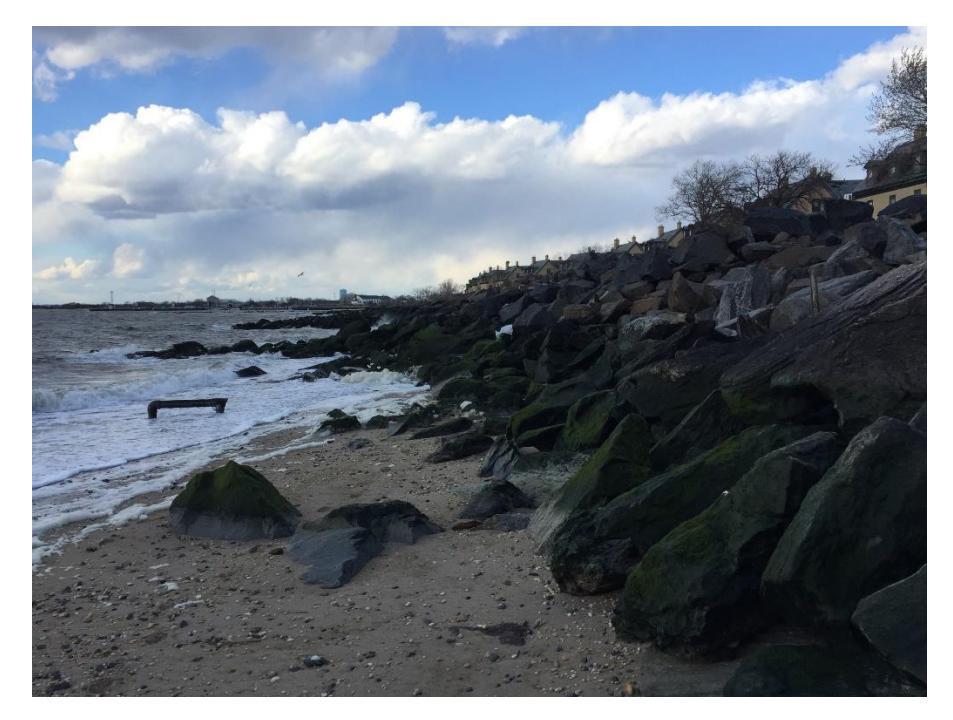
Figure 57. At low tide, the beach seaward of Revetment 2 is subaerial at the southern ends of groin compartments and submerged at the northern ends. Photograph was taken looking north.

GPS beach elevation measurements at Officer's Row North and Officer's Row South sites were not obtained because of concern about the safety of descending the face of the structure and collecting data within the submerged boulders. Accordingly, beach elevation measurements were collected in the groin compartment approximately 40 m south of the Officer's Row South site that provided the best vertical access. Beaches within each groin compartment along Revetment 2 share similar characteristics. At low tide, the northern halves of the beaches within each compartment remained submerged while accreting beaches at the southern halves were subaerial (Figure 57).

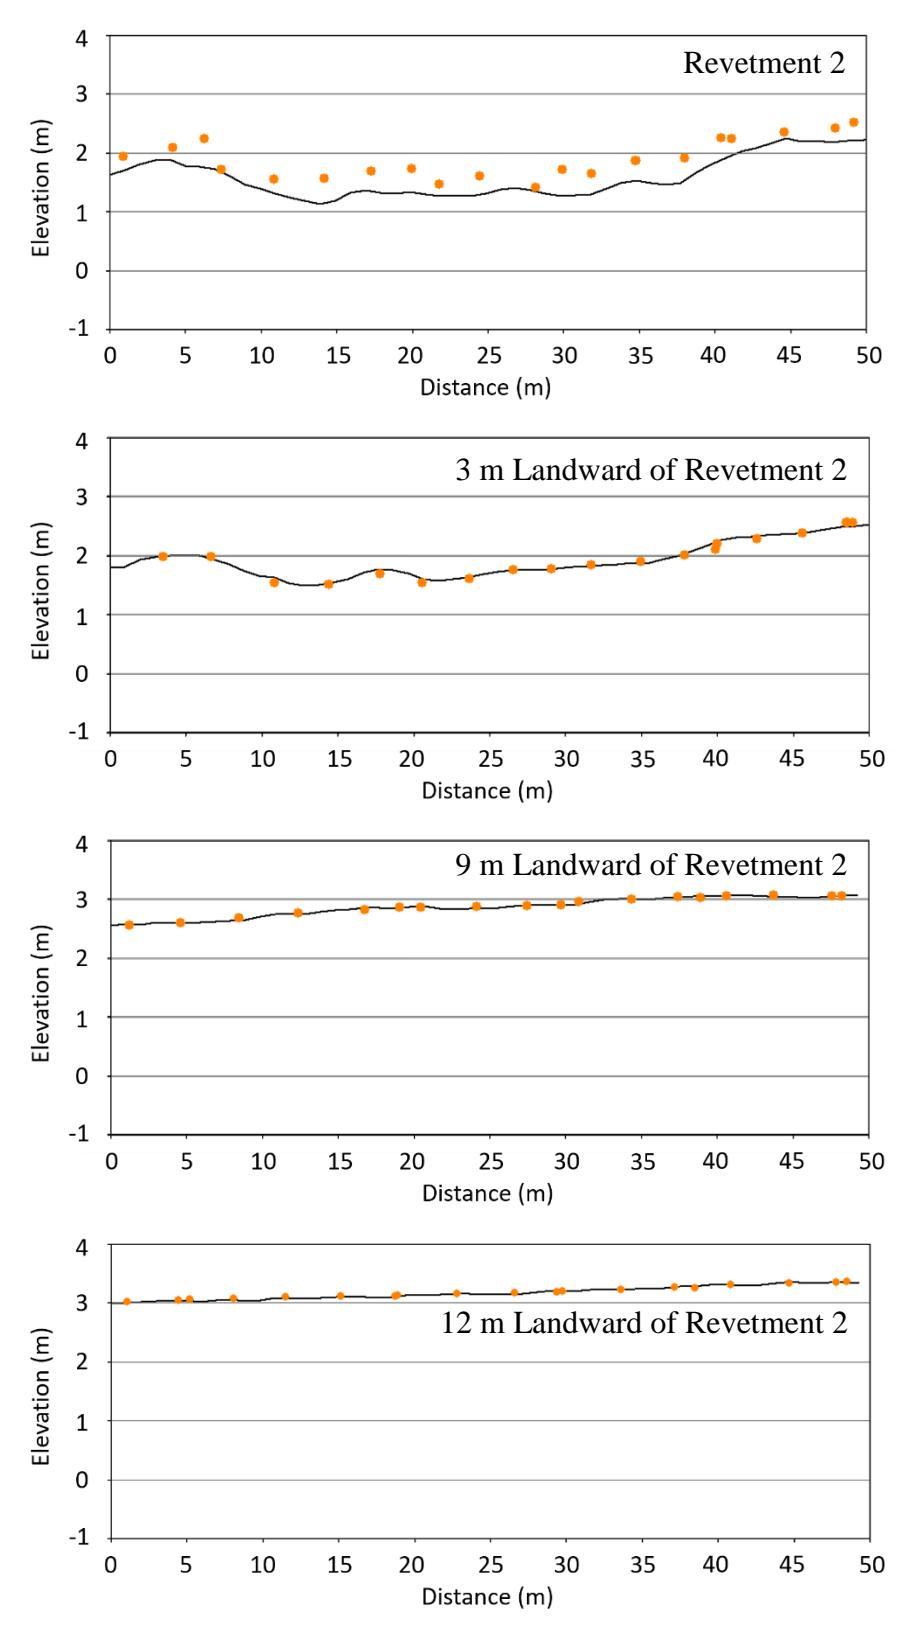
The elevation of the top of the revetment ranges between 1.4 and 2.4 m; the elevation is lowest at the center of the site and increases north and south. Elevation of the revetment is greater where groins attach to it; the profiles are located between two groins. Highest elevations of the structure (2.2-2.4 m) were at the southern extent of the data; elevations at the northern extent were about 1.9-2.2 m (Figure 59).

The elevation of the bare sand surface immediately landward of the revetment is highest in the southern half of the site and decreases northward, and is equal or lower in elevation than the structure. The ground elevation varies between approximately 1.5 and 2.6 m elevation at a distance of 3 m from the structure (Figure 59). The vegetated ground surface farther landward where no erosion has taken place displays a smaller range of elevations with increased distance from the revetment. The variations are 2.6 m to 3.1 m elevation at 9 m distance and 3.0 m to 3.4 m elevation at 12 m distance, indicating that an increase of irregularity in topography may occur when the land behind a revetment begins to erode. The scarp at the sand-vegetation boundary was more prominent in the north end of the site where the elevation of the structure was lower. The vertical distance between the top and bottom of the scarp was on average approximately 0.2 m (Figure 60).

Figure 59. Shore-parallel beach elevations at the Officer's Row North site. Elevations were taken at the revetment crest, 3 m landward of the structure, 9 m landward of the structure, and 12 m landward of the structure. GPS data points are depicted as orange dots. National Elevation Dataset surface is depicted as a black line.

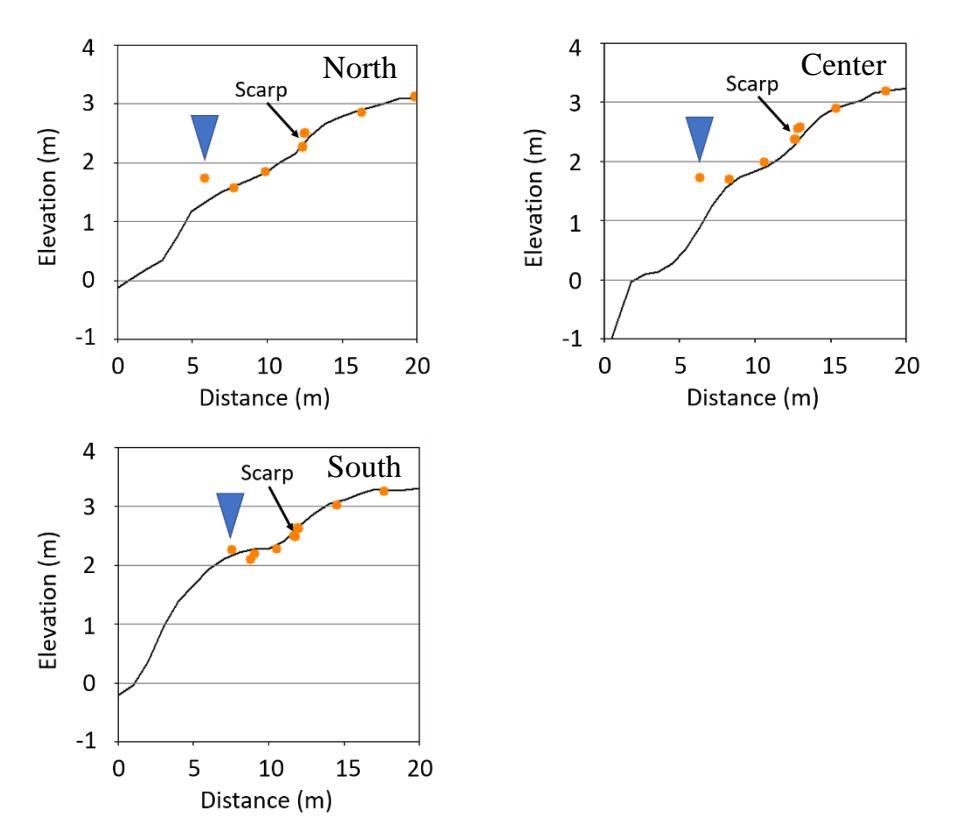
Figure 60. North, center, and south shore-normal beach profiles at the Officer's Row North site. GPS data points are depicted as orange dots. National Elevation Dataset surface is depicted as a black line. Blue arrows represent the location and elevation of the revetment.

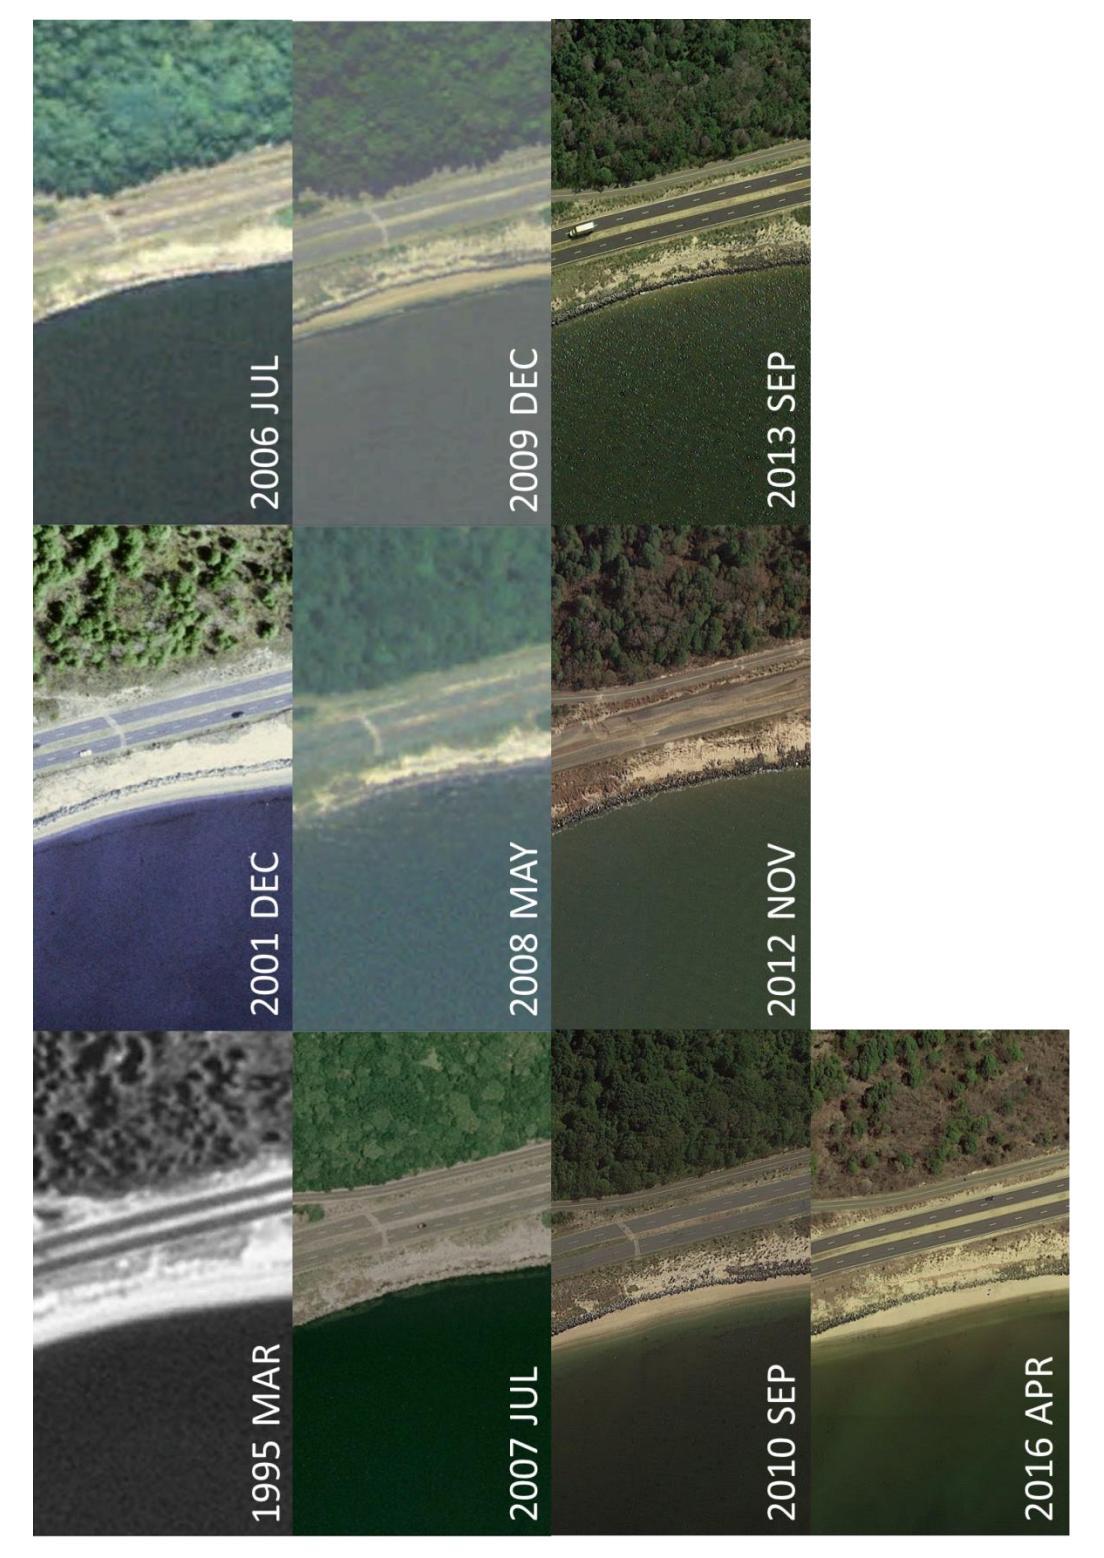
Bare sand is present landward of the revetment for the entire period covered by aerial imagery (Figure 61). The center portion of the site appears to historically experience more overwash than other areas, as indicated by the wider area covered by bare sand. It is difficult to assess the long-term trend in the amount of coverage of natural vegetation versus bare sand because the available historical images were taken during various times of the year. The entire beach seaward of the structure has been completely submerged during periods of high tide since at least 2006.

Figure 61. Bare sand has been present landward of the revetment at the Horseshoe Cove site over the past 21 years. Historical imagery obtained from Google Earth.

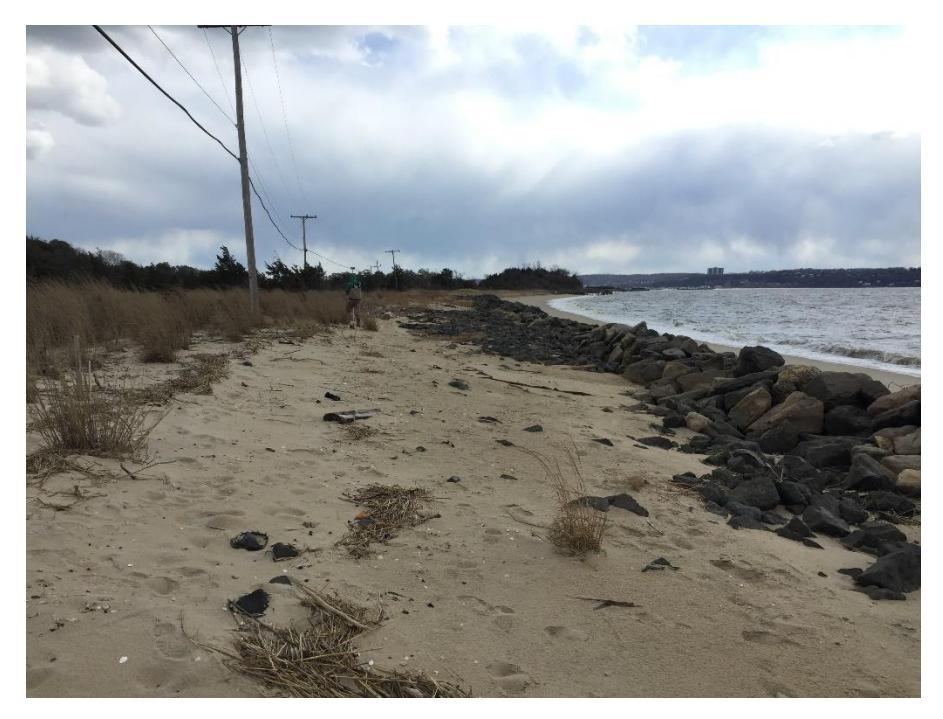
Most of the ground surface between the revetment and Hartshorne Drive is bare sand, with patchy dune grass and lawn grass within approximately 10 m of the road. Low-lying portions have overwash fans directly landward. These deposits cover riprap as well as live vegetation, indicating their relatively recent deposition and landward migration of the beach. Storm wrack lines were present landward of the revetment, at a distance of approximately 8 m, during the site visit (Figure 62).

Figure 62. Bare sand including fan deposits and wrack lines are present landward of the revetment at Horseshoe Cove site, Sandy Hook Unit, Gateway National Recreation Area. Photograph was taken looking south.

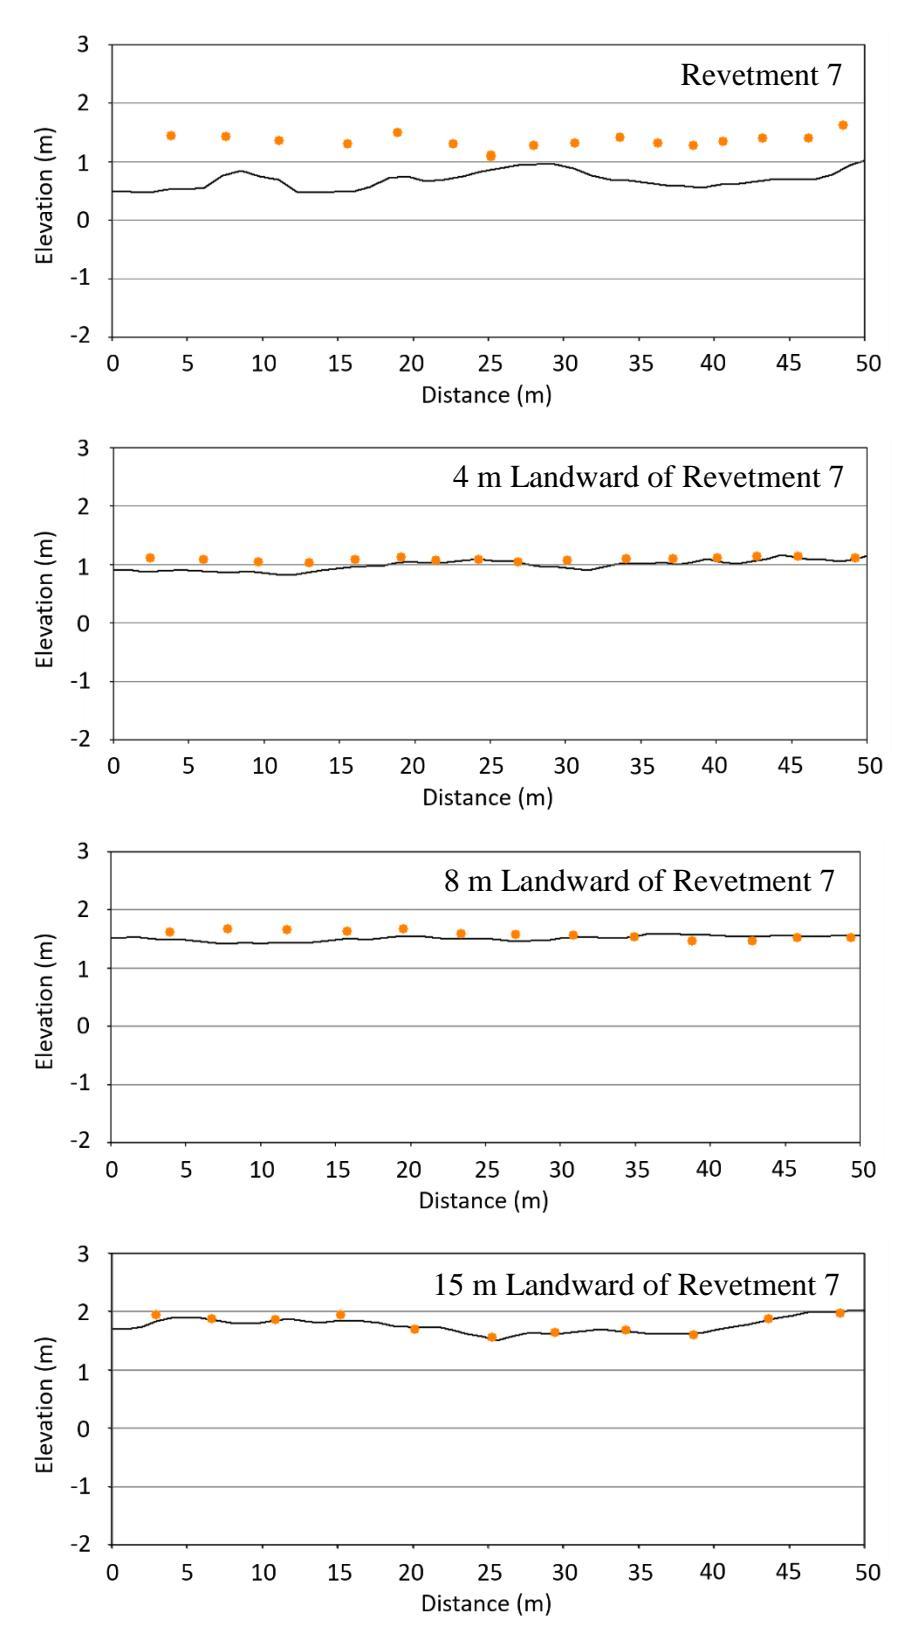
The highest elevations of the top of Revetment 7 at the Horseshoe Cove site range between 1.1 and 1.6 m (Figure 63), similar to the lowest elevations of the structure at the Officer's Row North site, and approximately 1.0 m above the elevation of beach directly seaward of the structure (Figure 64). The elevation is generally lower towards the center of the site and increases slightly to the north and south (Figure 63). The elevation of the top of the revetment is lower than that of the dune crest (Figure 64), and the elevation at the center of the revetment is lower than the storm wrack line landward of the beach. This indicates that during periods of high water, there are segments of the structure that may be submerged. The beach seaward of the revetment is completely submerged during high tide (Figure 61).

Figure 63. Shore-parallel beach elevations at the Horseshoe Cove site. Elevations were taken at the revetment crest, 4 m landward of the structure, 8 m landward of the structure, and 15 m landward of the structure. GPS data points are depicted as orange dots. National Elevation Dataset surface is depicted as a black line.

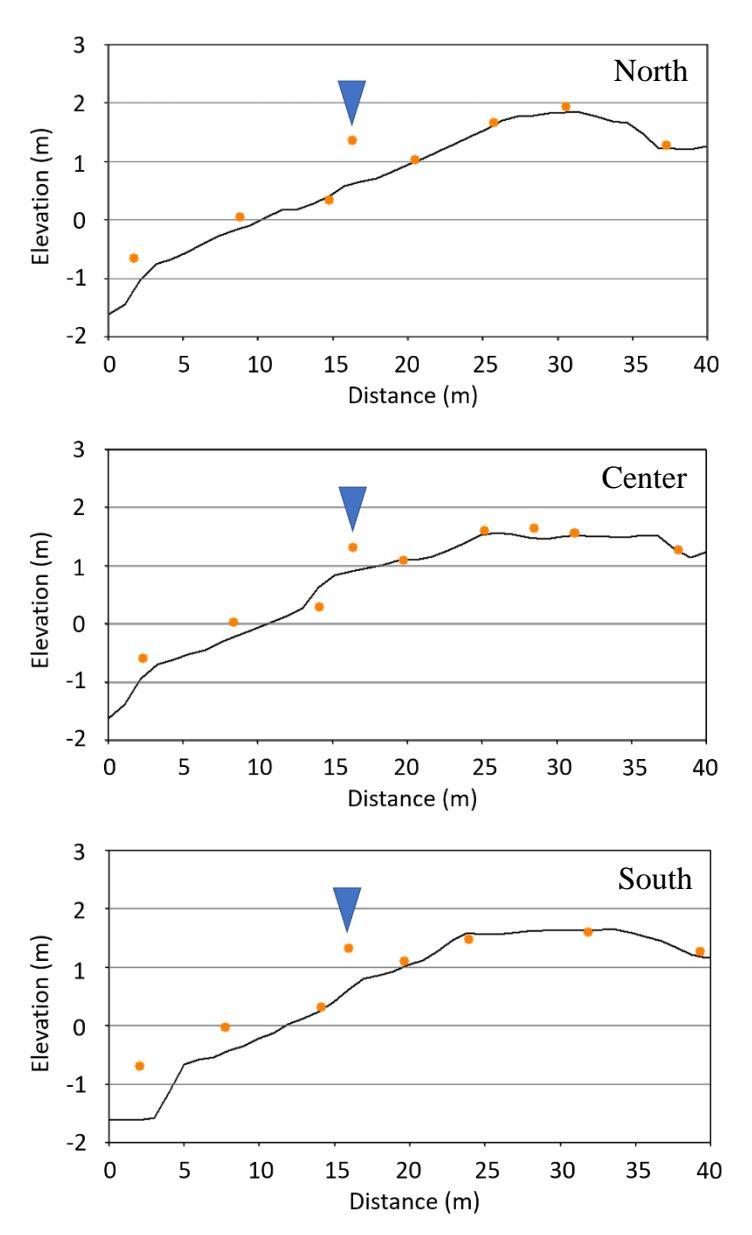
Figure 64. North, center, and south shore-normal beach profiles at the Horseshoe Cove site. GPS data points are depicted as orange dots. National Elevation Dataset surface is depicted as a black line. Blue arrows represent the location and elevation of the revetment.

The NED diverges from GPS data on the lower foreshore, at submerged

elevations, and at the location of the revetment (Figure 64) for the reasons mentioned earlier.
