Flood of April 2-4, 2005, Delaware River Main Stem from Port Jervis, New York, to Cinnaminson, New Jersey

Prepared in cooperation with the Federal Emergency Management Agency

Scientific Investigations Report 2007-5067

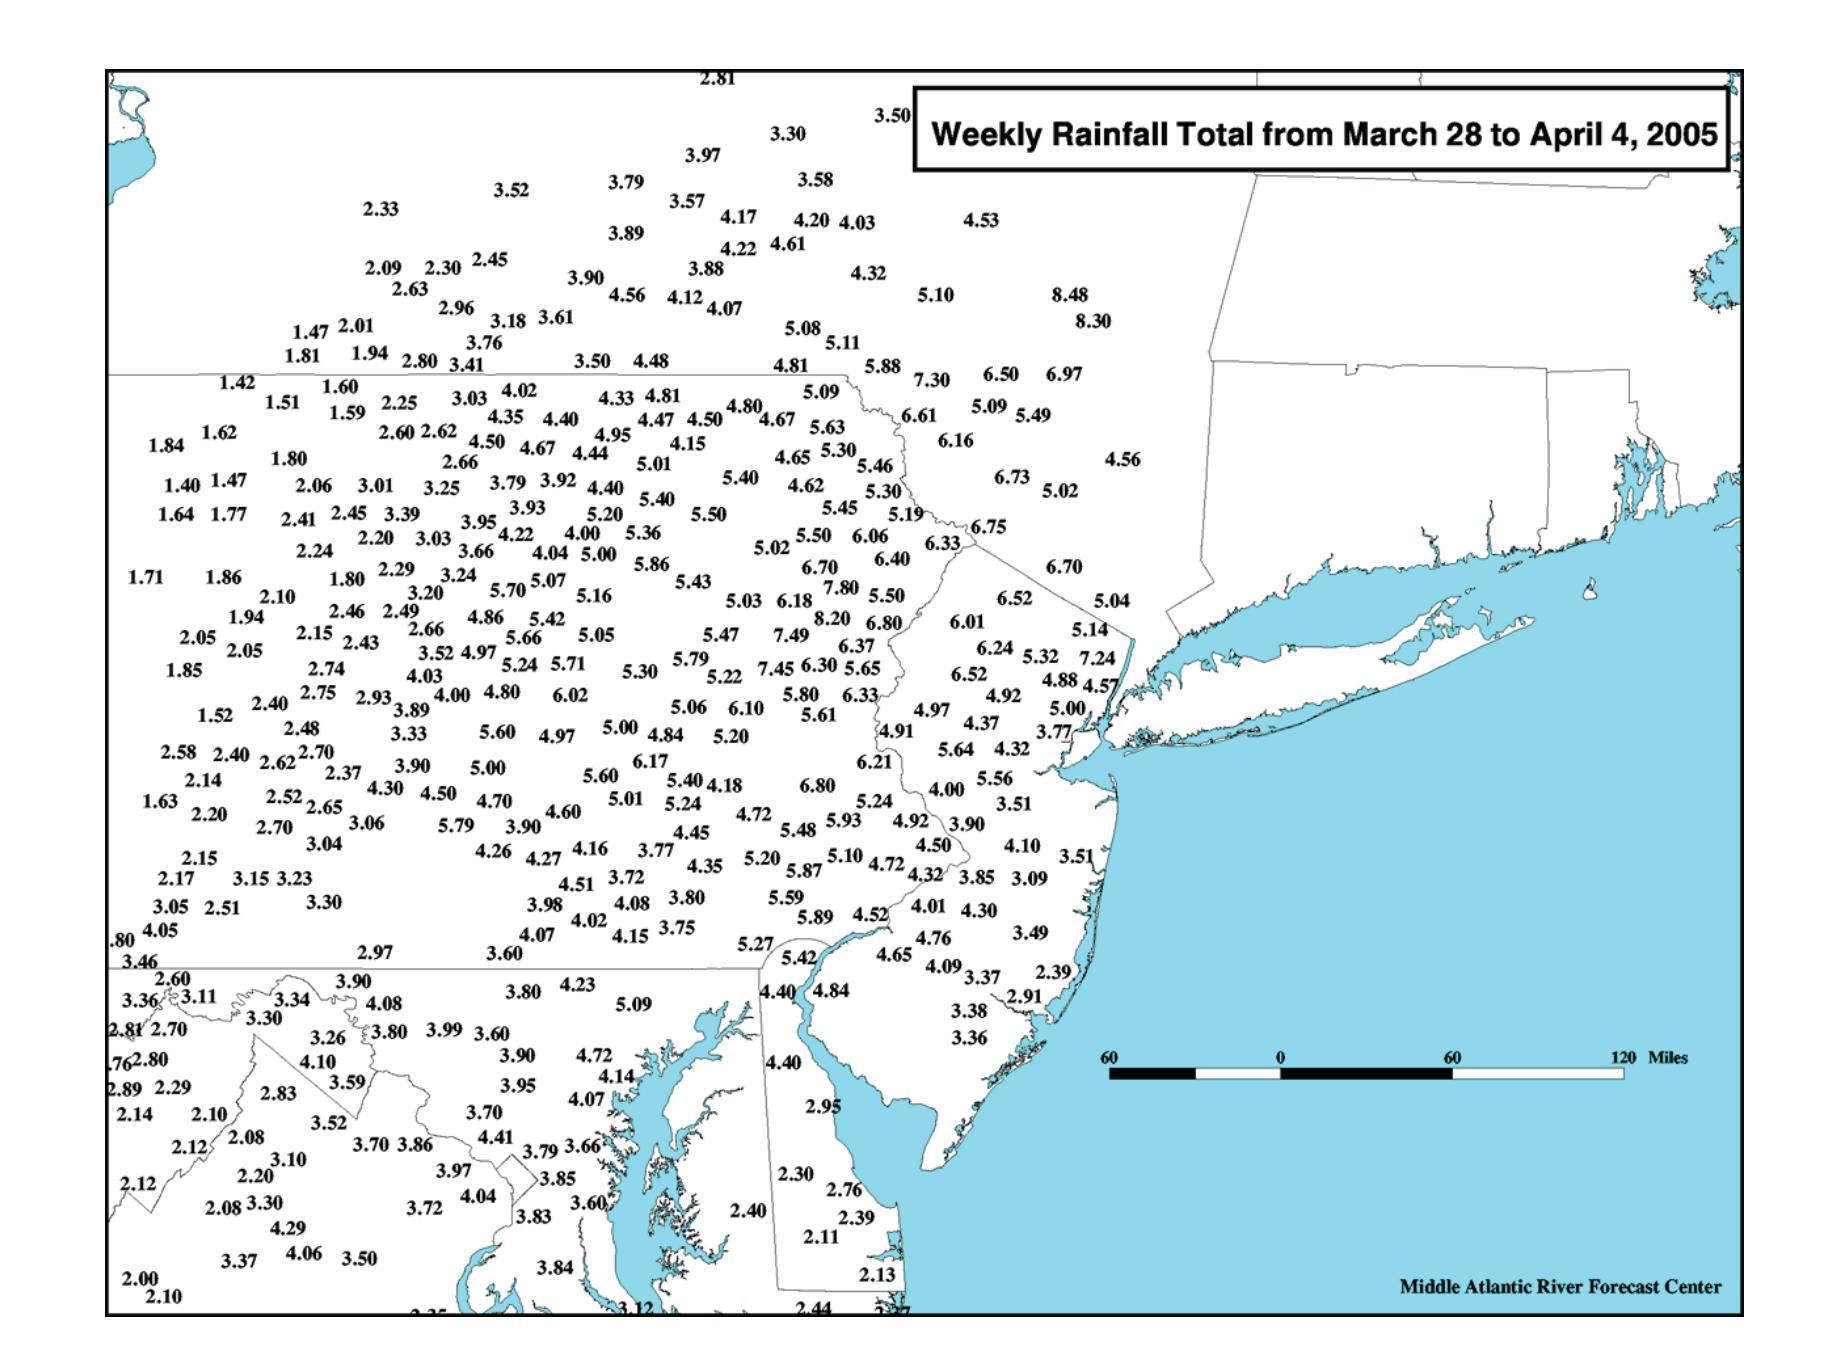
Figure 3. Total combined rainfall during March 28 to April 4, 2005, in and around the Delaware River Valley. (Figure provided by National Weather Service.)

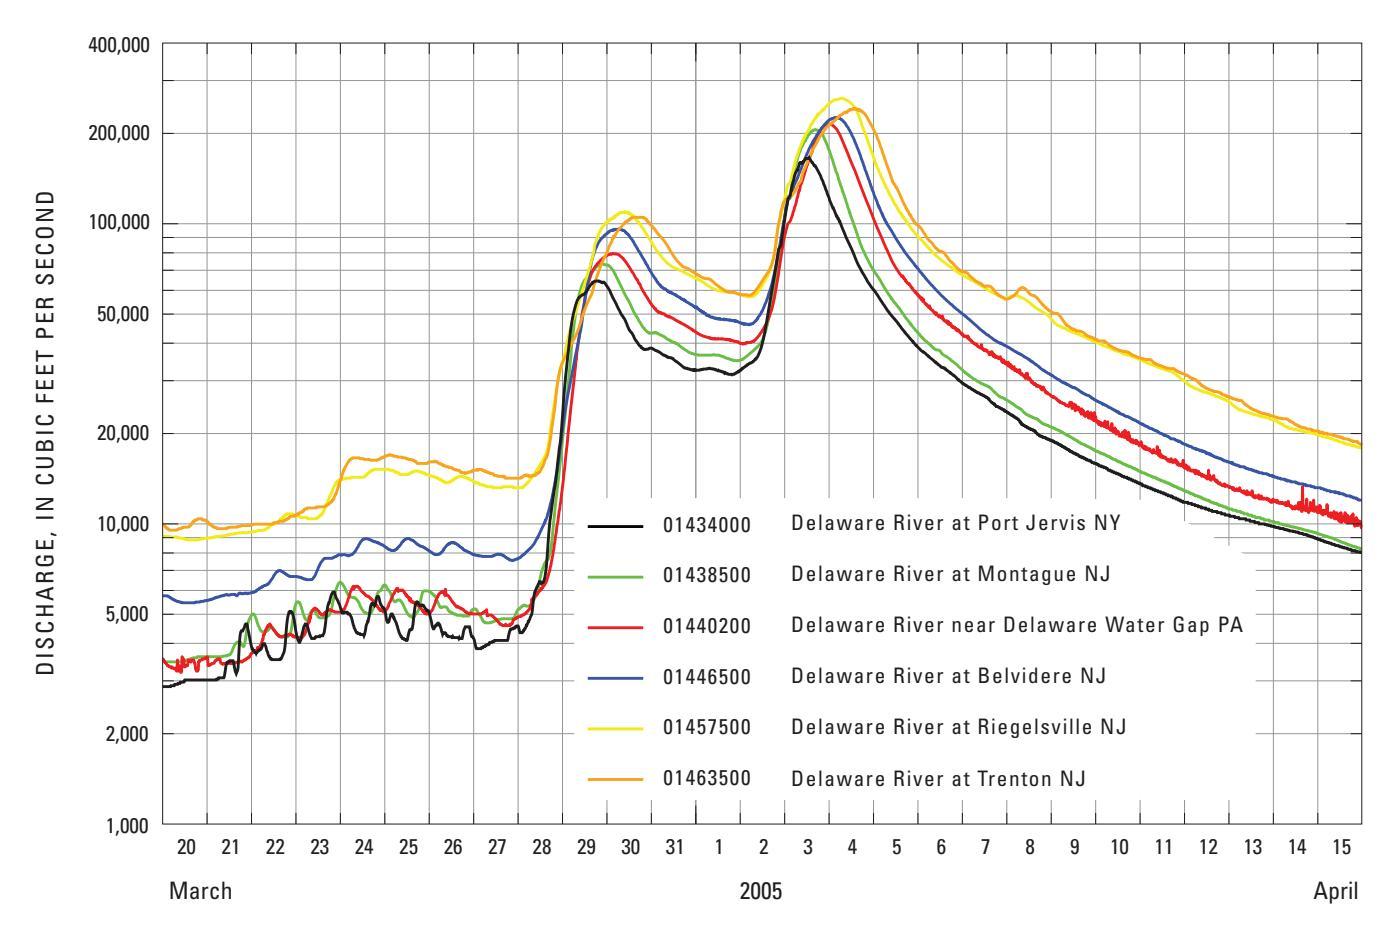
Figure 4. Hydrographs showing streamflow at six continuous-record streamflow-gaging stations on the Delaware River, March 20 to April 15, 2005.

The initial rise in streamflow from the March runoff caused the Delaware River to reach a preliminary peak flow on March 29-30, 2005 (fig. 4). The recession of that peak was slowed slightly by additional snowmelt as temperatures became warmer. The flow had decreased by 50 percent in 3 days, but was still from 300 to 360 percent greater than the monthly mean March flow when the second rainfall began on April 2. The resulting second peak on April 2-4 more than doubled the first, as the basin was vulnerable to any additional rainfall.

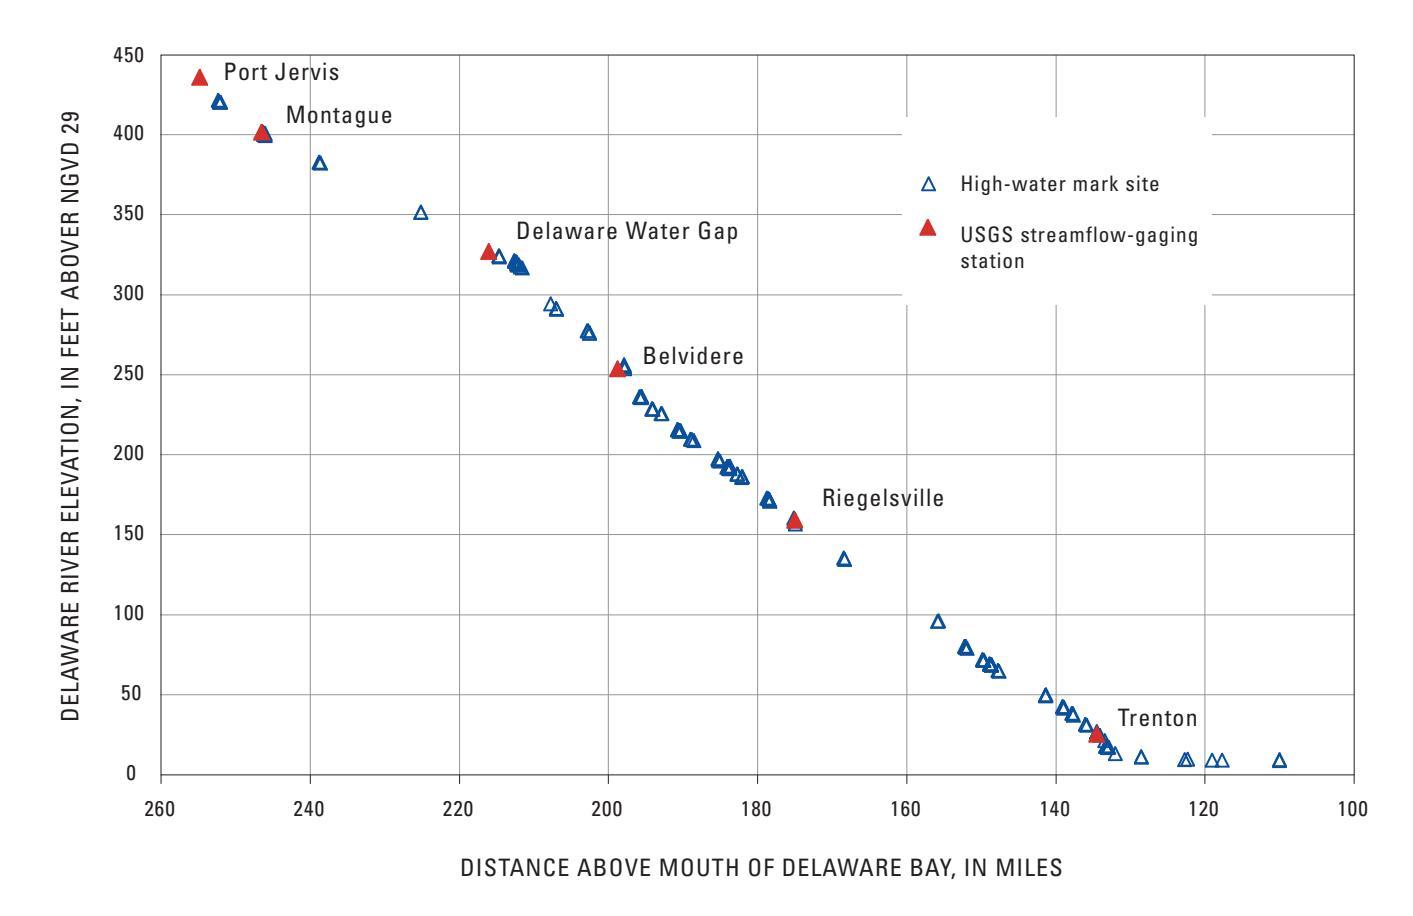
Figure 5. Delaware River peak elevations at U.S. Geological Survey (USGS) streamflow-gaging stations and high-water mark sites, April 2-4, 2005.

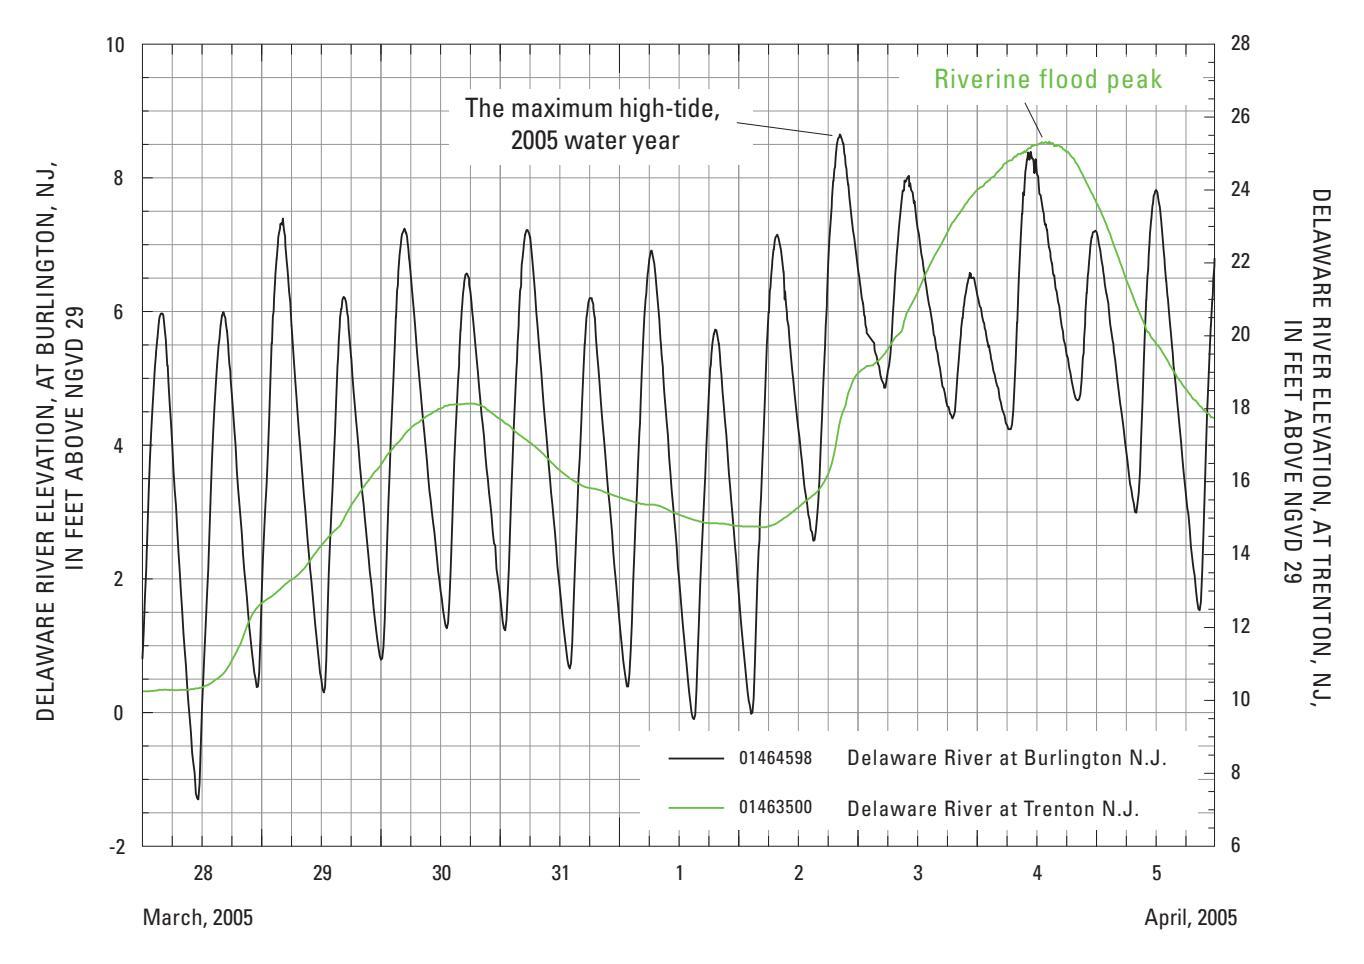
Figure 6. Hydrographs showing tide cycles on the Delaware River at Burlington, New Jersey, and stream elevations on the Delaware River at Trenton, New Jersey, March 28 to April 5, 2005. (NGVD 29, National Geodetic Vertical Datum of 1929)

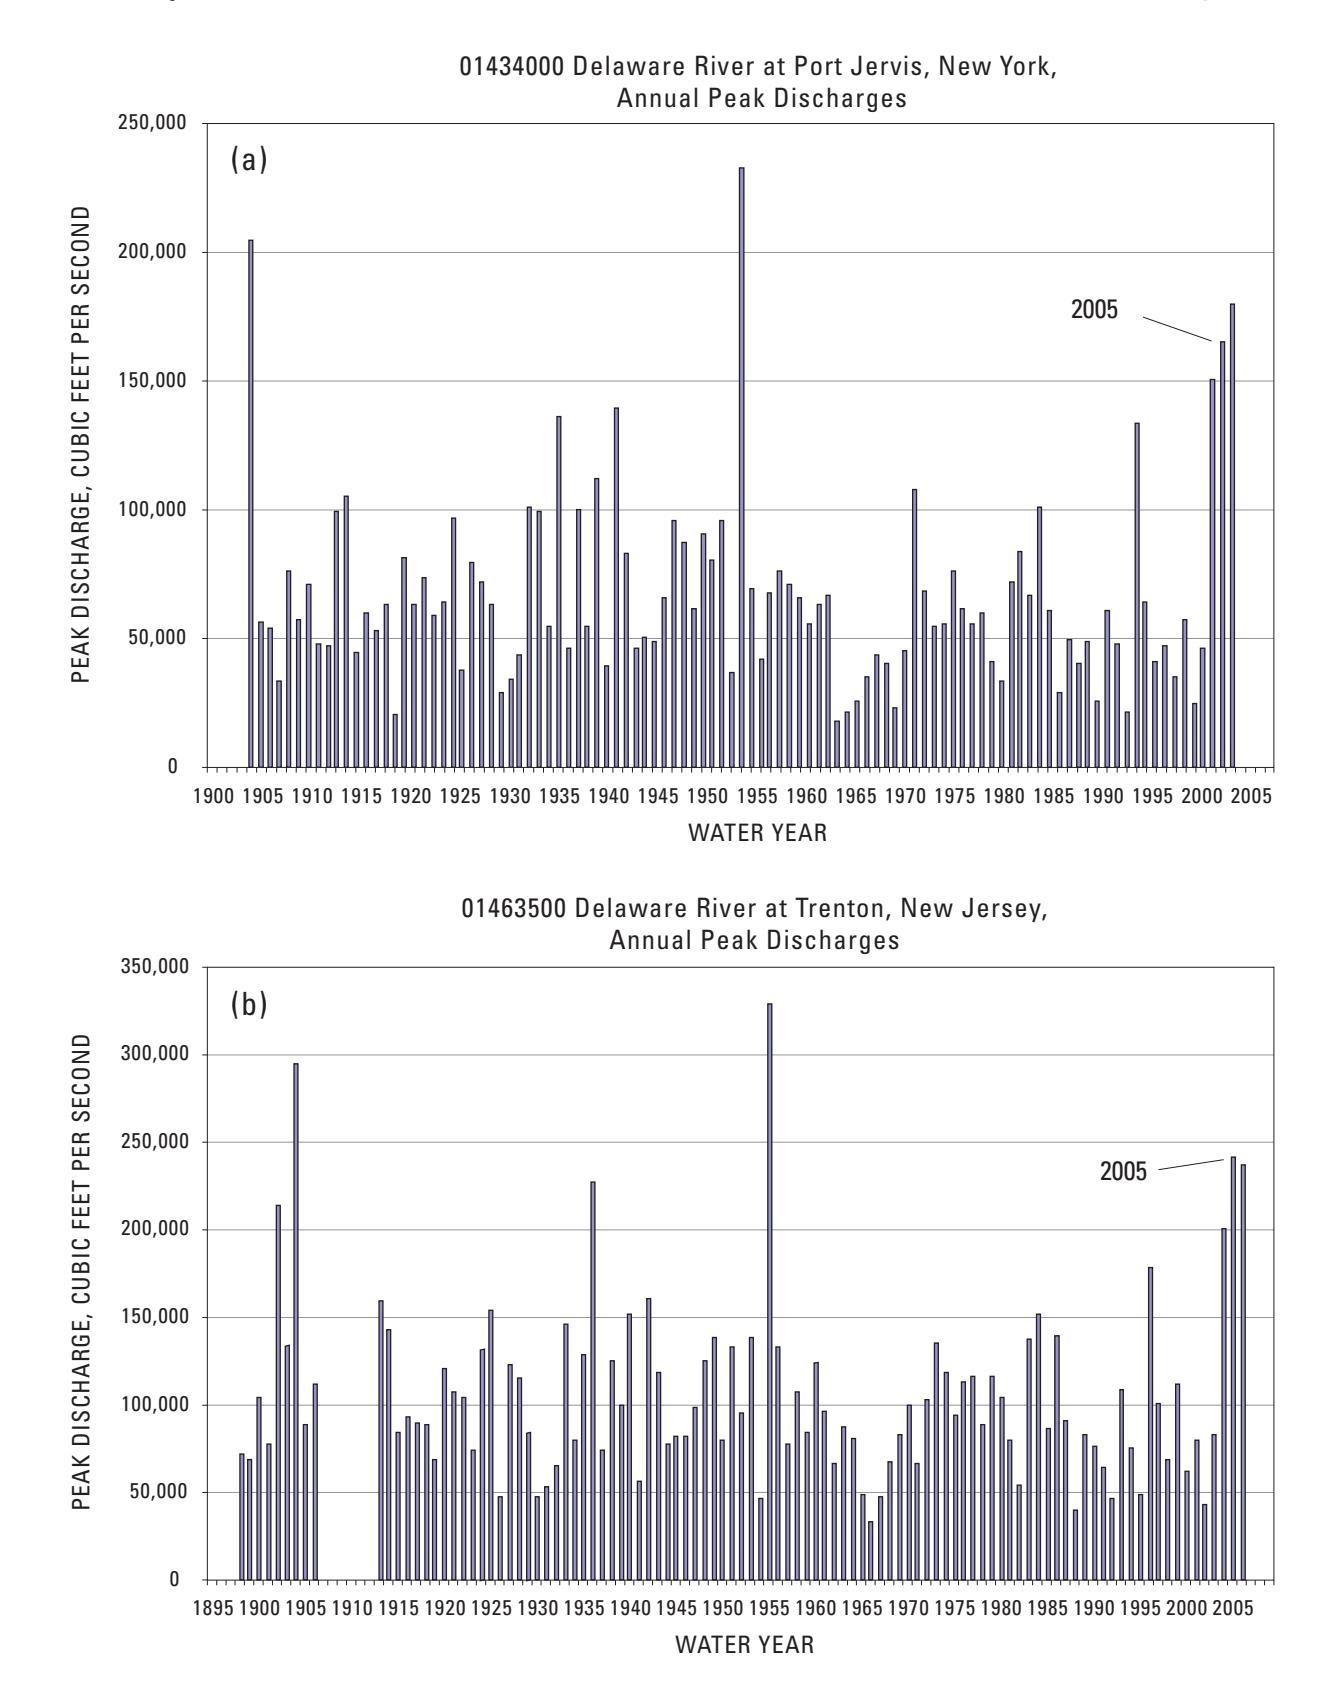
Figure 7. Annual peak discharges for the Delaware River at (a) Port Jervis, New York, and (b) Trenton, New Jersey for the respective periods of record. (Water year is defined as 12-month period from October 1 through September 30, and is designated by the calendar year in which it ends. Thus, the year ending September 30, 2002, is called the "2002 water year.")

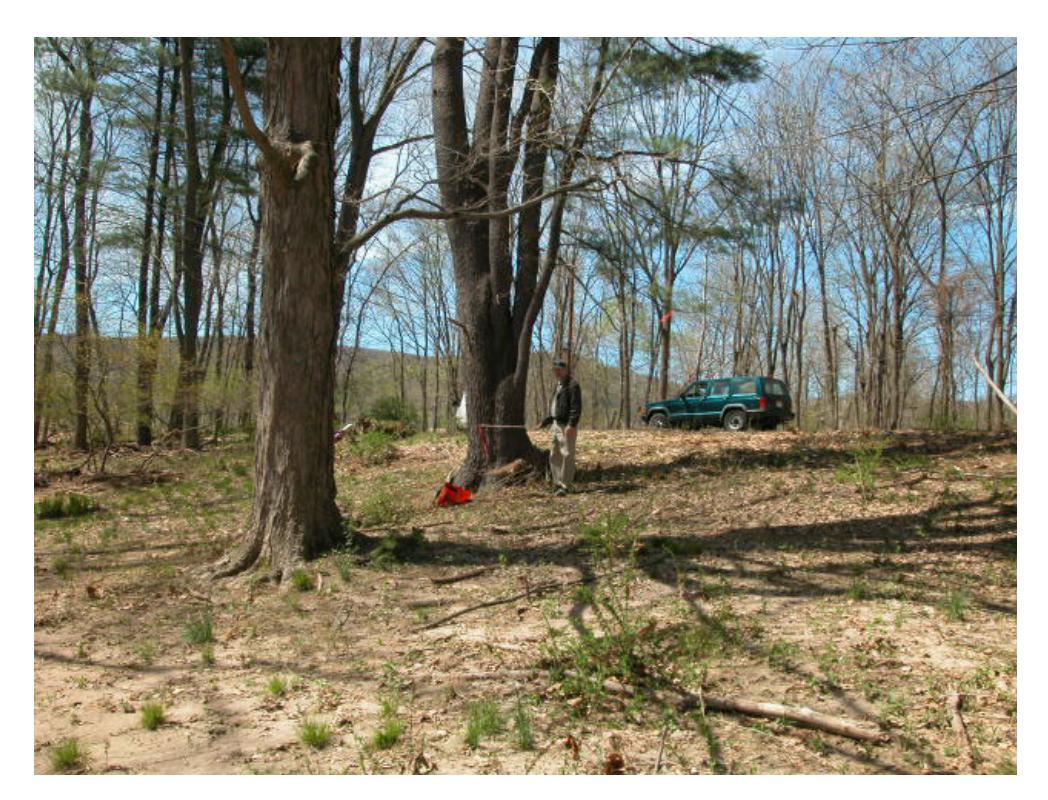
High-water mark PA 1.1 (lat 41° 20' 59.0", long 74° 43' 22.0"), at an elevation of 420.3 feet above NGVD 29, is a good seed line on a 3-foot diameter tree, 3.4 feet above the ground, and was marked with a metal USGS washer and nail.

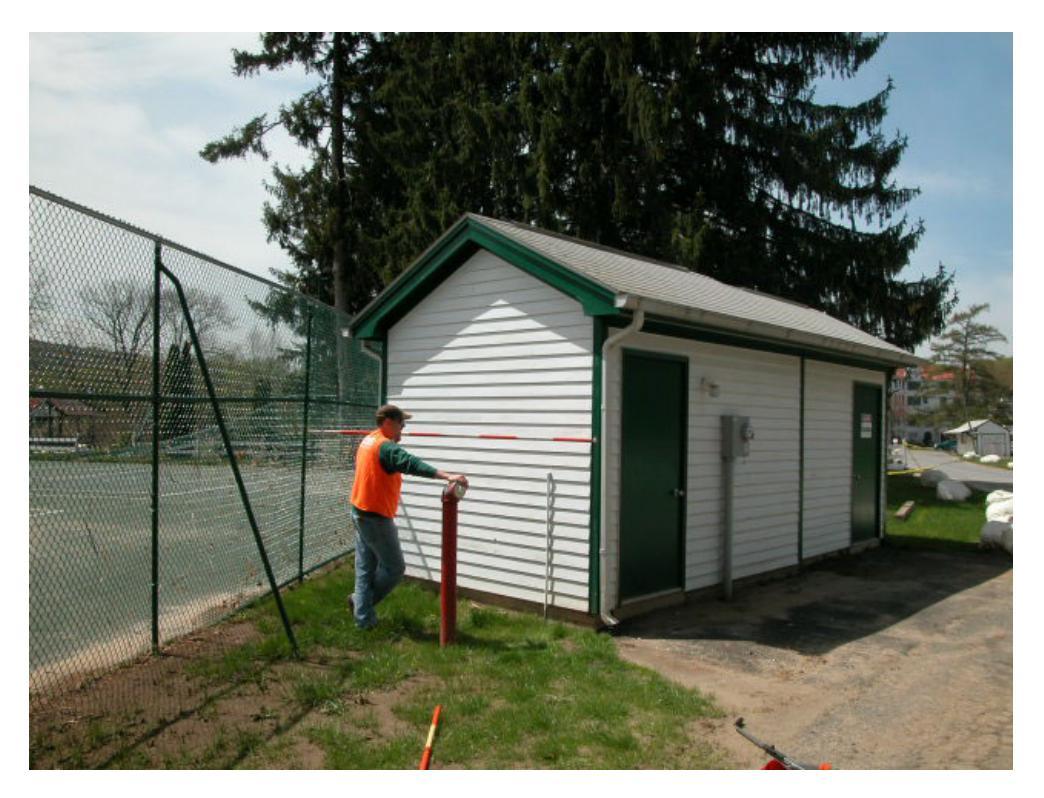
High-water mark PA 5.3 (lat 41° 00' 23.8", long 75° 06' 30.6"), at an elevation of 324.3 feet above NGVD 29, is an excellent mud line on a building (pool maintenance shed), 5.2 feet above the ground, near the Shawnee Inn, and was marked with a metal USGS washer and nail.

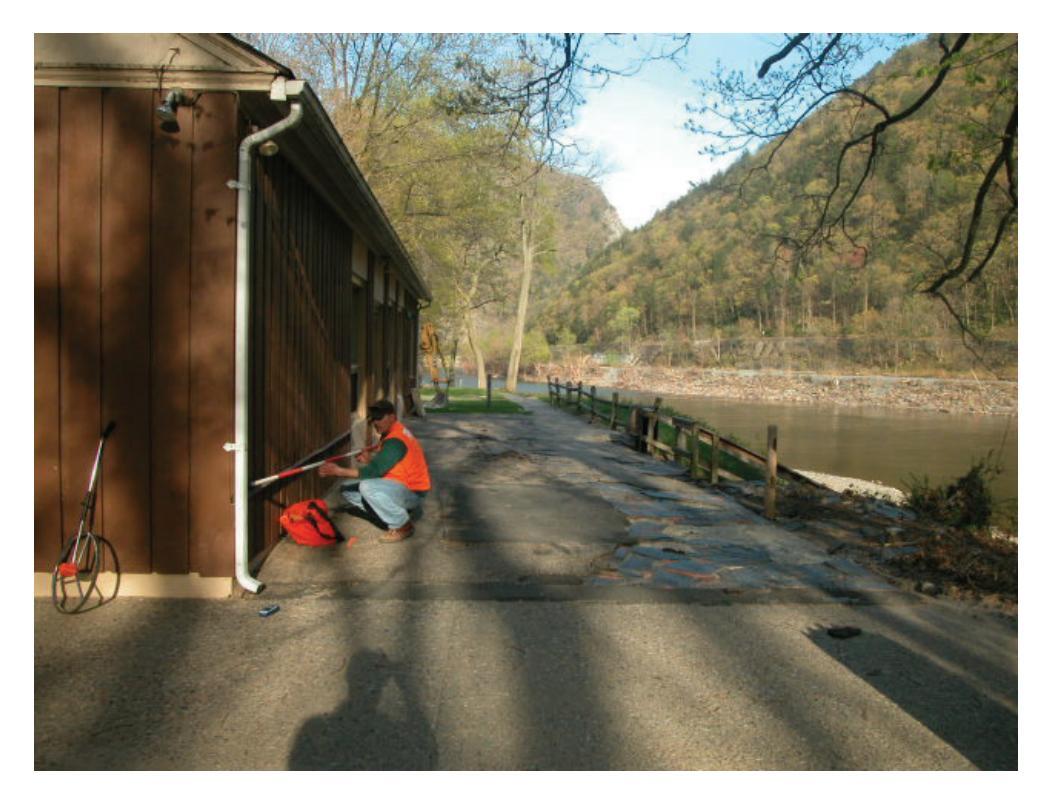
High-water mark NJ 4.7 (lat 40° 58' 12.0", long 75° 07' 48.0"), at an elevation of 316.6 feet above NGVD 29, is an excellent mud line on a building, 2.1 feet above the ground, 320 feet downstream from USGS reference mark 241, and was marked with a metal USGS washer and nail.

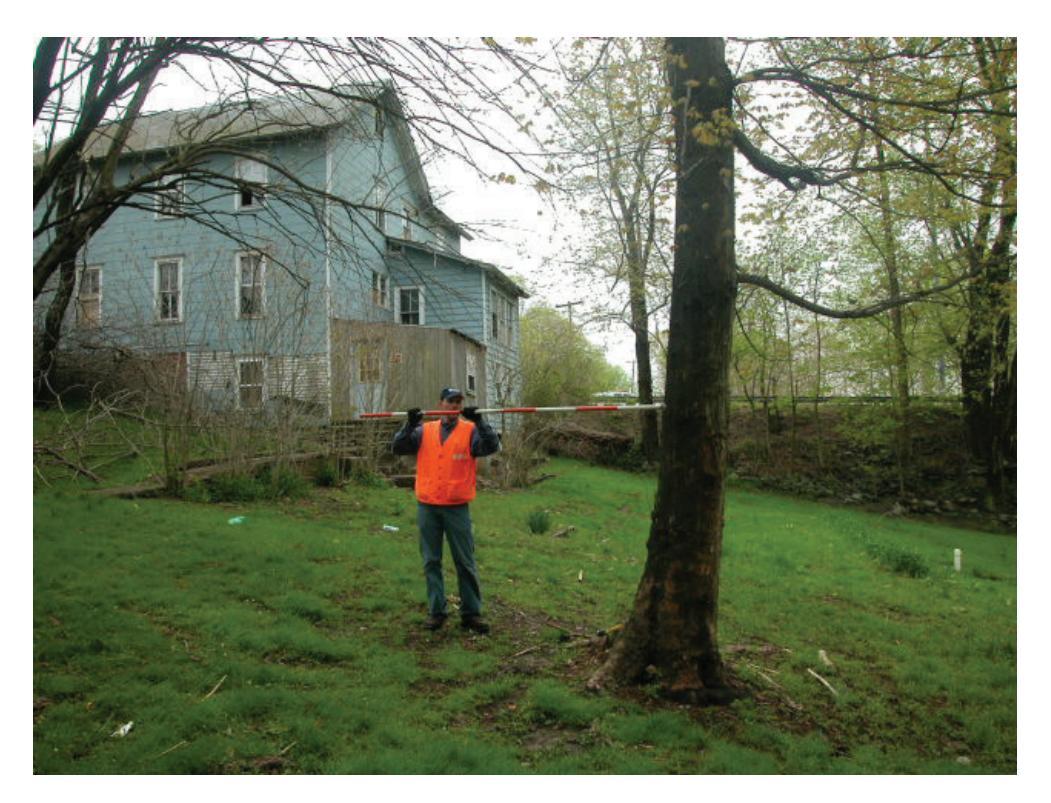
High-water mark NJ 5.3 (lat 40° 55' 31", long 75° 05' 40"), at an elevation of 294.4 feet above NGVD 29, is a good seed line on a 1.4-foot diameter tree, 6 feet above the ground, 1,520 feet upstream from the Columbia-Portland bridge, and was marked with a metal USGS washer and nail.

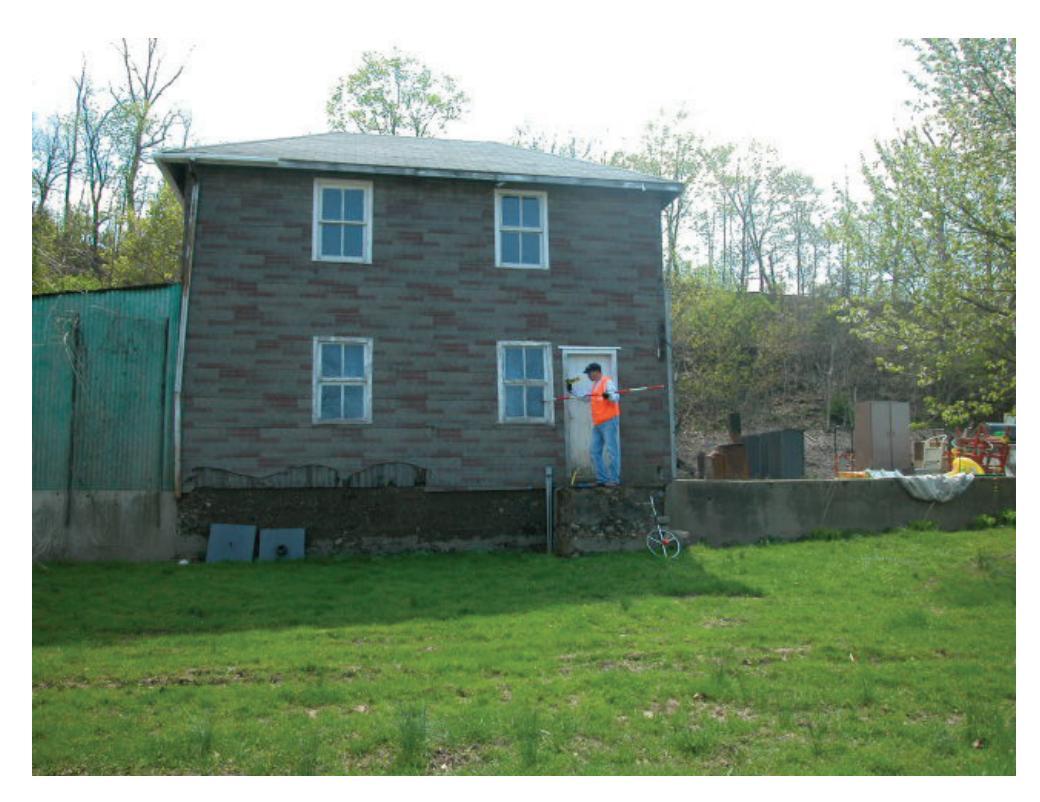
High-water mark NJ 9.1 (lat 40° 46' 27", long 75° 07' 50"), at an elevation of 225.7 feet above NGVD 29, is an excellent mud line on a house, 7.7 feet above the ground, 0.14 miles upstream from Buckhorn Creek, and was marked with a black marker line on window.

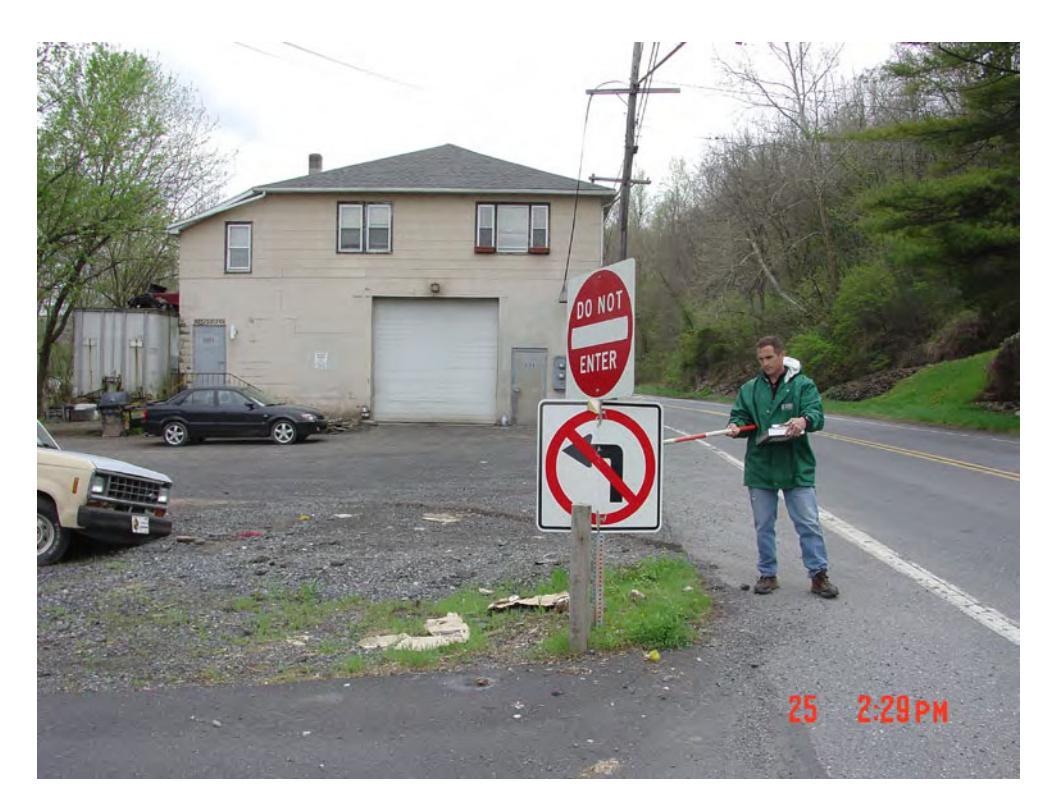
High-water mark PA 10.3 (lat 40° 46' 20.0", long 75° 10' 41.1"), at an elevation of 214.9 feet above NGVD 29, is a good mud line on the back of a street sign, 3.4 feet above the ground, 0.3 miles downstream from Martins Creek, and was marked with a black marker line.

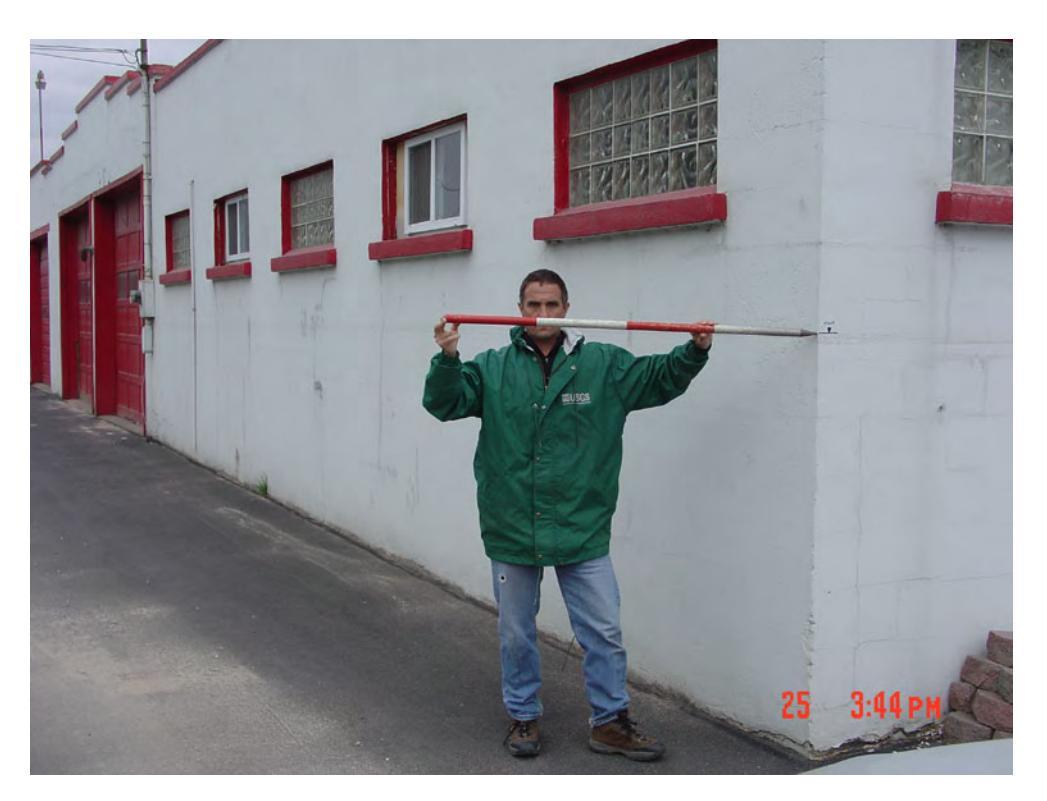
High-water mark PA 11.3 (lat 40° 45' 29.7", long 75° 11' 21.9"), at an elevation of 209.7 feet above NGVD 29, is an excellent mud line on a building, 5.0 feet above the ground, 200 feet upstream from Martins Creek, and was marked with a black marker line.

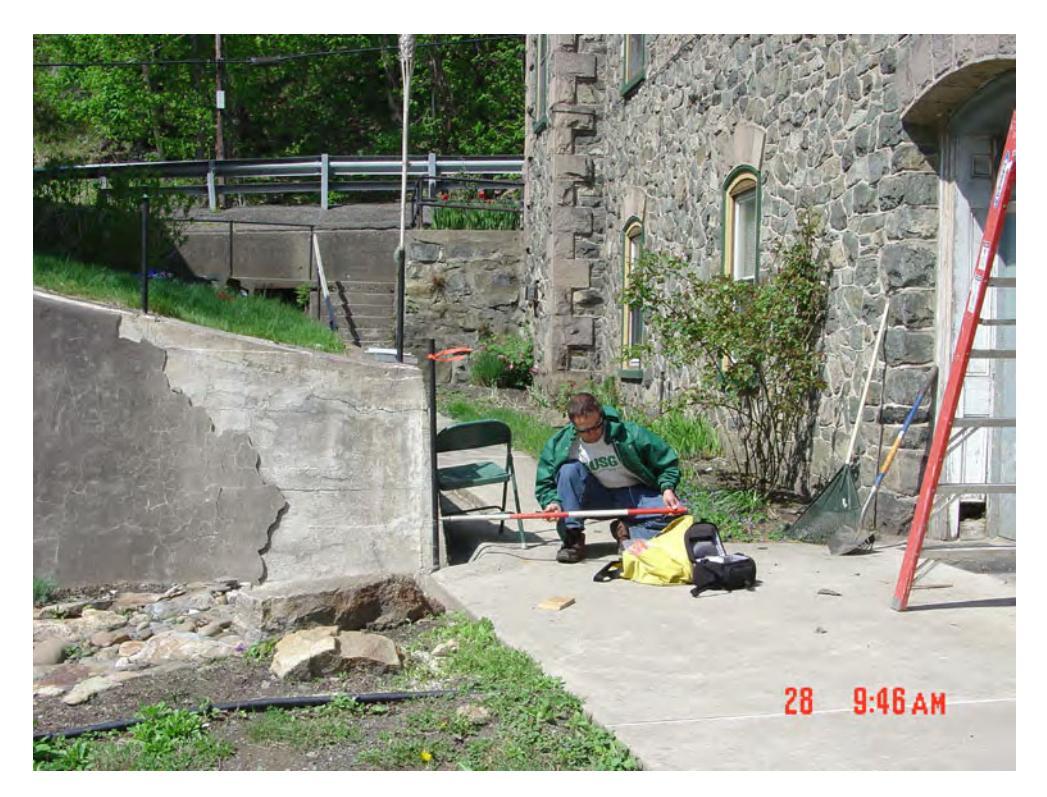
High-water mark PA 16.3 (lat 40° 38' 18.4", long 75° 11' 39.9"), at an elevation of 172.8 feet above NGVD 29, is a good mud line on a metal post next to a church on PA State Route 611, 0.9 feet above the ground, 2.0 miles upstream from Frya Run, and was marked with a black marker line.

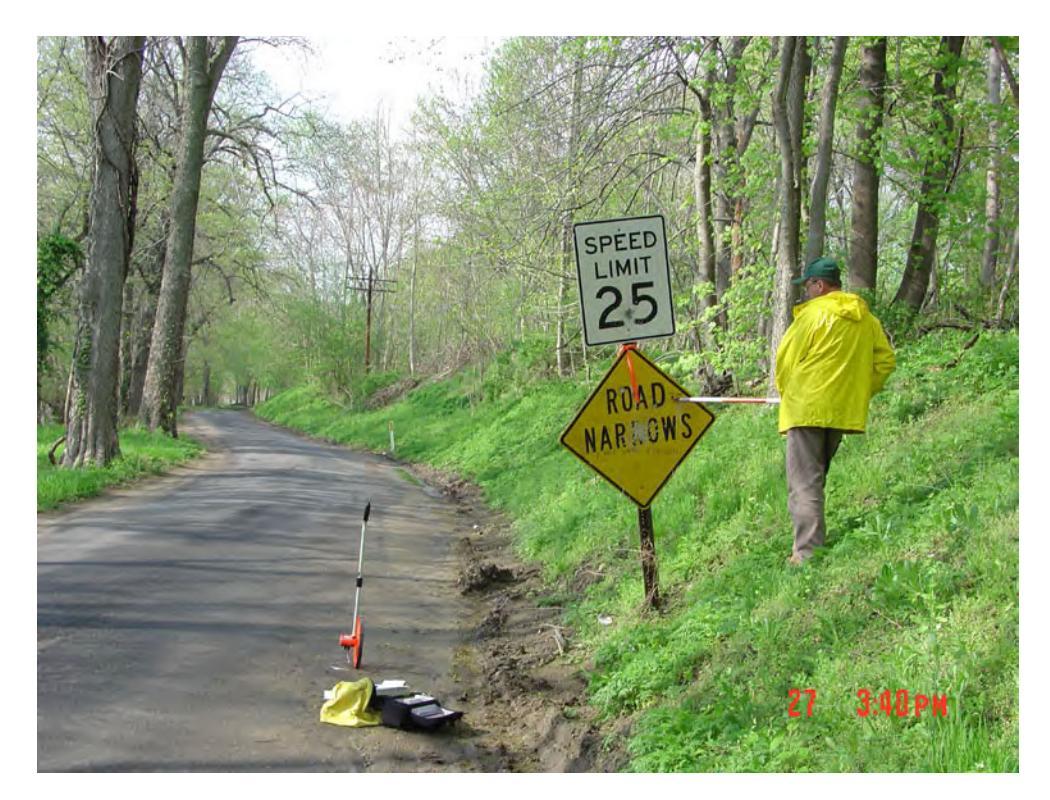
High-water mark NJ 15.5 (lat 40° 35' 45.7", long 75° 11' 24.8"), at an elevation of 156.7 feet above NGVD 29, is an excellent mud line on a"ROAD NARROWS" sign, 4.6 feet above the ground, 560 feet upstream from the Riegelsville bridge, and was marked with a black marker line.

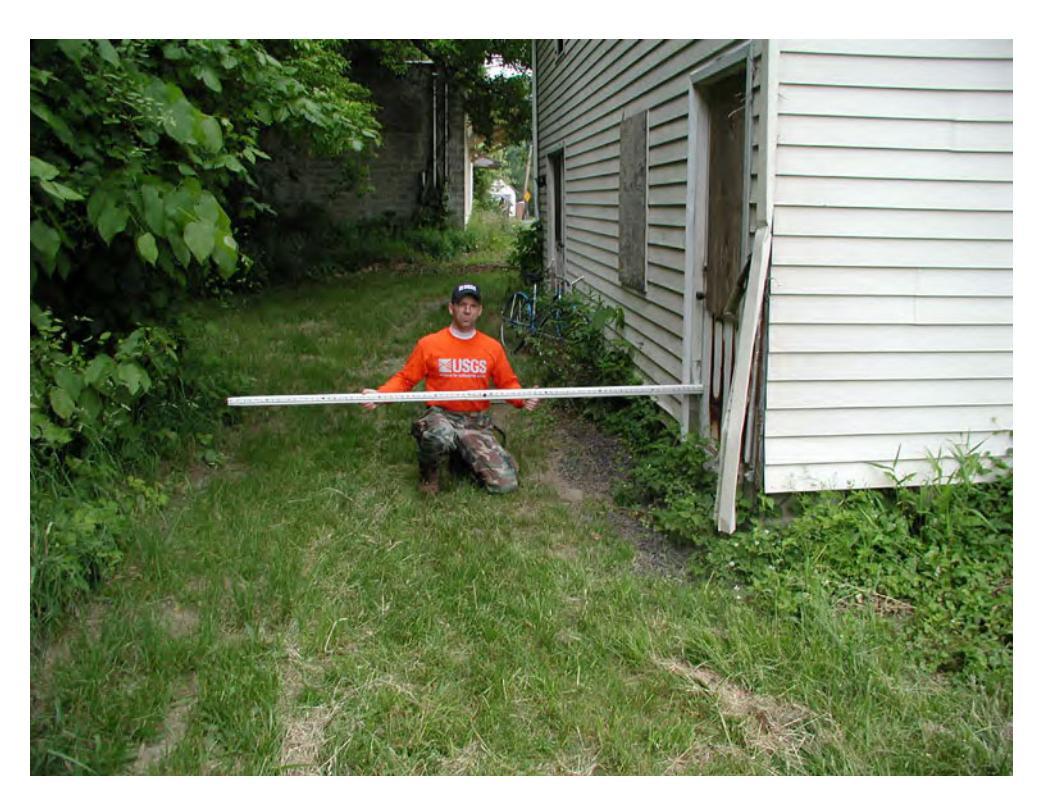
High-water mark NJ 16.3 (lat 40° 33' 59.8", long 75° 05' 48.4"), at an elevation of 134.5 feet above NGVD 29, is an excellent mud line on the door of a house, 2.0 feet above the ground, 290 feet downstream from the Bridge Street bridge, and was marked with a black marker line.

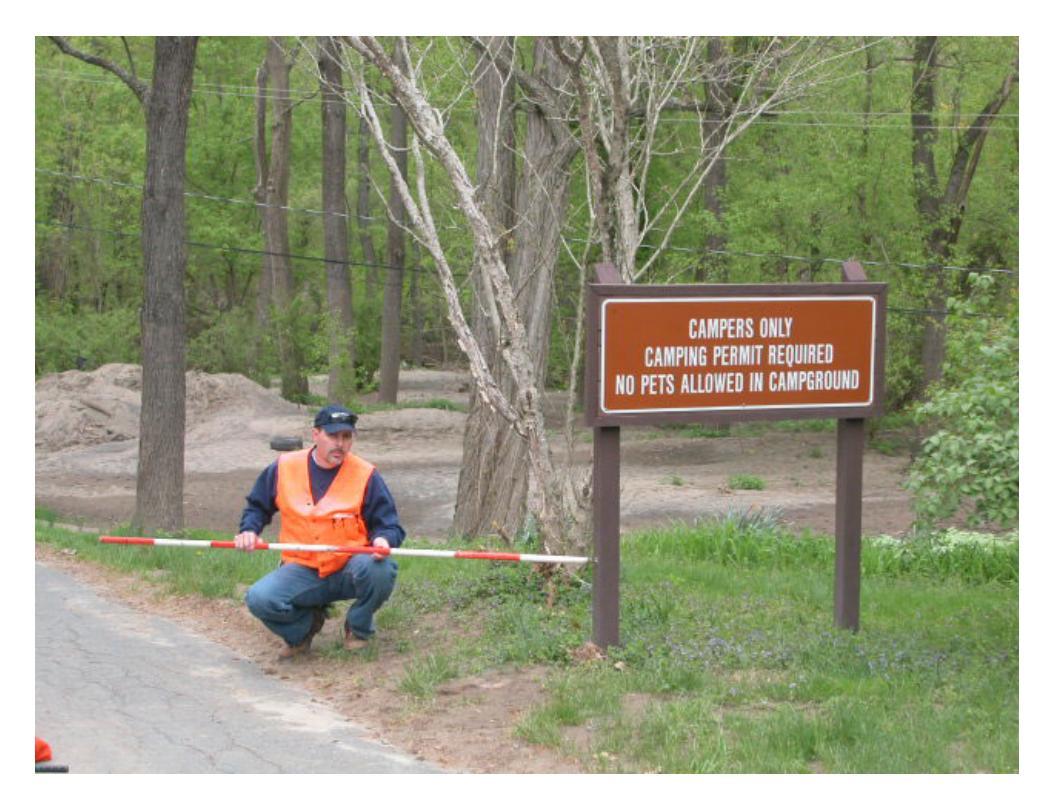
High-water mark NJ 18.3 (lat 40° 24' 36.0", long 75° 02' 09.0"), at an elevation of 96.3 feet above NGVD 29, is a good mud line on the "Campers Only" sign post on Bulls Island, 1.5 feet above the ground, 150 feet upstream from Quarry Road, and was marked with a metal USGS washer and nail.

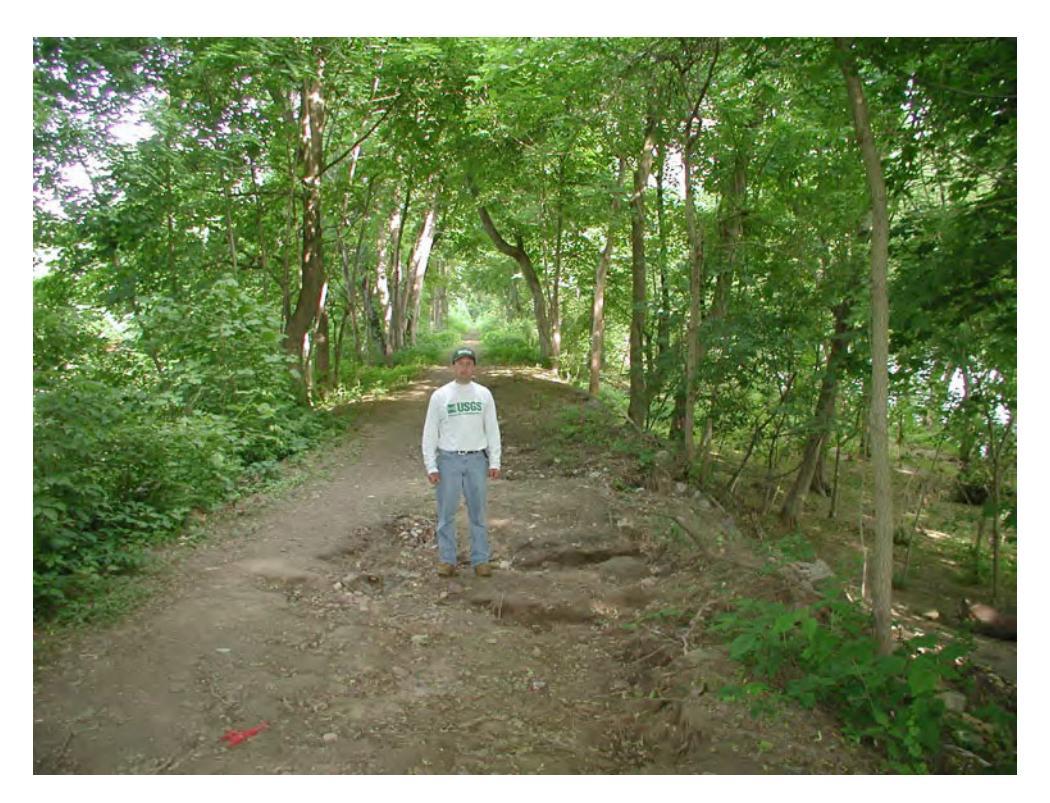
High-water mark NJ 19.5 for the Delaware River (lat 40° 24' 15.0", long 74° 58' 42.0"), at an elevation of 80.0 feet above NGVD 29, is a poor debris line on the ground at the canal path, 44 feet downstream from the Bridge Street bridge, and was marked with a metal rebar.

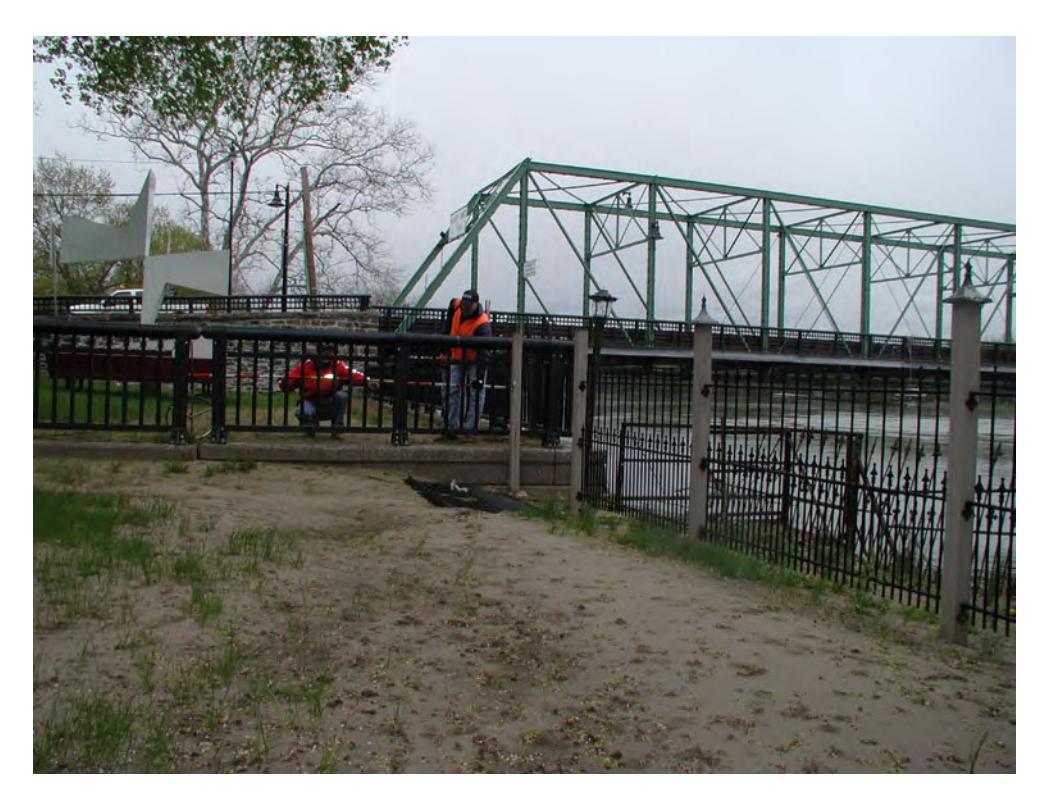
High-water mark PA 23.1 (lat 40° 21' 51.5", long 74° 57' 2.1"), at an elevation of 68.7 feet above NGVD 29, is an excellent mud line on a railing, 2.1 feet above the ground, 50 feet downstream from the East Bridge Street bridge, and was marked with a yellow grease pencil line.

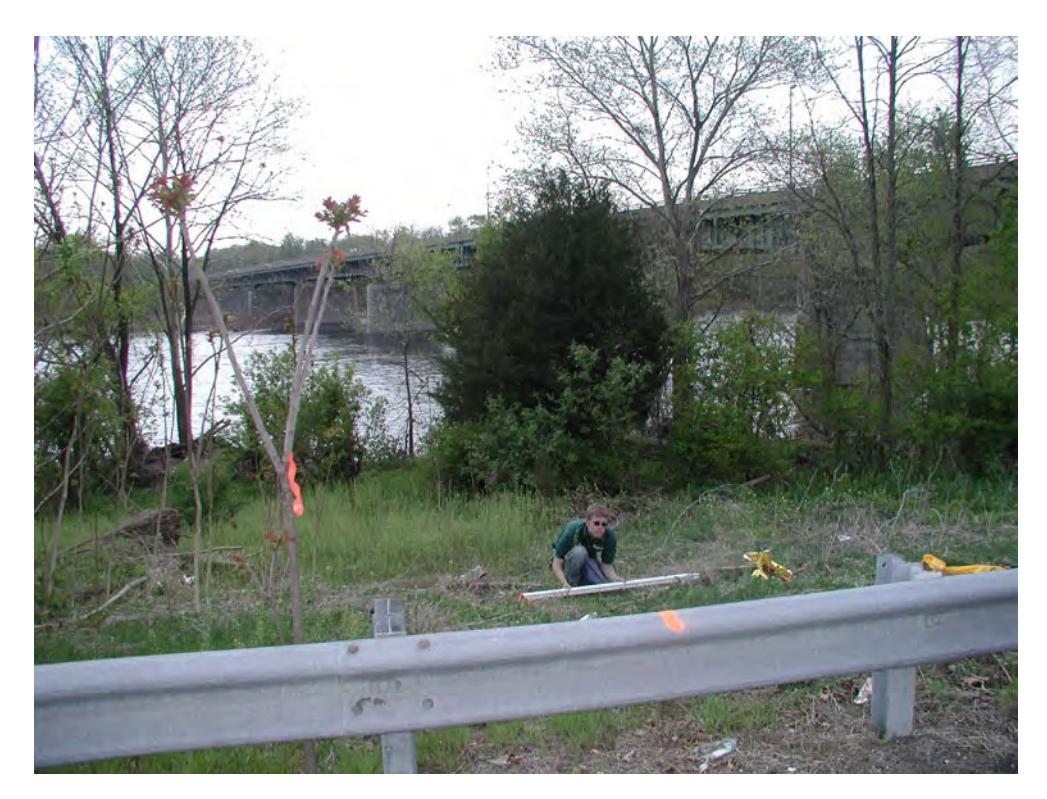
High-water mark NJ 23.1 (lat 40° 15' 33.2", long 74° 50' 43.1"), at an elevation of 42.2 feet above NGVD 29, is a fair debris line on the embankment, 177 feet downstream from the Interstate Route 95 bridge, and was marked with a metal rebar.

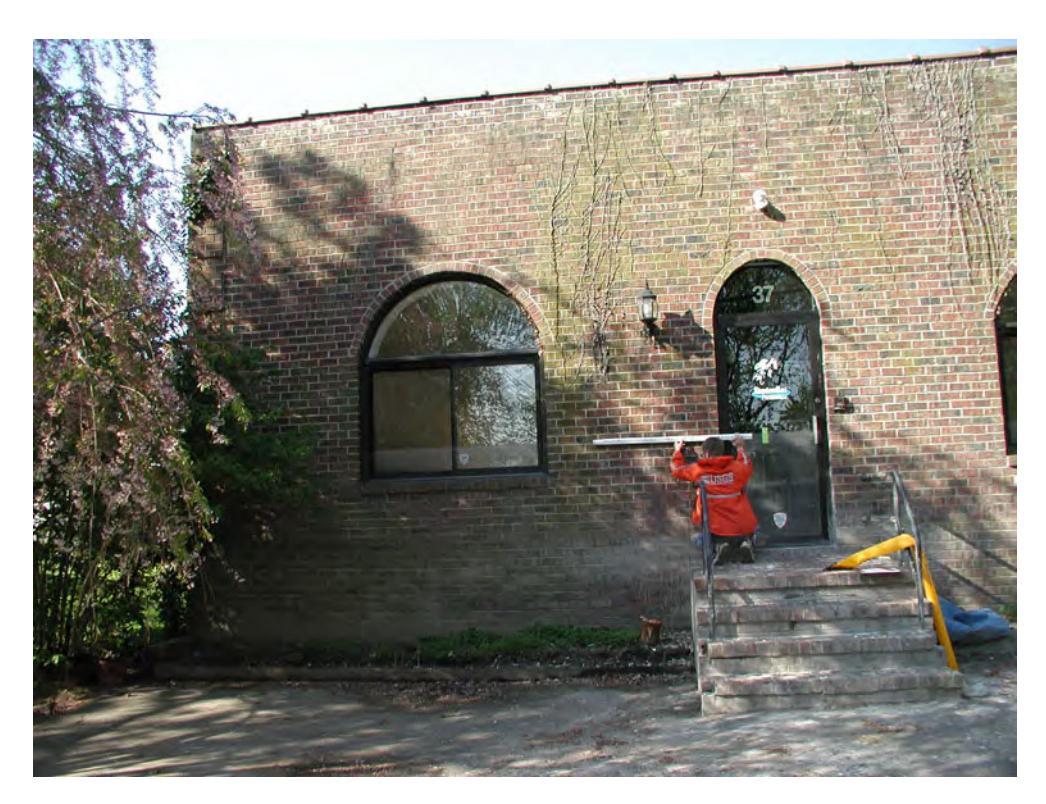
High-water mark PA 27.3 (lat 40° 14' 37.2", long 74° 50' 0.0"), at an elevation of 37.3 feet above NGVD 29, is an excellent mud line on the door of a building, 6 feet above the ground, 1.3 miles downstream from the Interstate Route 95 bridge, and was marked with a metal USGS washer and nail.
