Flood of April 2-4, 2005, Delaware River Main Stem from Port Jervis, New York, to Cinnaminson, New Jersey

Prepared in cooperation with the Federal Emergency Management Agency

Scientific Investigations Report 2007-5067

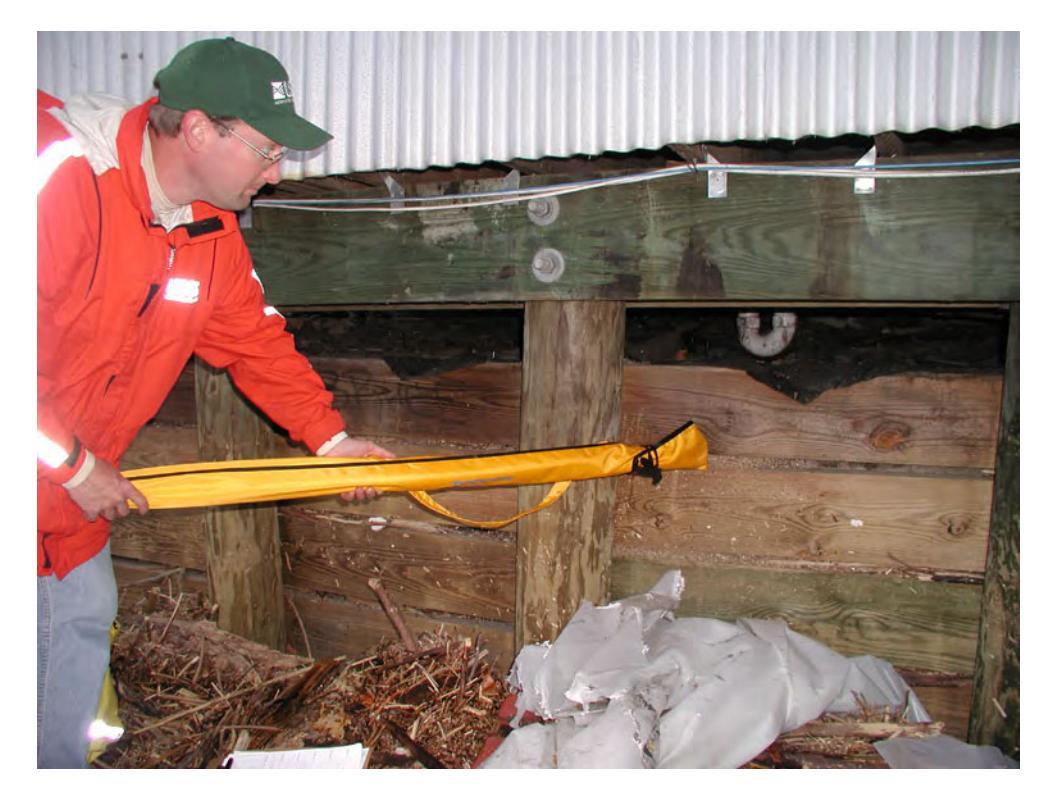
High-water mark NJ 27.3 (lat 40° 12' 25.2", long 74° 45' 55.1"), at an elevation of 16.9 feet above NGVD 29, is a good seed line on the deck of a restaurant (Kat Man Du), 1,000 feet downstream from the US Route 1 bridge. NOTE: The mark was transferred from under the deck to a 2-foot diameter tree nearby and marked with a metal USGS washer and nail (transferred mark on tree is about 7 feet above the ground).

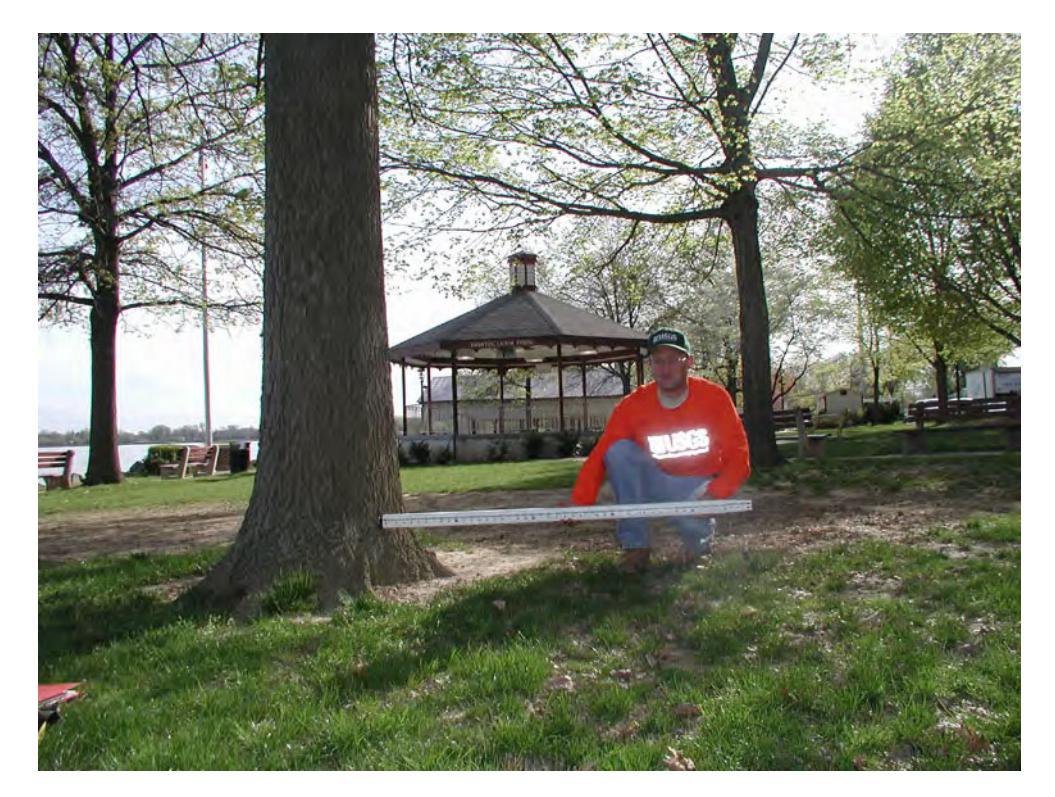
High-water mark PA 32.1 (lat 40° 05' 38.3", long 74° 51' 26.3") at an elevation of 9.1 feet above NGVD 29, is a good seed line on a 2.3-foot diameter tree at Bristol Lions Park, 2.4 feet above the ground, 1.2 miles upstream from Burlington-Bristol Bridge, and was marked with a metal USGS washer and nail.
